Technical Service Information

THM 4T60-E 1-2 ROLLER CLUTCH FAILURE

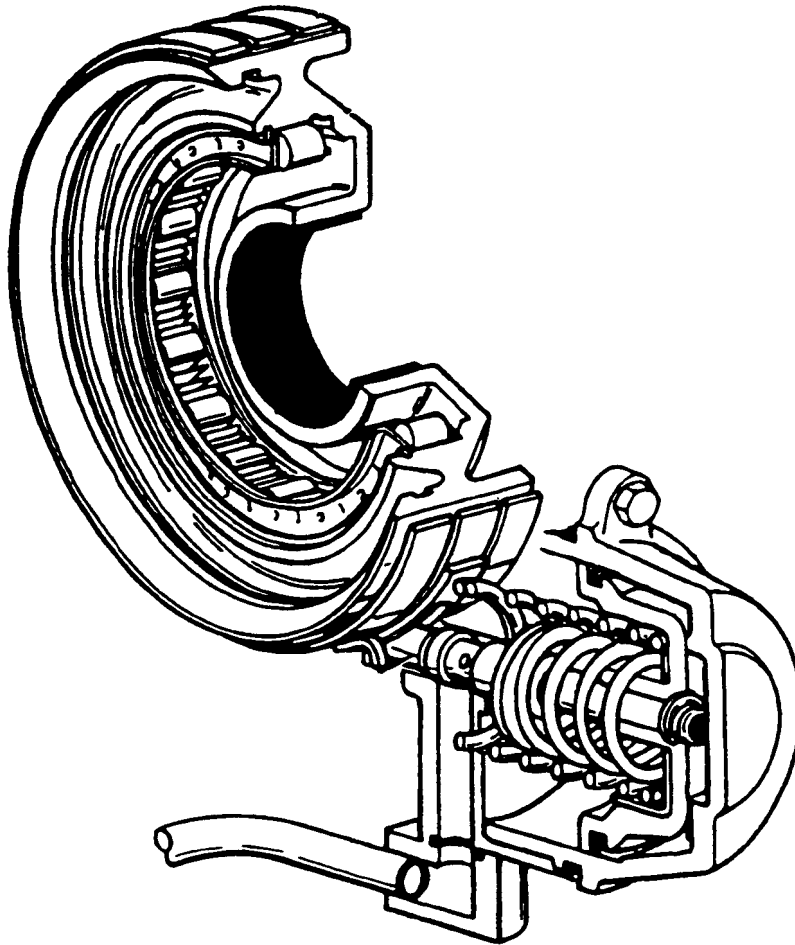
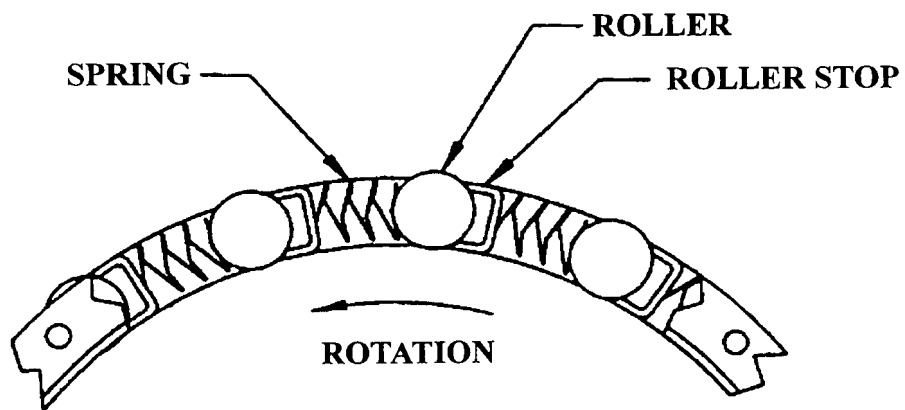
Figure 1

COMPLAINT: NO. 1: Some 1991-1995 model vehicles equipped with the THM 4T60-E transaxle may exhibit a no movement condition, with the selector lever in the D4 or D3 ranges, but will move when the selector lever is placed into D2 or Lo range.

CAUSE: NO. 2: When the engine RPM is increased with the selector lever in the Park or Neutral position, you may hear a noise that sounds like “Marbles in a Can”, but still moves and shifts properly.

CORRECTION: The cause for both complaints listed above is a 1-2 roller clutch failure.

1-2 ROLLER CLUTCH ASSEMBLY

Replace the 1-2 Roller Clutch Assembly and any related parts that may be damaged or 1 broken (See Figure 1). Before installing into the transaxle, always replace the OEM 1-2 roller clutch springs with Sonnax part number K84956-SP, which contains 16 stronger according springs and is available from your aftermarket parts supplier (See Figure 1).

***ALWAYS REPLACE THE 1-2 ROLLER CLUTCH SPRINGS
WITH SONNAX PART NUMBER K84956-SP***
