Technical Service Information

VOLVO 50-40LE/50-42LE NO REVERSE, 1ST OR 4TH GEAR

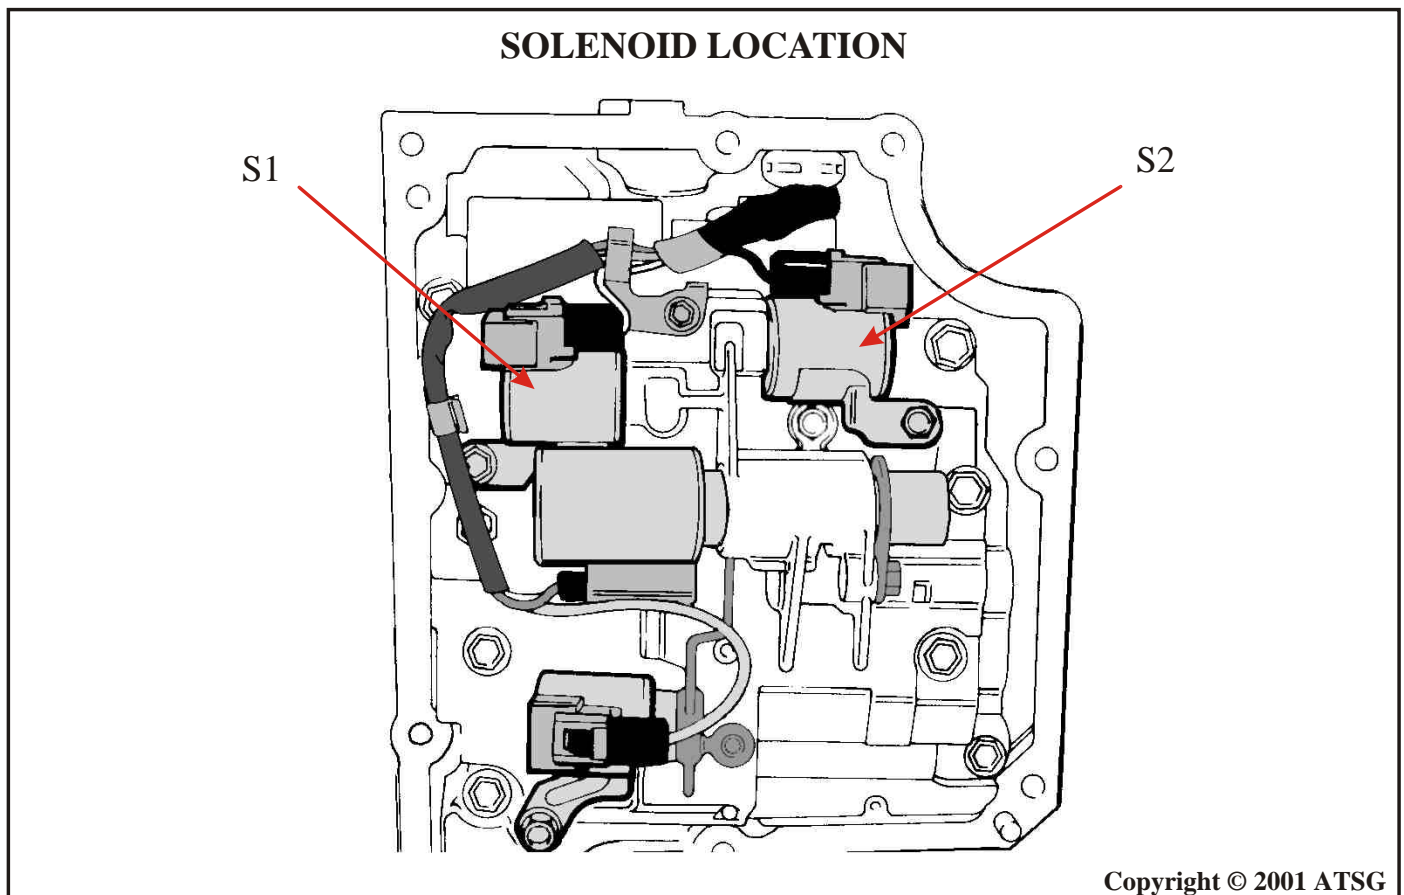
Figure 1

SOLENOID SCREENS

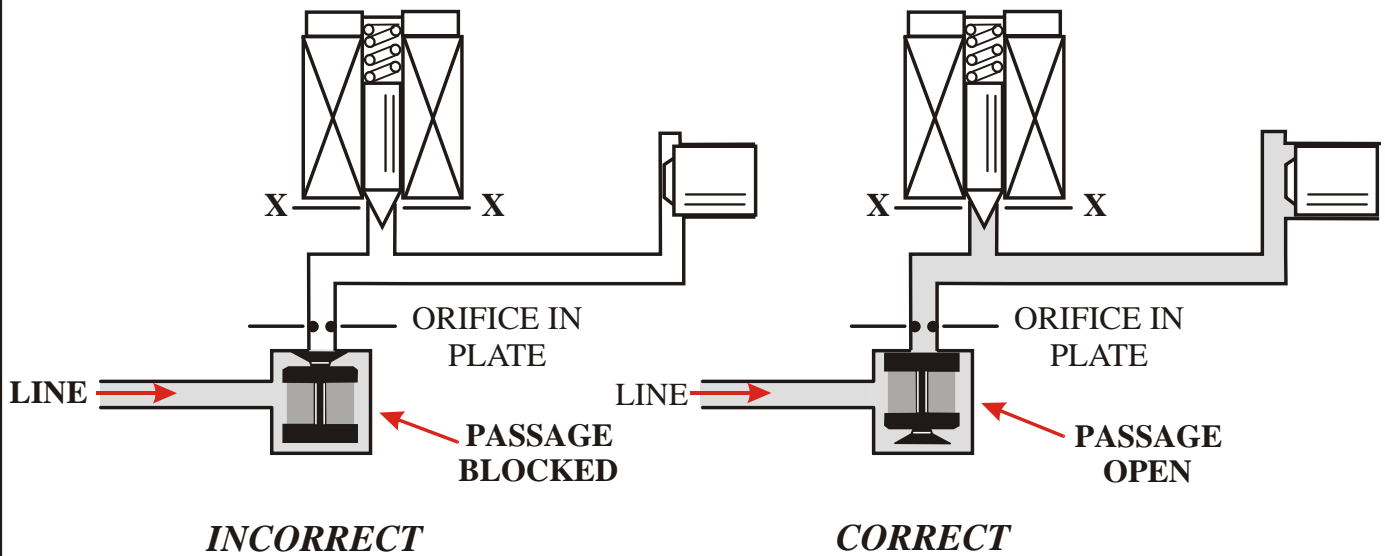
Figure 2

CAUSE: The cause may be,
1. While cleaning and servicing the valve body, the solenoid screens were installed upside down blocking solenoid feed to the shift solenoids and shift valves as shown in Figure 2. The
2. Shift solenoids are not functioning mechanically.

SOLENOID 1 AND 2 PARTIAL HYDRAULIC SCHEMATICS

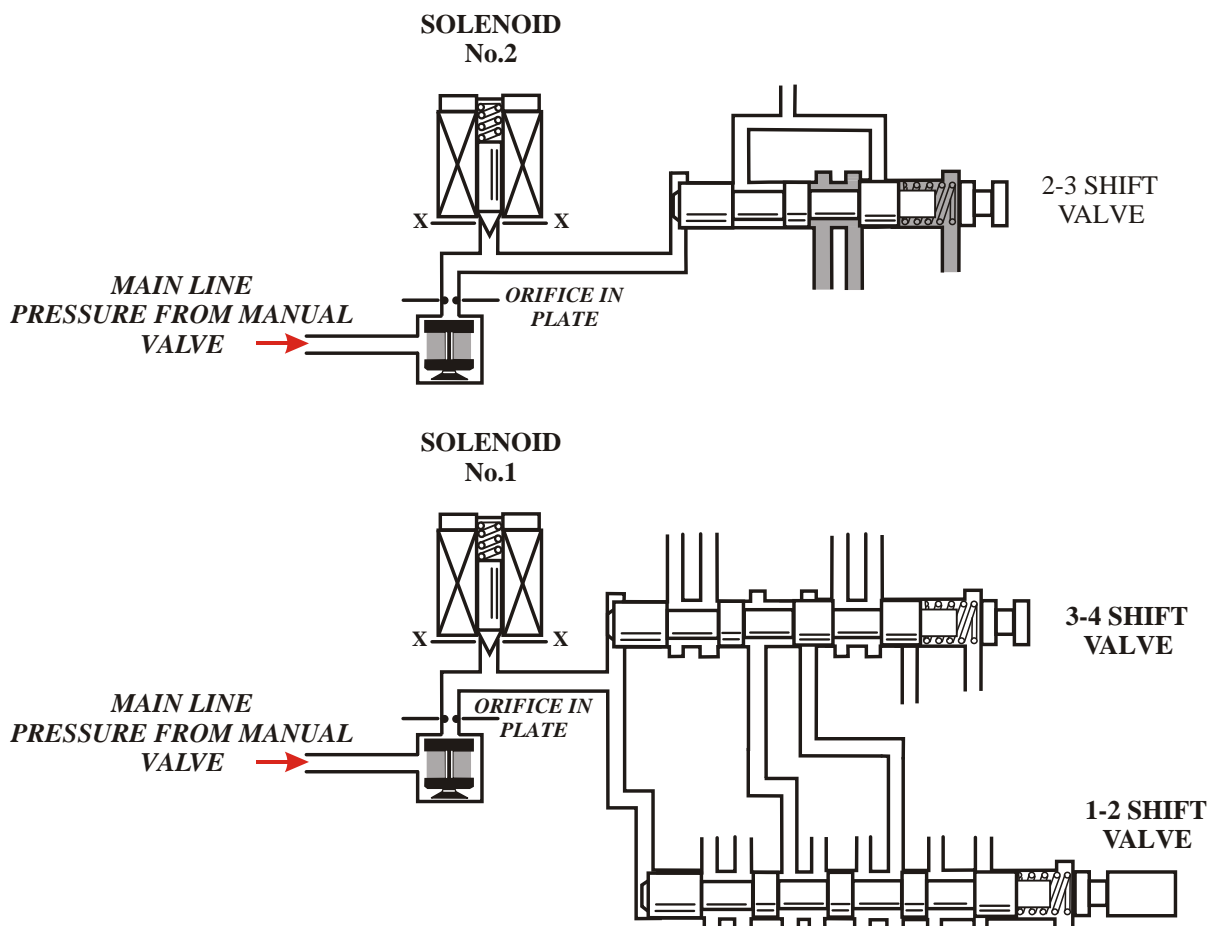
Figure 3

CENTER VALVE BODY AND SPACER PLATE

CORRECTION: Follow the corrections listed below:
1. Assemble the solenoid screens as shown in Figure 3.
2. Check the Shift Solenoids mechanically as shown in Figure 4 and replace as necessary.

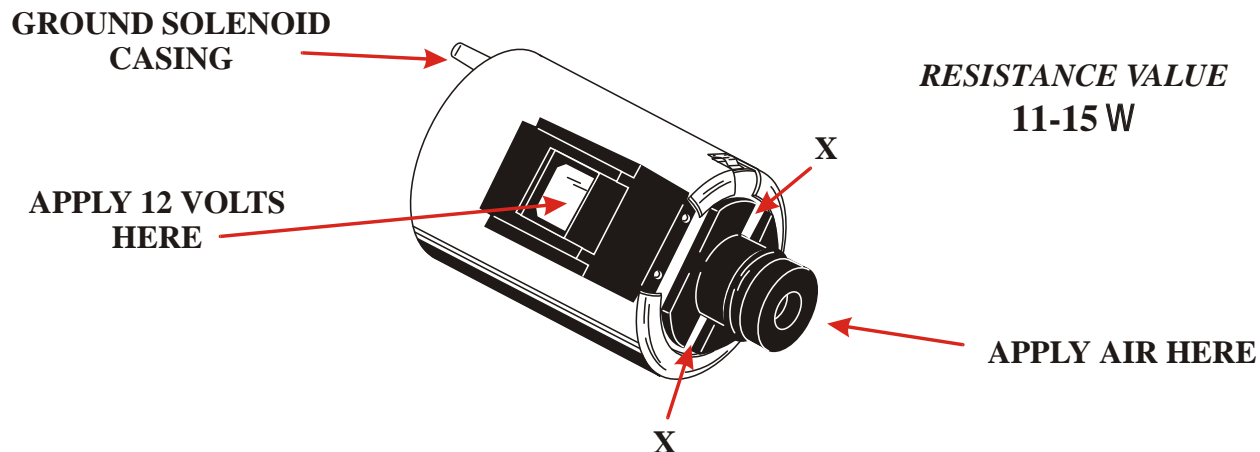
EARLY VERSION S1 "BLACK CONNECTOR"

***SOLENOID 1 IS NORMALLY CLOSED
APPLY 40-60 psi. OF AIR PRESSURE TO THE SNOOT OF SOLENOID
AIR PRESSURE MUST NOT LEAK OUT OF EXHAUST PORTS UNTIL
THE SOLENOID IS ENERGIZED***

NOTE: THE EARLY VERSION SOLENOID 1 IS NOW REPLACED BY SOLENOID 2

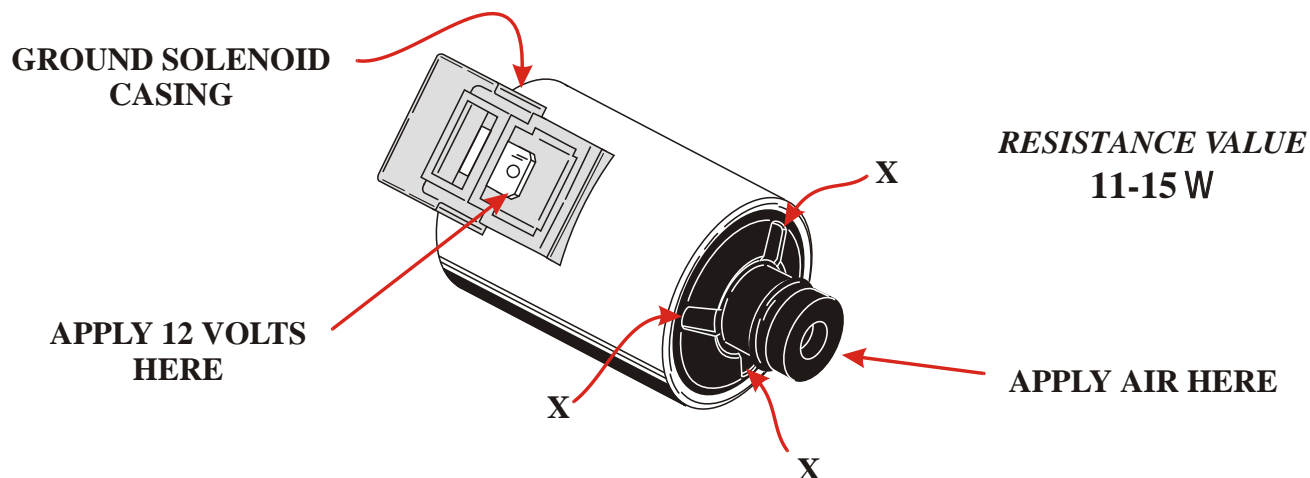
LATE VERSION S1&S2 "GREEN CONNECTOR"

***SOLENOID 2 IS NORMALLY CLOSED
APPLY 40-60 psi. OF AIR PRESSURE TO THE SNOOT OF SOLENOID
AIR PRESSURE MUST NOT LEAK OUT OF EXHAUST PORTS UNTIL
THE SOLENOID IS ENERGIZED***
