FORD AXOD

SOFT 1-2 SHIFT

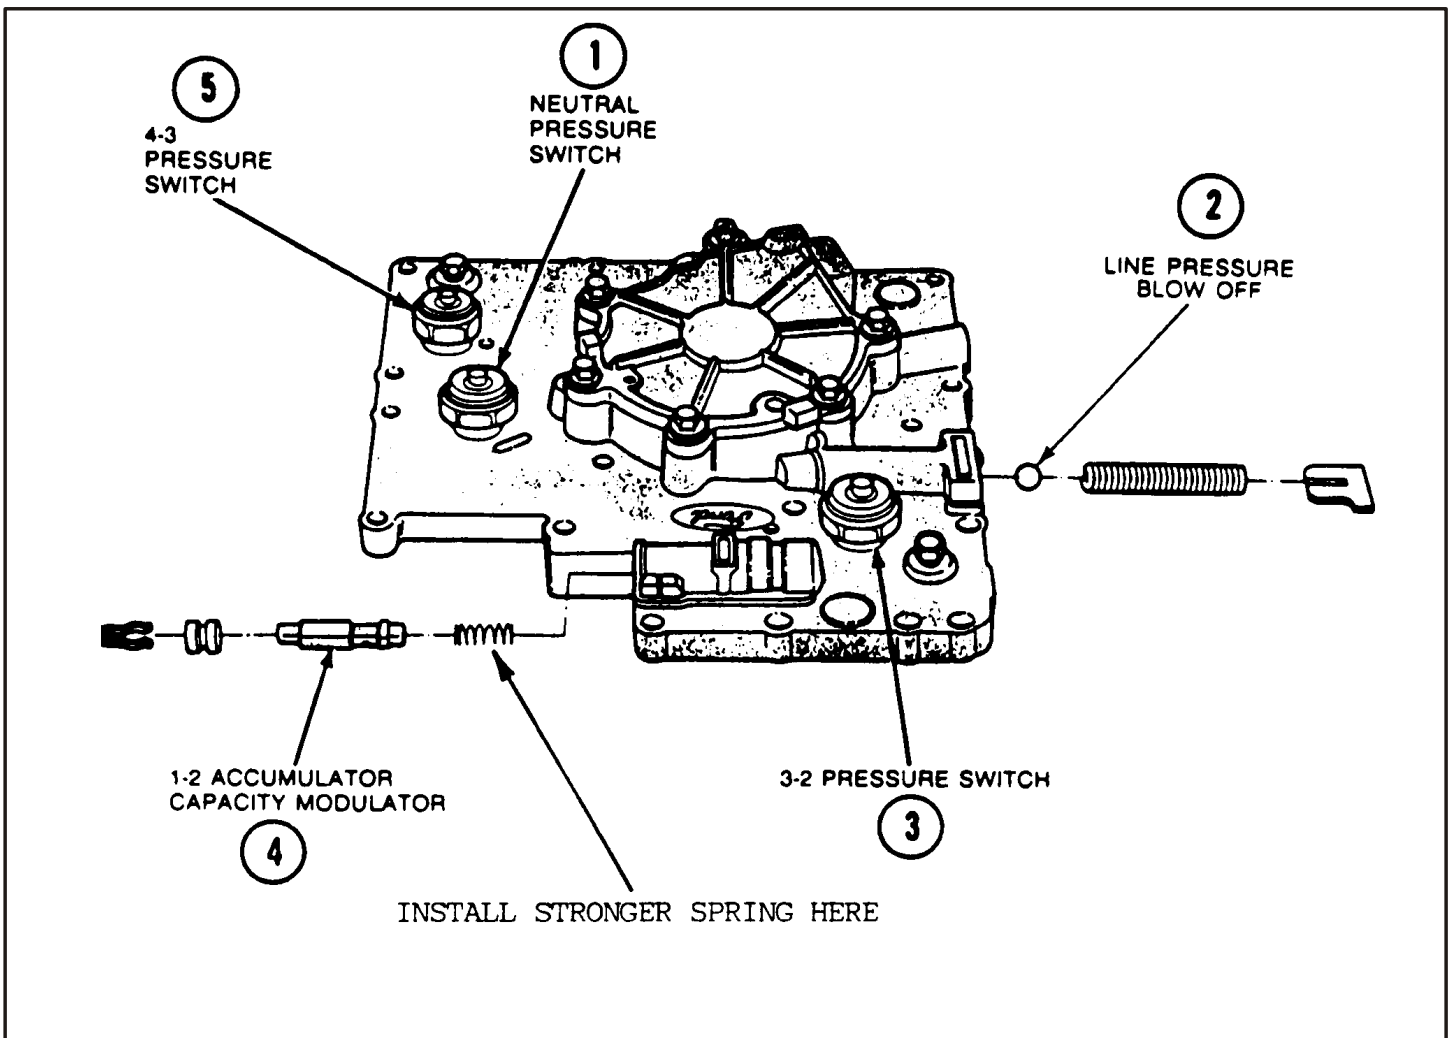
Figure 1

COMPLAINT: Soft or mushy 1-2 upshift only.

CAUSE: Fill time for intermediate clutch too slow.

CORRECTION: Install stronger spring on the 1-2 capacity modulator valve located in pump body (See Figure 1).
