Technical Service Information

MAZDA/FORD GF4A-EL NO 4TH GEAR, AFTER REBUILD

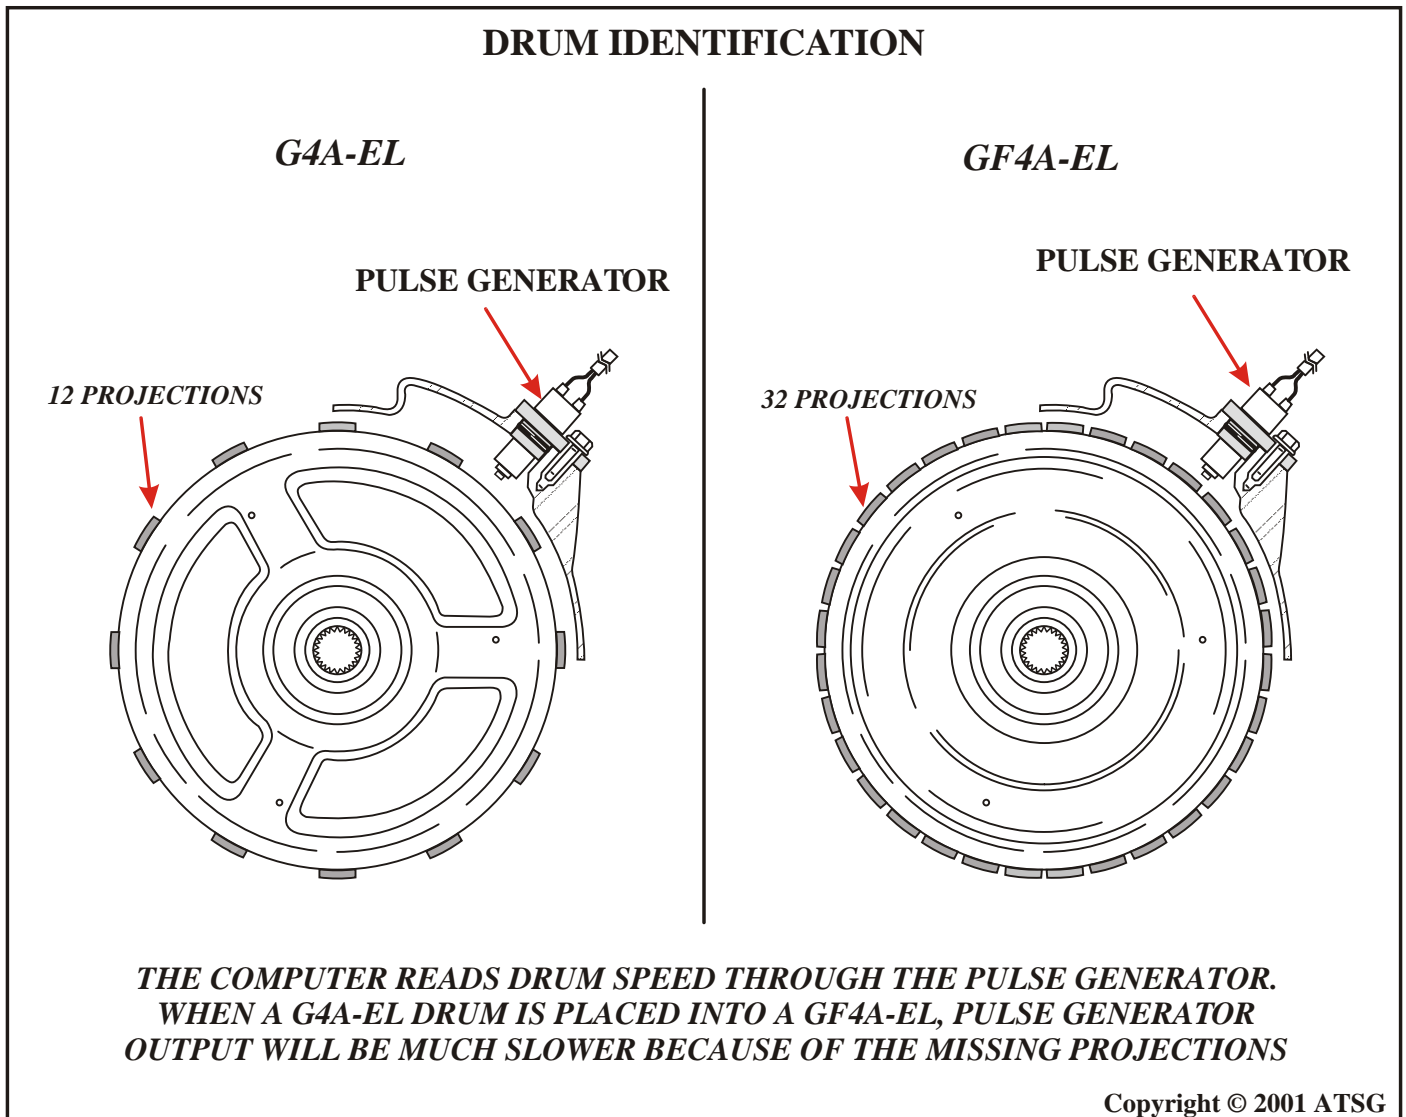
COMPLAINT: Vehicles equipped with *GF4A-EL* transaxles may exhibit a NO 4th gear condition after overhaul.

CAUSE: The cause may be, a 12 projection *G4A-EL* Reverse, Forward and Coast drum was installed into a *GF4A-EL* application, which requires a 32 projection drum. When this happens the computer will not command 4th gear because of the missing projections which results in slower drum speed.

CORRECTION: To correct this condition, refer to Figure 1 for drum identification and ensure that the 32 projection drum is installed on all *GF4A-EL* applications.
