Technical Service Information

THM 200-4R - 325 - 325-4L NO REVERSE AND NO UP-SHIFT

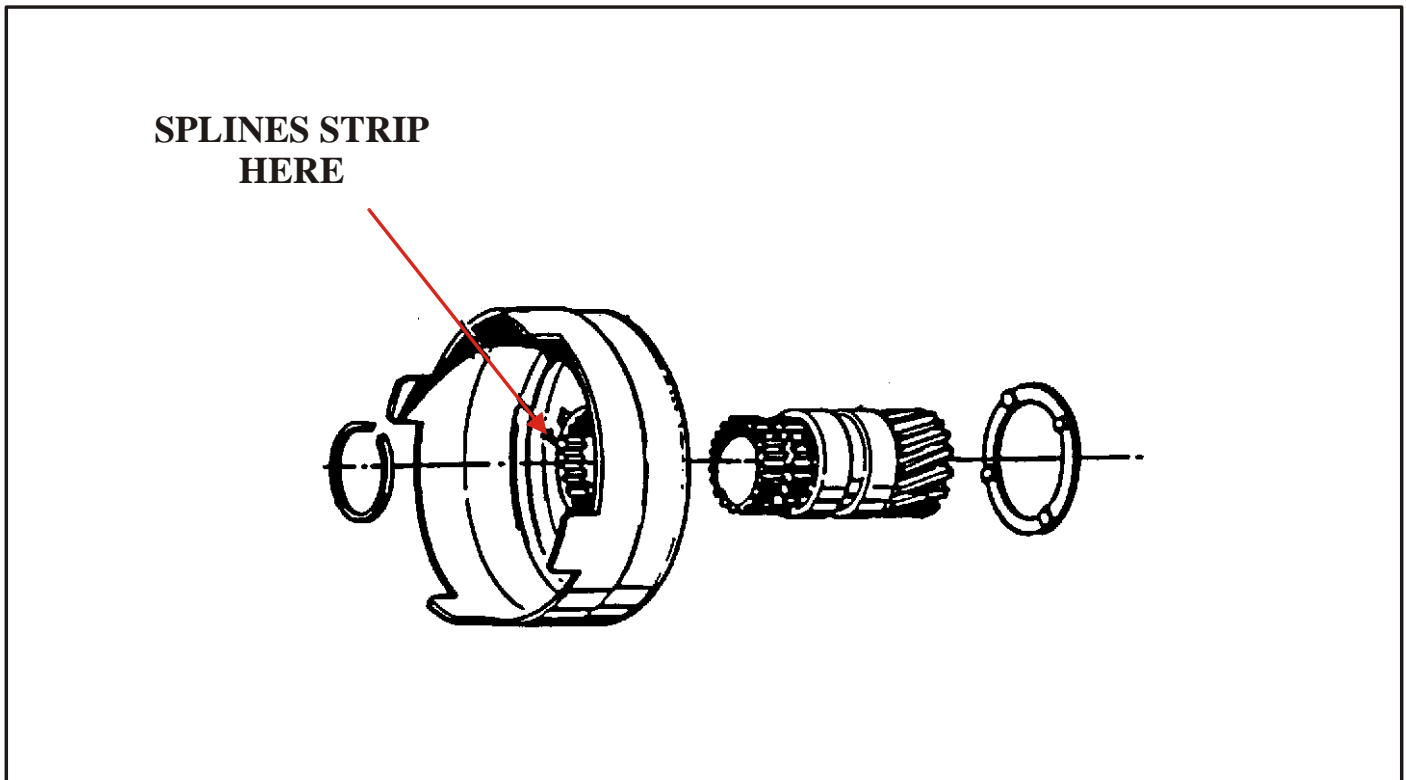
Figure 1

COMPLAINT: No Reverse no upshifts, low gear only.

CAUSE: Stripped splines on the sun gear shell as shown in Figure 1.

CORRECTION: Replace the sun gear shell. If the vehicle is used in heavy duty operation (police-taxi) a new hardened shell is available. It is a flat black in color. Part number 8648360
