NISSAN RL4R01A NO 2ND GEAR AFTER REBUILD

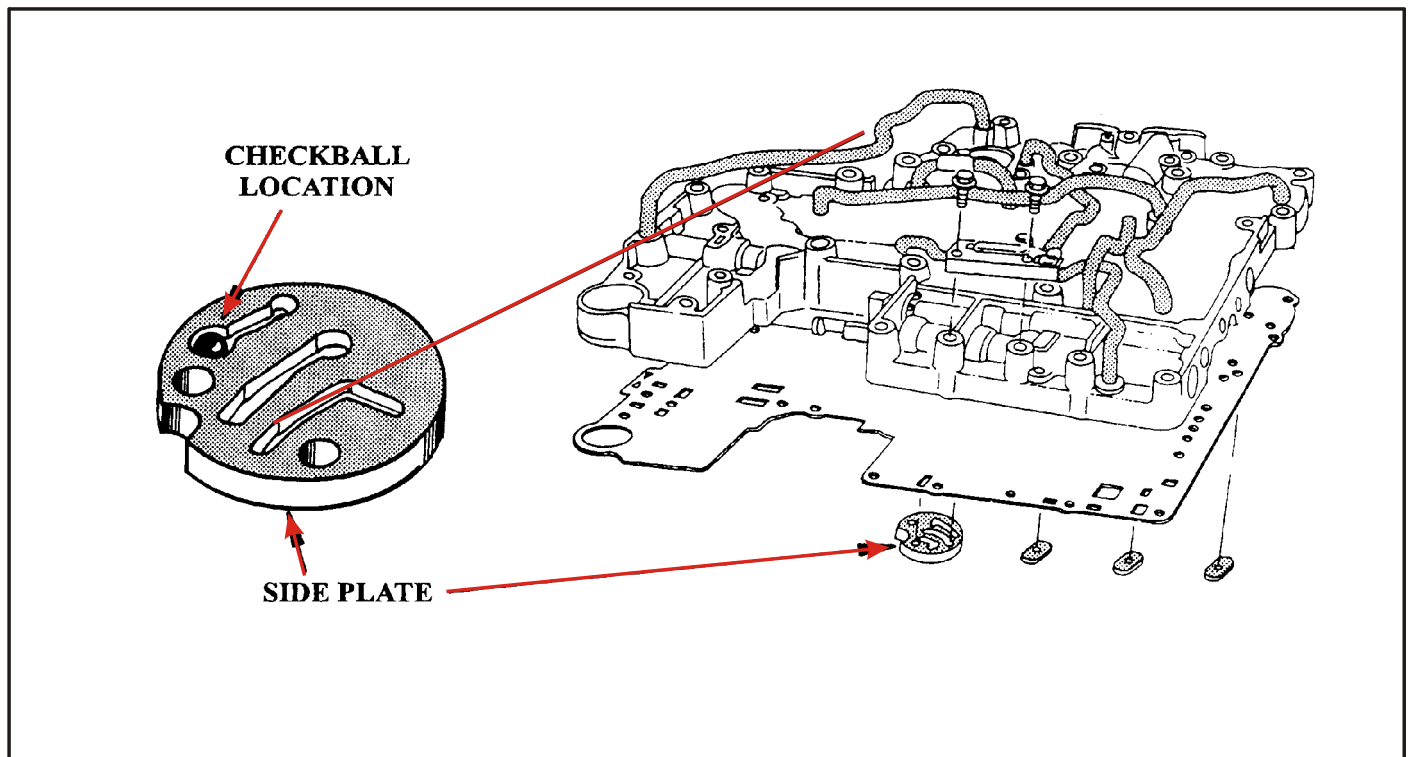
Figure 1

COMPLAINT: After rebuild, the vehicle starts off in first gear, skips second and shifts to third, and then on to fourth gear. The shift pattern is 1-3-4.

CAUSE: cause may be a missing checkball located in the side plate as shown in Figure 1. This checkball location is overlooked because ALL factory manuals fail to show where it belongs. When this checkball is omitted, 2nd gear apply oil is allowed to enter the 4th apply circuit, and exhaust past the 4-2 sequence valve.

CORRECTION: Install a .220" diameter, steel checkball into the side plate location, as shown in Figure 1. Install the servo piston retainer onto the servo piston with the "Castle Notches" facing the servo cover as shown in Figure 3.

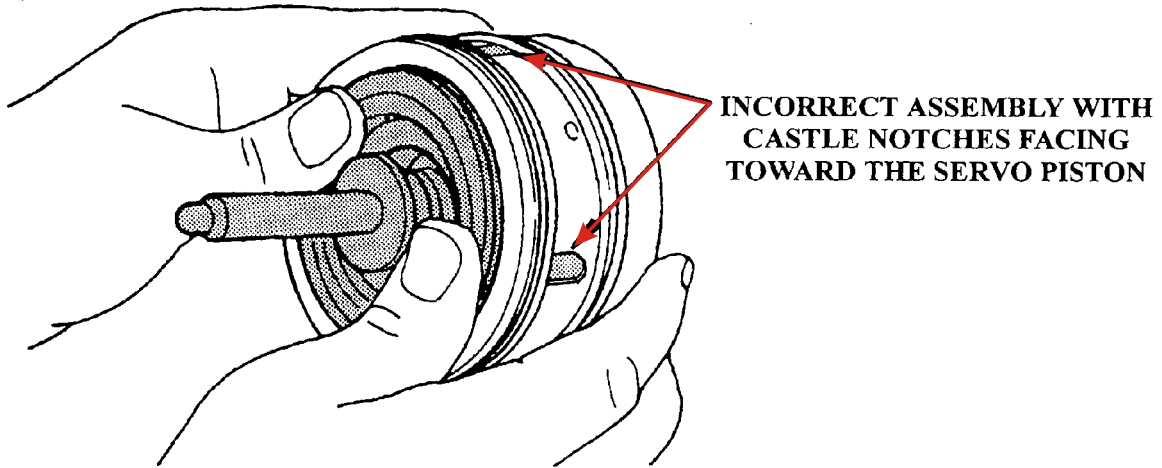
Another cause may be the 2-4 servo mis-assembled. When the servo piston retainer is installed with the "Castle Notches" facing the servo piston, the 2nd gear feed holes to the servo piston become mis-aligned and all 2nd gear apply oil is exhausted (See Figure 2).

INCORRECT ASSEMBLY

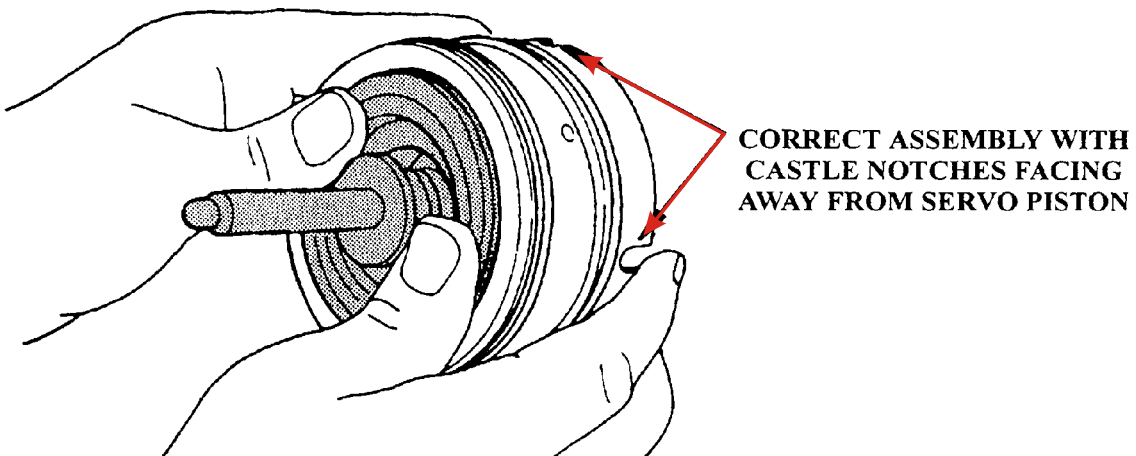
CORRECT ASSEMBLY
