# Technical Service Information

## **FORD A4LD DIRECT CLUTCH FAILURE DELAY IN REVERSE**

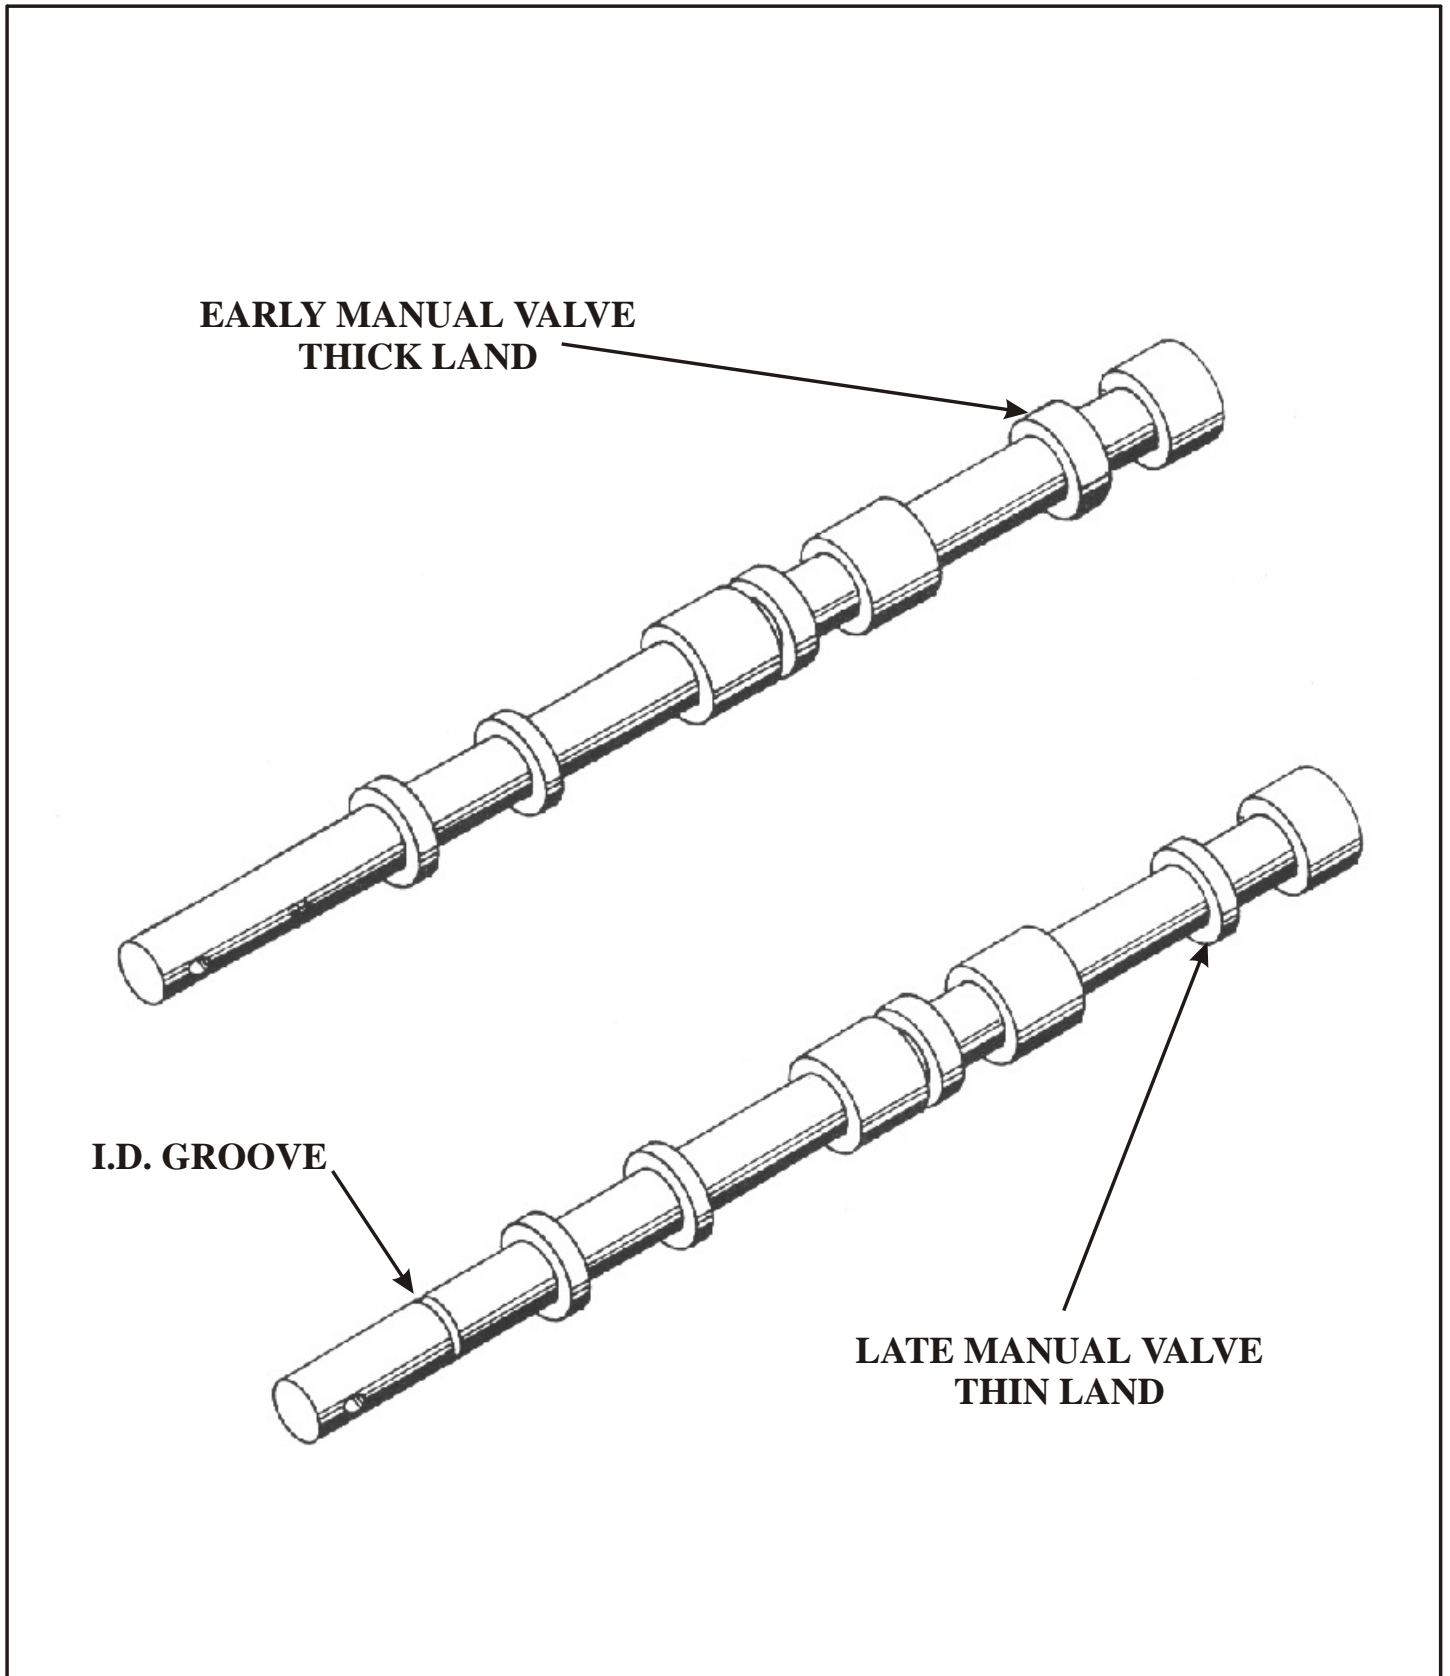
Figure 1

**COMPLAINT:** Premature failure of the direct clutch pack.

- \* Rear end play out of specification. Select #4 thrust washer that will obtain an end play of close to .012". DO NOT go under .012".
- \* Nicked or cut center support viton (Rubber) seals. DO NOT use steel or teflon seals in this location.
- \* Direct clutch piston check ball leaking.
- \* Shift Cable - High resistance to movement.
- \* Shift Bezel - High resistance to movement.
- \* Manual valve out of position.

**CORRECTION:** There is now a new design manual valve available for service, and can be identified by a groove on the valve stem just behind the manual valve link hole (See Figure 1). The 2nd design manual valve has a thinner land on it, as shown in Figure 1, and went into production vehicles in January, 1988.

**SERVICE INFORMATION:**  
Manual Valve (2nd Design)..... E8TZ-7C389-A
