Technical Service Information

CHRYSLER A604

PREMATURE FAILURE OF O.D./REVERSE CLUTCHES

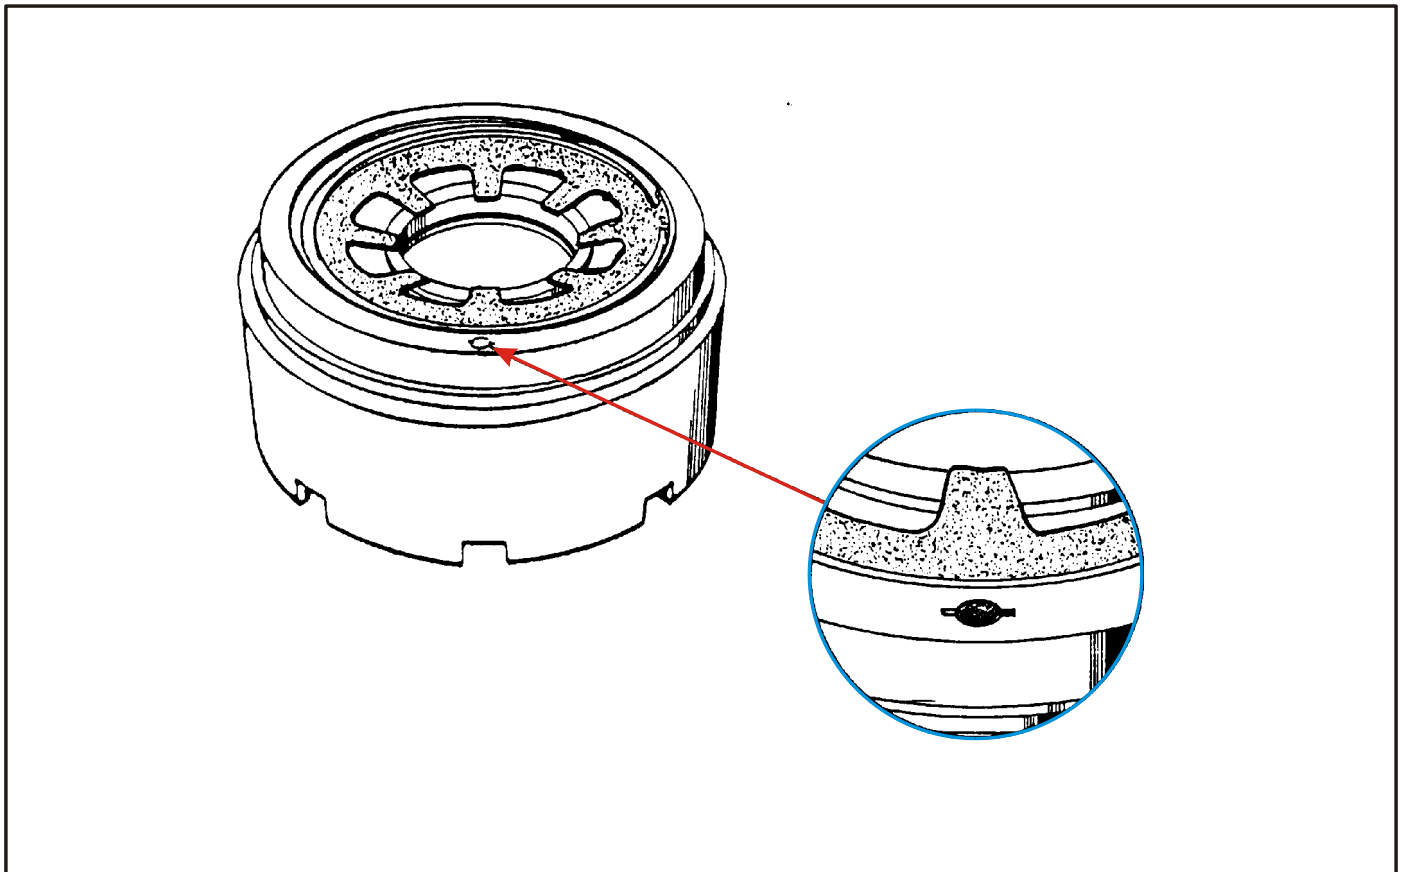
Figure 1

COMPLAINT: Premature failure of the overdrive and the reverse clutch plates, and all lip seals and "O" rings are good.

CAUSE: The cause may be an orifice and screen assembly blown out of the overdrive/reverse piston (See Figure I).

CORRECTION: Replace the Orifice/Screen Assembly with a new one, available under OEM part number 4531903, and stake the new assembly in place (See Figure 1). They were not all staked in place at the factory.

Overdrive/Reverse Piston Orifice/Screen Assy 4531903
