Technical Service Information

HONDA BAXA/B7XA FAMILY FLARES OR SLIPS ON UP SHIFTS

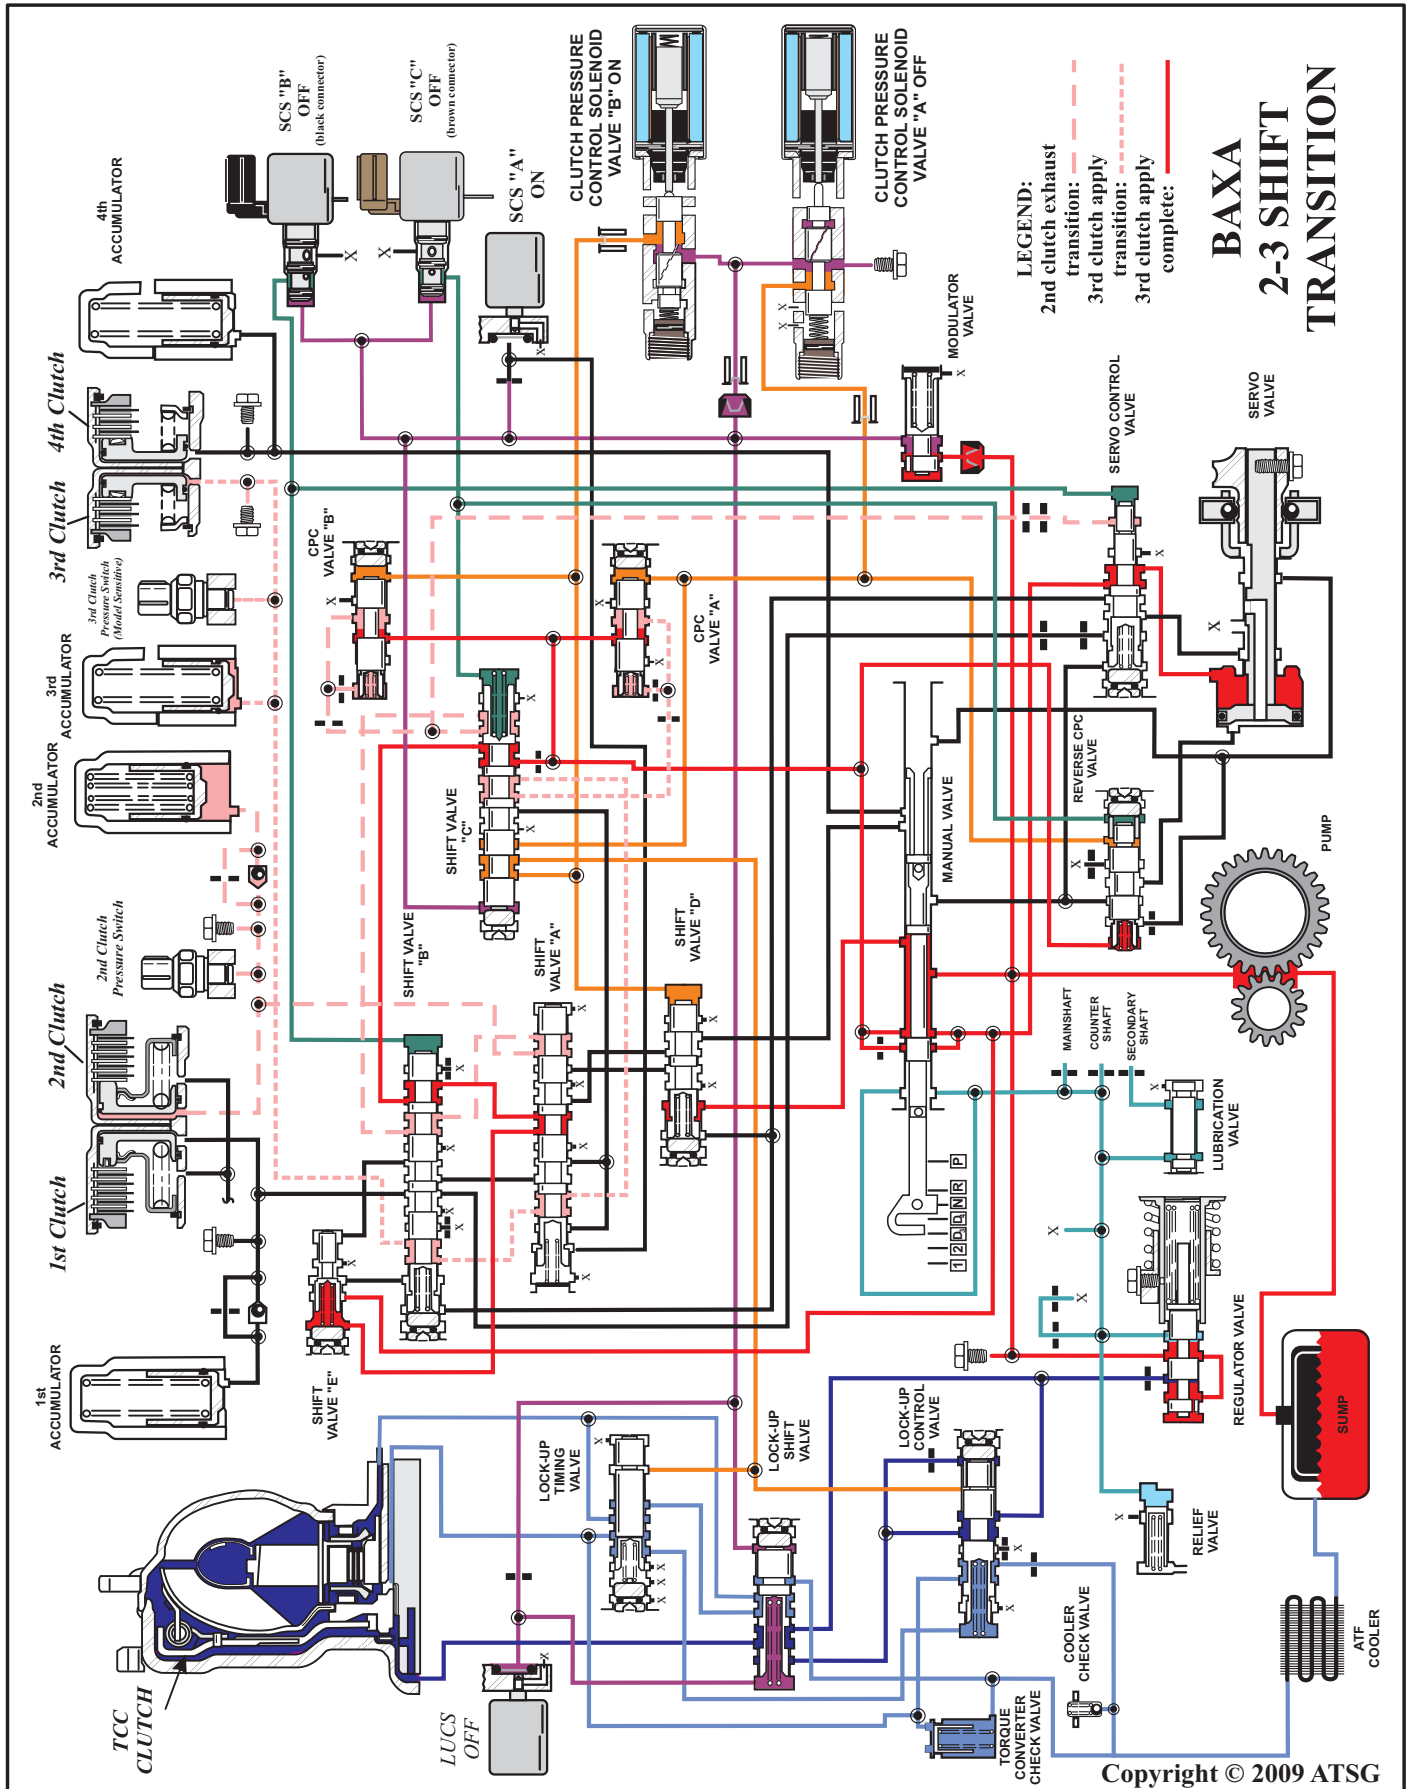
CAUSE: One cause may be a loss of clutch apply pressure at the Clutch Pressure Control (CPC) valves in the accumulator valve body. Clutch apply pressure loss can be caused by faulty Clutch Pressure Control Solenoids, a faulty Clutch Pressure Switch, or a problem with the CPC valves in the valve body. The CPC valves are used to regulate clutch apply oil during each gear shift transition. The CPC valves are regulated by pressure from the Clutch Pressure Control Solenoids. The Solenoids are activated and modulated by the ECM and use the Clutch Pressure Switches as an input for clutch apply control. The valves may stick in the bore during cold operation. If this happens, they cannot regulate clutch control pressure adequately, causing a flared or sliding shift. The bore plugs that retain the CPC valves may become loose in the bore or the bore where the CPC valves travel may become worn causing a loss of clutch control pressure. This also can cause a flared or sliding shift.

Refer to Figure 1 for a partial hydraulic diagram of the Clutch Pressure Control System showing the transition between 2nd and 3rd gear. Refer to Figure 2 for partial hydraulic diagram showing 3rd gear fully applied.

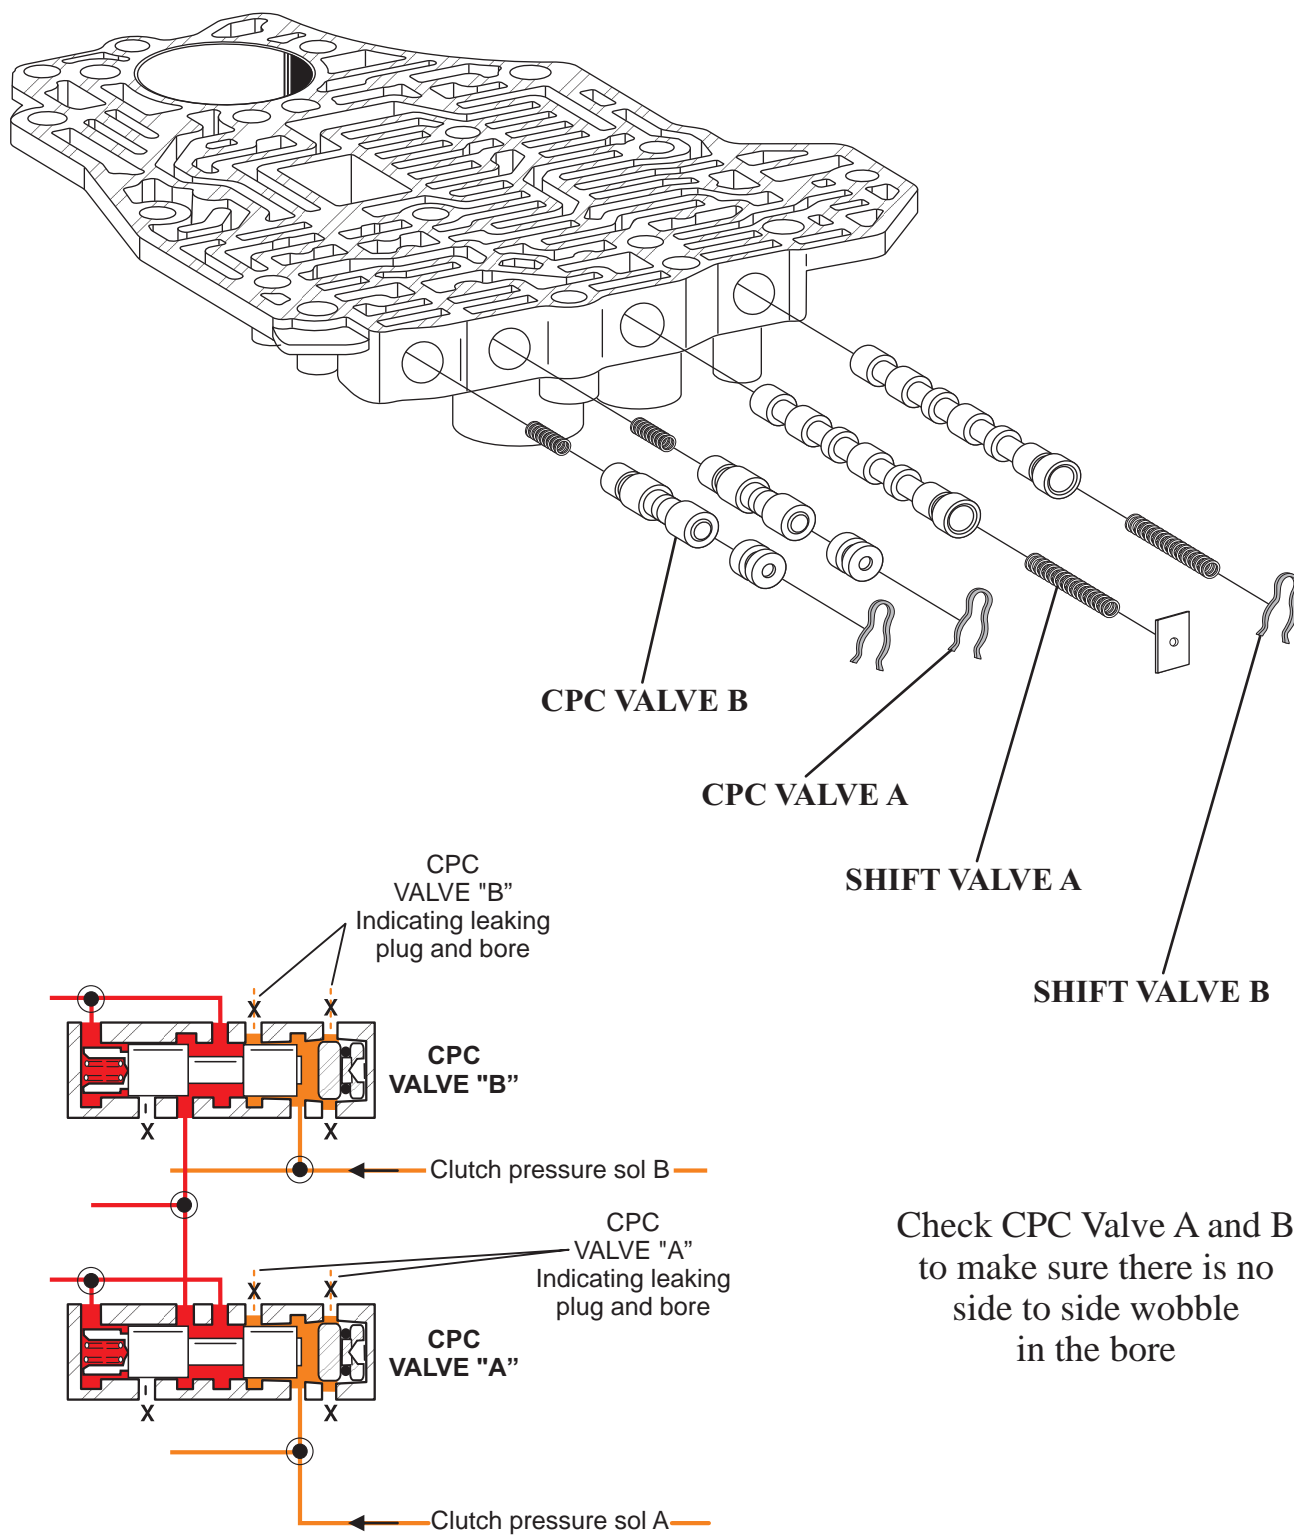
Figure 3

Refer to figure 3 for accumulator valve body diagram and CPC valve locations.

The bores in the accumulator valve body where the CPC valves travel must be closely inspected for wear. If the bores are worn the accumulator valve body will need to be replaced.

Remove the CPC valve springs from the body (*leave the valves in and replace the bore plugs*). Place the accumulator body in a freezer for at least two hours. After the body has had a chance to get good and cold, turn the body from side to side and check if the valves drag. The valves should float freely back and forth, if there is any drag, clean the bores with some very slightly abrasive cloth, (*be careful not to scratch the bore*) or replace the accumulator body as necessary.

Make certain the bore plugs fit snugly in the bore. Use a tubing cutter around the outside of each plug to raise a ridge that will help the bore plugs fit much tighter and help reduce the possibility of leaking.
