Technical Service Information

MERCEDES 722.3 - 722.4 SLIPPING AND/OR NO REVERSE

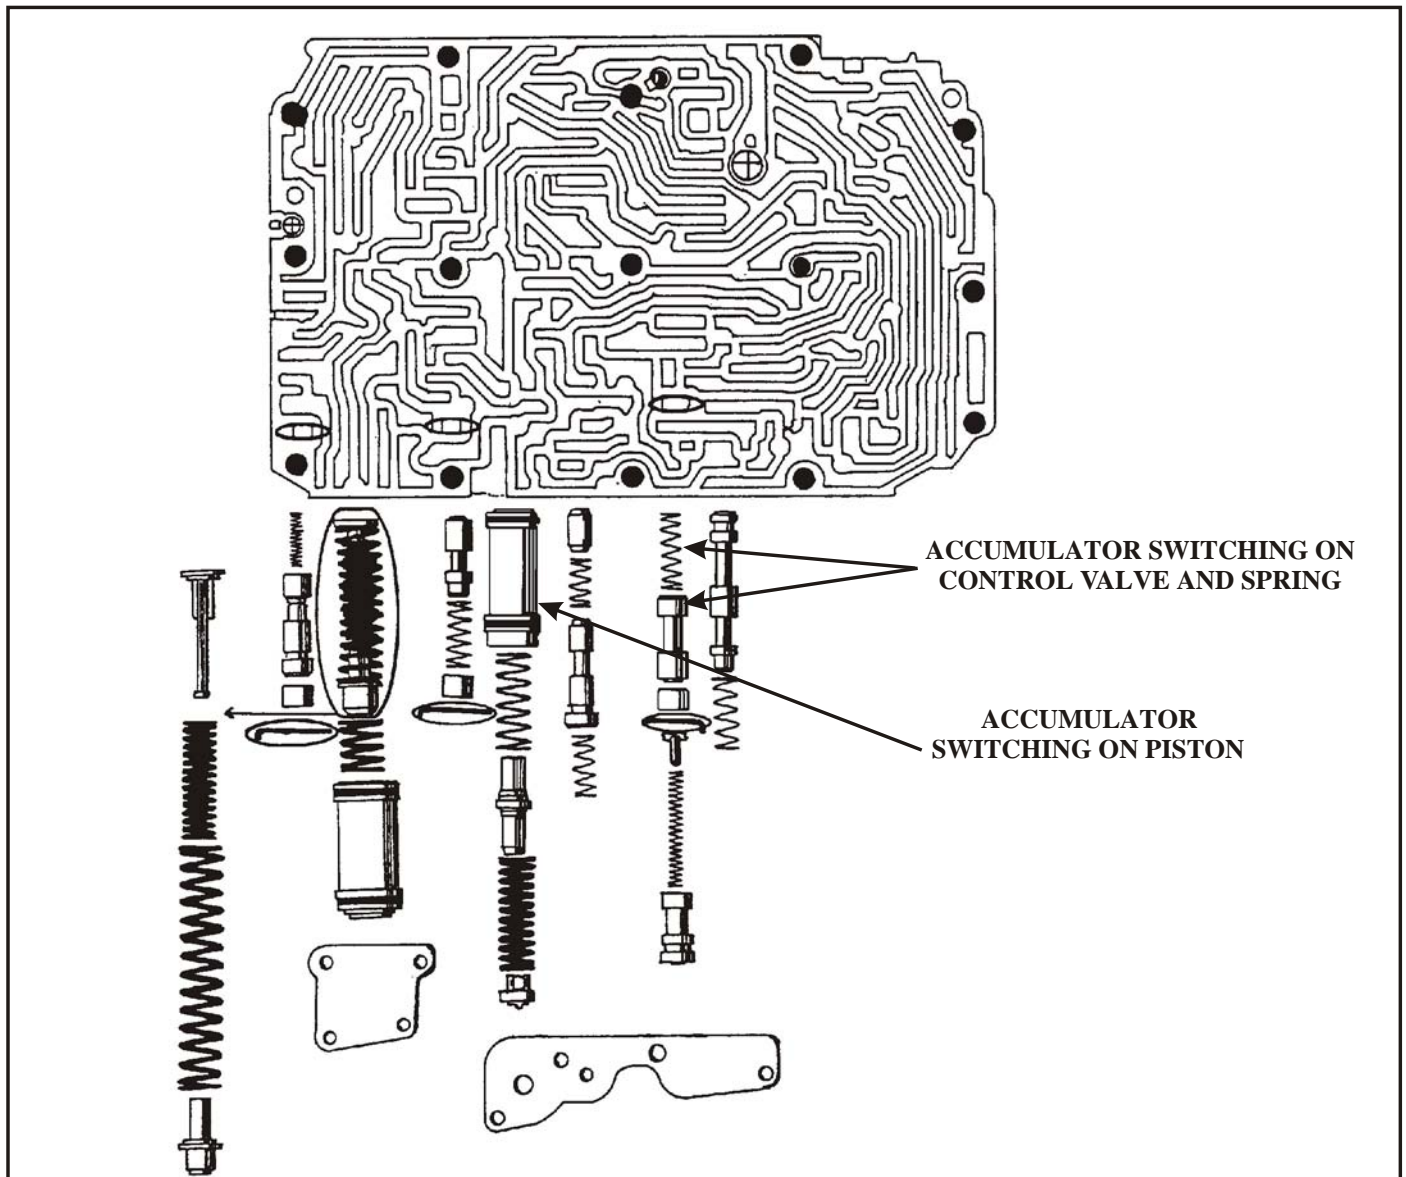
Figure 1

COMPLAINT: Before and/or after rebuild, any Mercedes equipped with the 722.3 - 722.4 transmission may exhibit a chattering in reverse, slipping in reverse, or no reverse.

CAUSE: The cause may be, a stuck or sticking *Accumulator Switching On Control Valve*, a collapsed or broken *Accumulator Switching On Control Valve Spring*, a missing, cut, or leaking seal ring on the accumulator piston, or a cracked *Accumulator Switching On Piston* (See Figure 1).

CORRECTION: Remove and disassemble the valve body. Inspect and replace as necessary, the parts and concerns listed above, as shown in Figure 1.
