# Technical Service Information

## ATSG AISIN SEIKI 450-43LE NO THIRD OR REVERSE

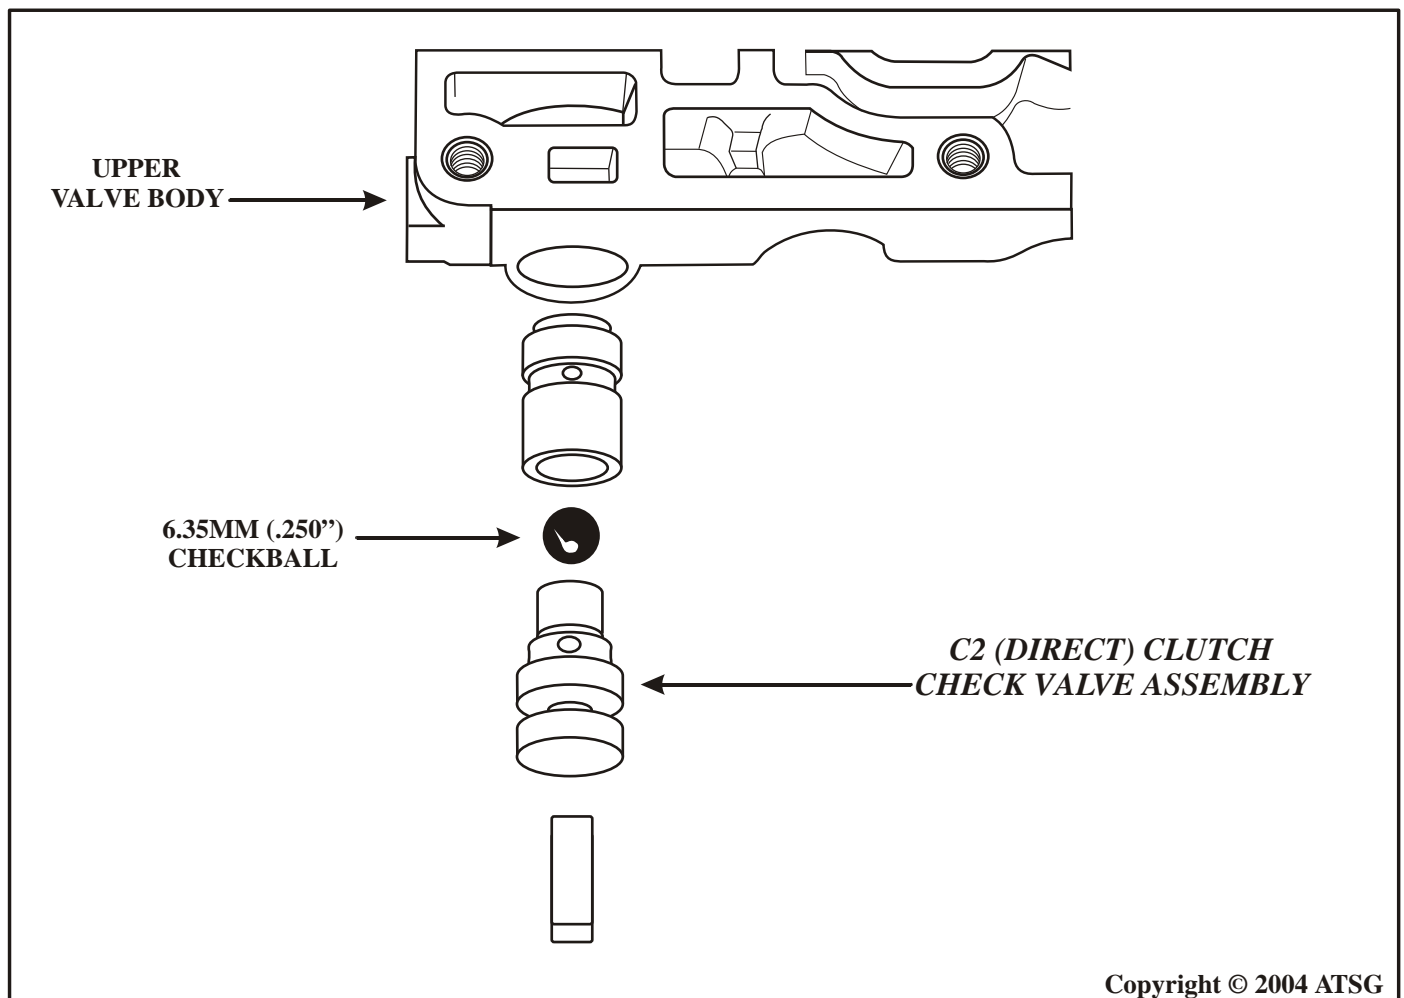
Figure 1

**COMPLAINT:** After rebuild, the transmission exhibits no movement in reverse and no third gear.

**CAUSE:** The cause may be, the C2 (Direct) Clutch check valve missing. This check valve is actually a 6.35mm (.250") checkball, as shown in Figure 1, and switches C2 (Direct) Clutch apply oil between the 3rd gear circuit and reverse circuit. If left out both circuits are exhausted.

**CORRECTION:** Install the correct C2 (Direct) Clutch check valve line-up, as shown in Figure 1. The steel checkball in the C2 Clutch check valve assembly is 6.35mm (.250") in diameter. We have also provided you with the other checkball locations for both the upper and lower valve bodies in Figure 2 and 3.

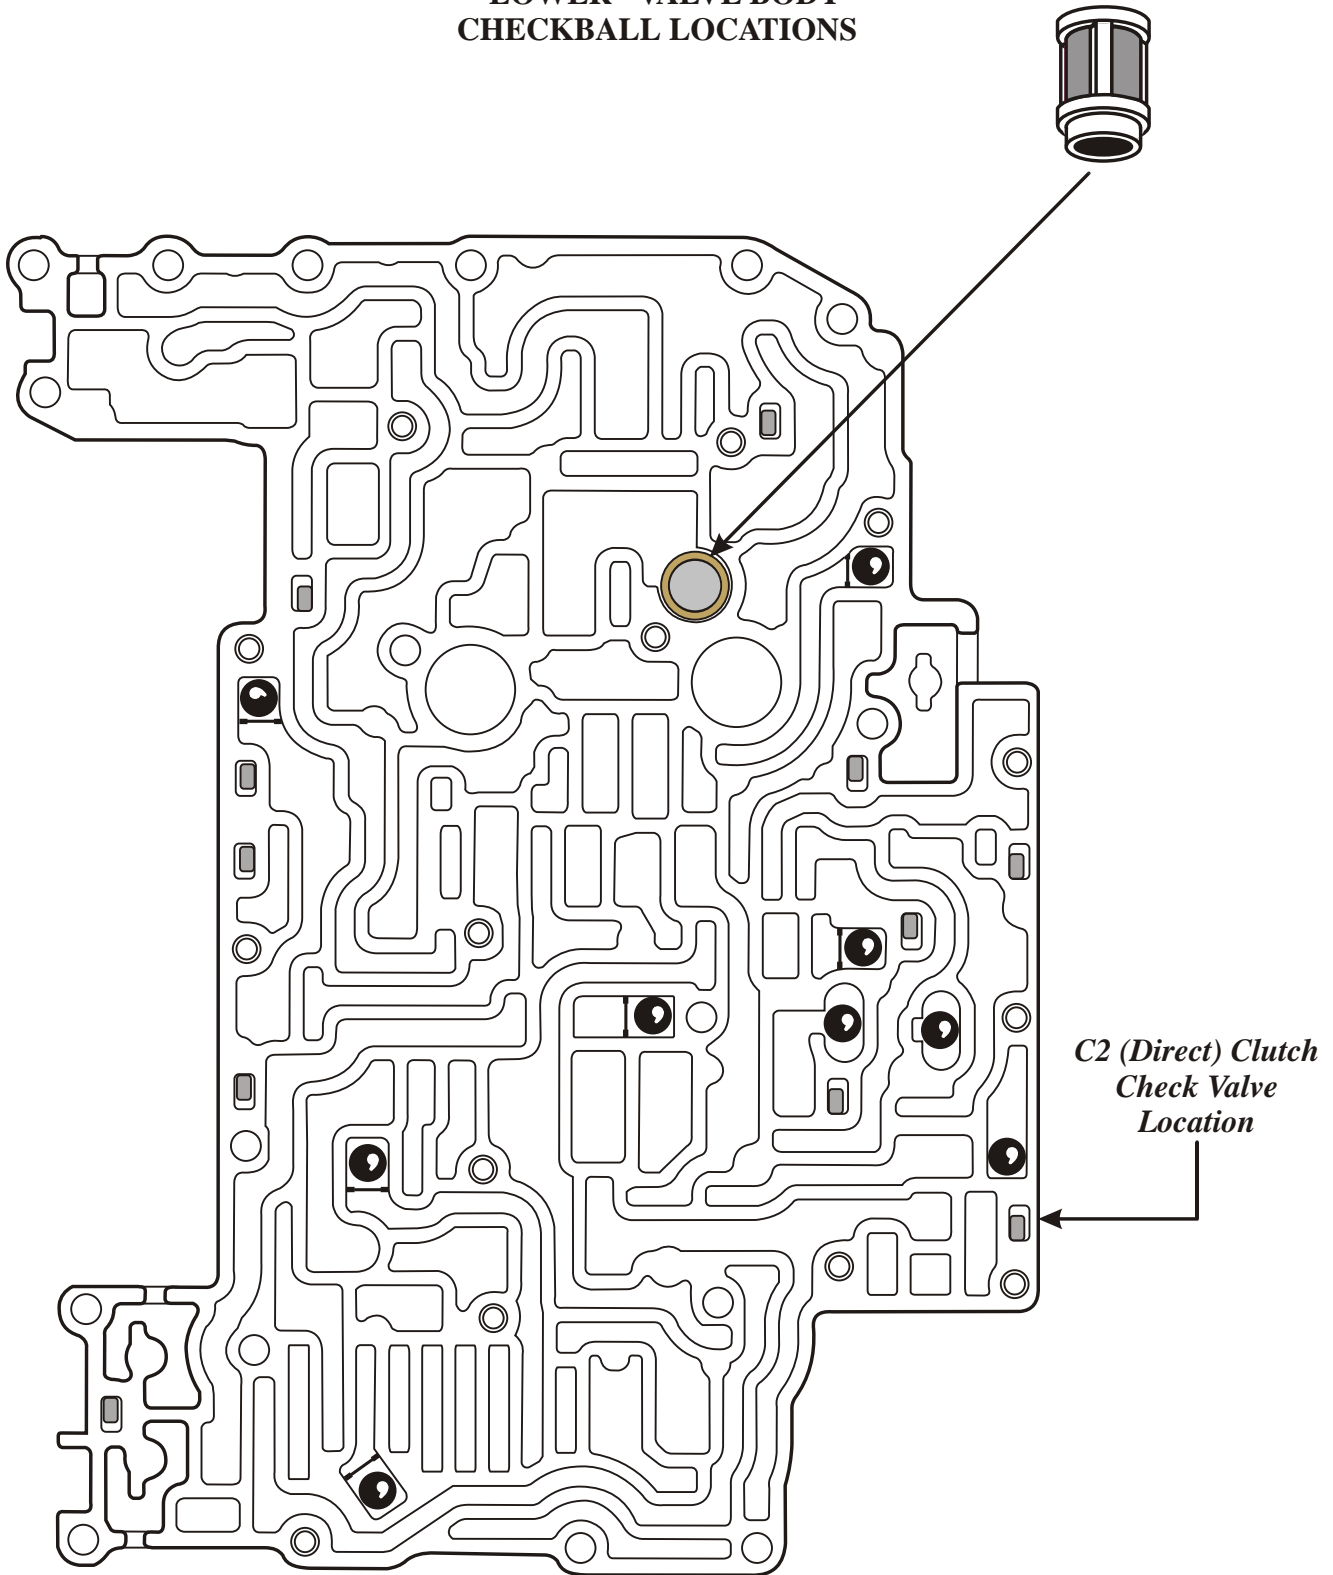
Figure 2

**THE UPPER VALVE BODY REQUIRES NINE 6.35MM (.250") STEEL CHECKBALLS IN THE WORM TRACK AREA, PLUS THE "C2" CLUTCH CHECK VALVE ASSEMBLY.**

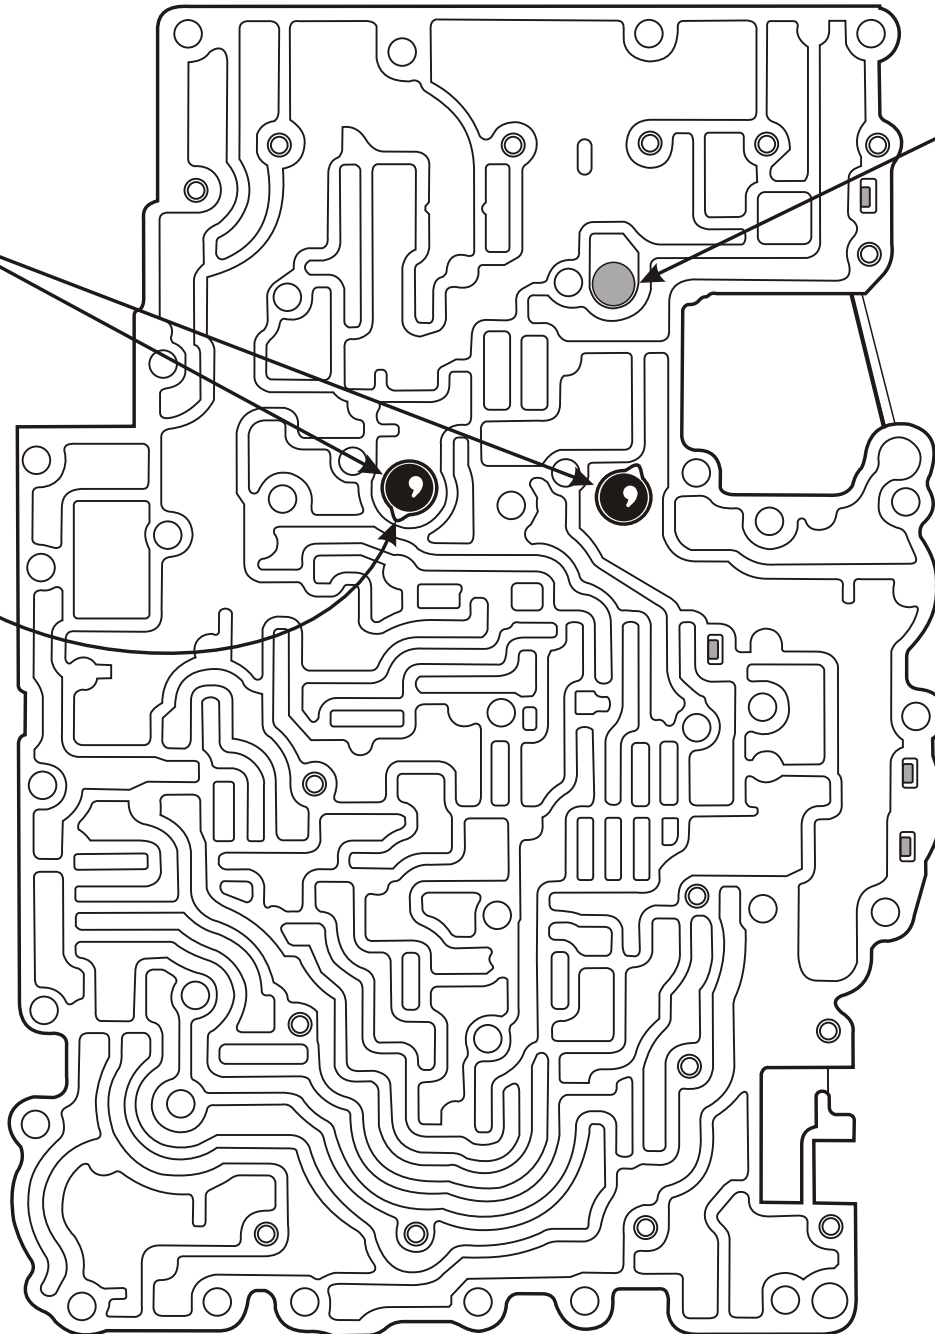
Figure 3

*Make Certain  
This Raised Leg  
Fits Into The  
Notch In The  
Valve Body*

**THE LOWER VALVE BODY HAS TWO 10.00MM (.394")  
STEEL CHECKBALLS ON BARREL SPRINGS AND CAPSULES**
