## FORD MOTOR COMPANY TRUCKS 1996 AND LATER

### NO TORQUE CONVERTER CLUTCH APPLICATION AT LESS THAN 30 PERCENT THROTTLE

# Technical Service Information

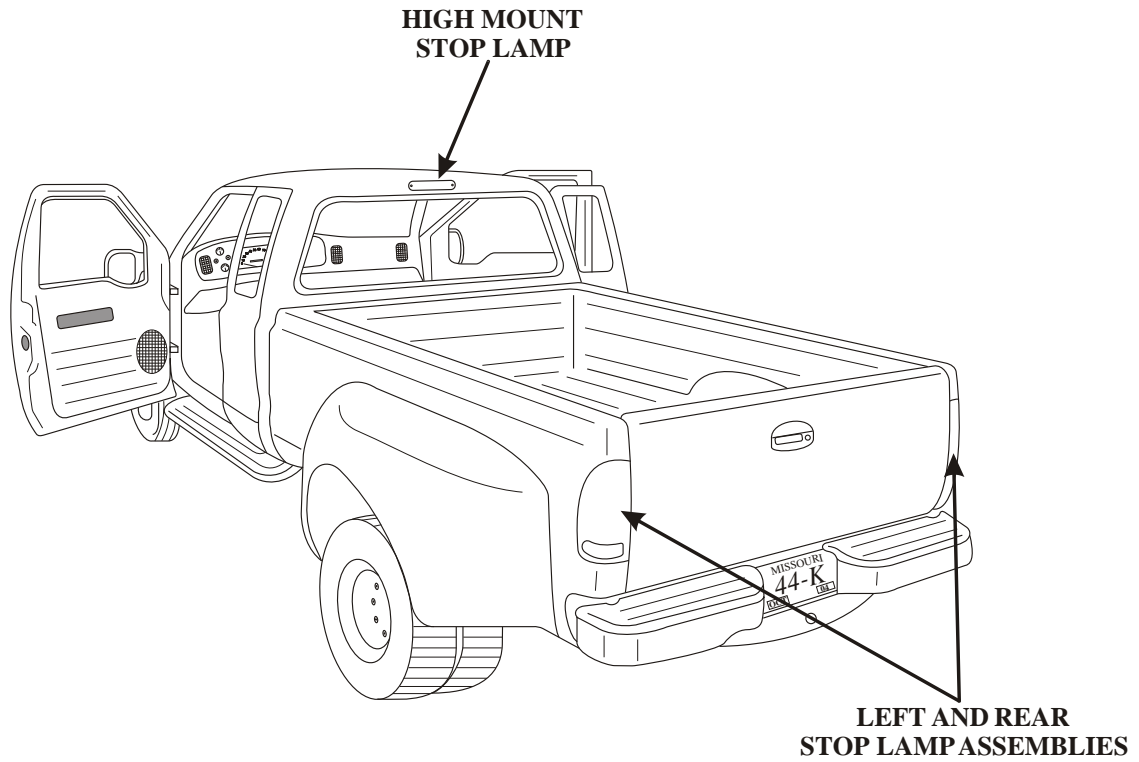
Figure 1

**CAUSE NO. 1:** One cause for this condition may be that one or more of the vehicle brake light bulbs, including the High Mount brake light may be burned out, or have a damaged filament (See Figure 1). When this condition is present, the PCM will detect an open in the brake lamp circuit, and due to a pull-up resistor in the PCM, will output voltage from PCM terminal 92 to the brake on-off switch (See Figure 2). As a result, the Torque Converter Clutch will not be applied at less than 30 percent throttle.

Replace any burned out brake lamp bulbs, including the High Mount brake lamp bulb, as shown in Figure 1. It is also important to note, that a bad ground for the rear lamp assembly, has also been known to cause the identical symptom. Refer to Figure 5 for the rear lamp assemblies ground location.

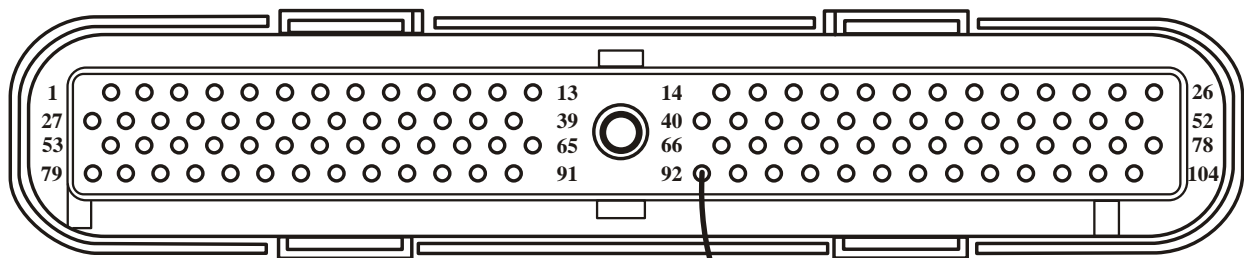
Figure 2

**Malfunction:** Check for 5 to 8 volts DC at PCM pin 92  
or at the Light Green wire at the Brake On-Off Switch

**Normal Operation:** 0 volts DC brake off  
12 volts DC brake on

Prior to any part replacement or modifications, it would be recommended to check for a 5 to 8 volt DC signal coming out of the PCM at terminal 92 using a volt meter set to read DC voltage. Voltage may also be checked at the Light Green wire located at the back of the Brake On-Off Switch. **Note:** *The example given is for a 1996 F-Series 7.3 Diesel.* This test will help to confirm that a circuit fault has been detected by the PCM. Refer to Figure 2. **Normal operation will be 0 volts DC, brake off, and 12 volts DC, brake on.**

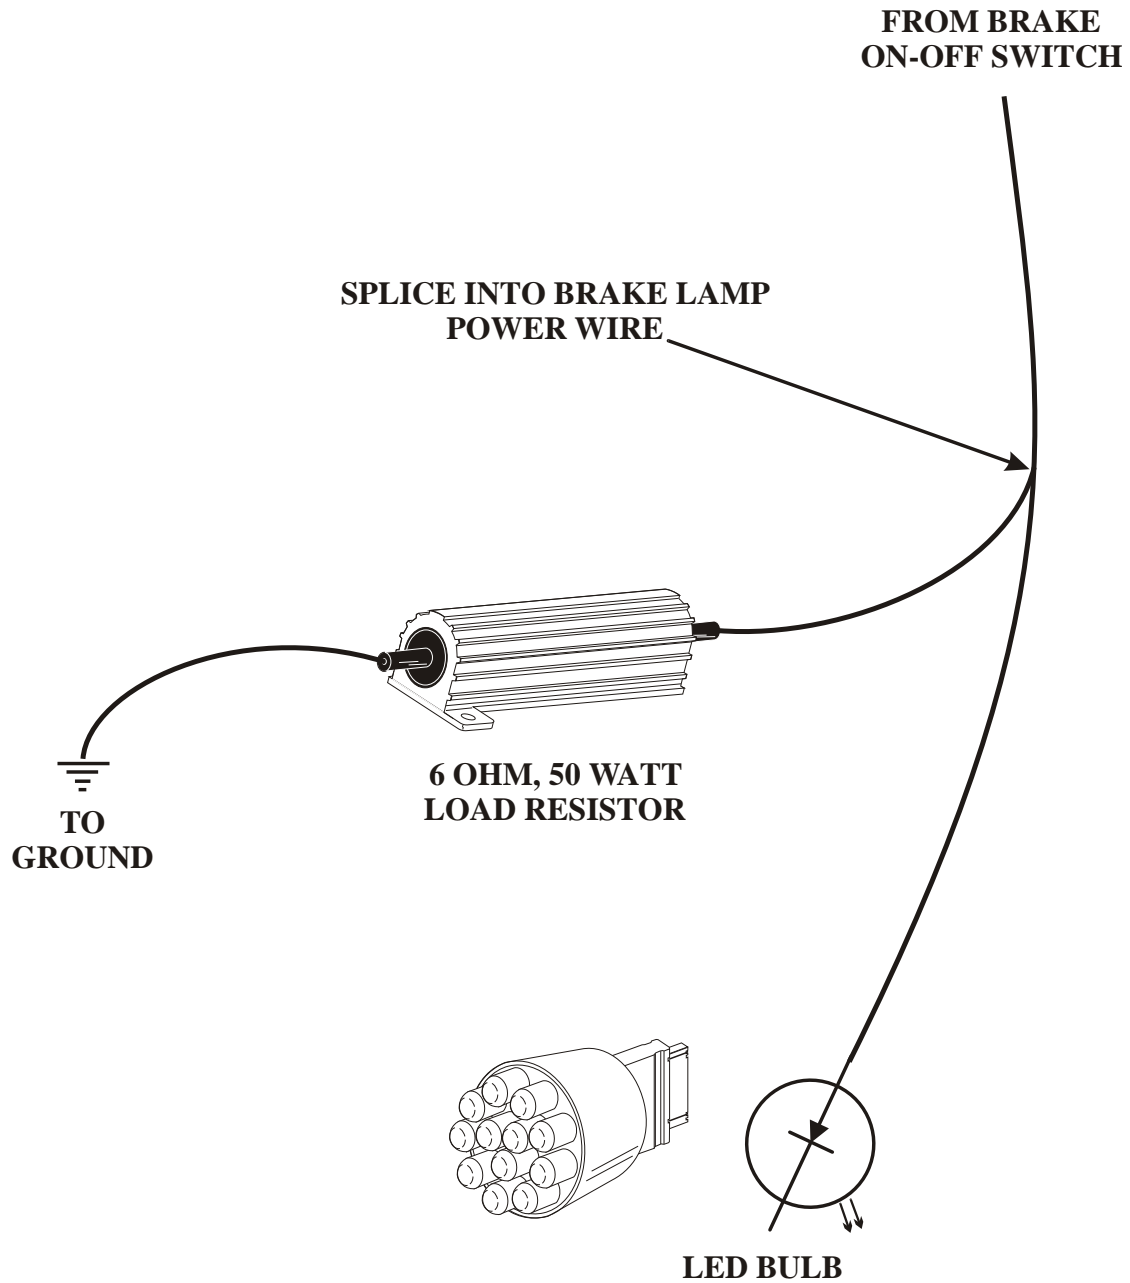
Figure 6

**CAUSE NO. 2:** Recently there has been an increase in the popularity of replacing the stock incandescent brake lamp bulbs, with aftermarket LED lamp assemblies. Refer to Figures 3 and 4. The main advantages of switching to LED lamp assemblies is that there are no fragile filaments to burn out or break, which means that the LED lamp assemblies may possibly last for the entire life of the vehicle, and LED lamps consume much less energy than the stock incandescent bulbs. Due to the low power consumption, the PCM *may* view this reduced current draw as being a burned out bulb, resulting in a no Torque Converter Clutch apply at less than 30 percent throttle.

For those vehicles that have had the stock incandescent bulbs replaced with aftermarket LED bulb assemblies, it *may* be necessary to install a 6 ohm- 50 watt Load Resistor across the brake light power wire to simulate the load of the regular stock incandescent bulb (See Figure 6). **Note:** *One resistor is required for use on each LED bulb assembly.*
