# Technical Service Information

## THM 4T65-E NO 3-4 SHIFT

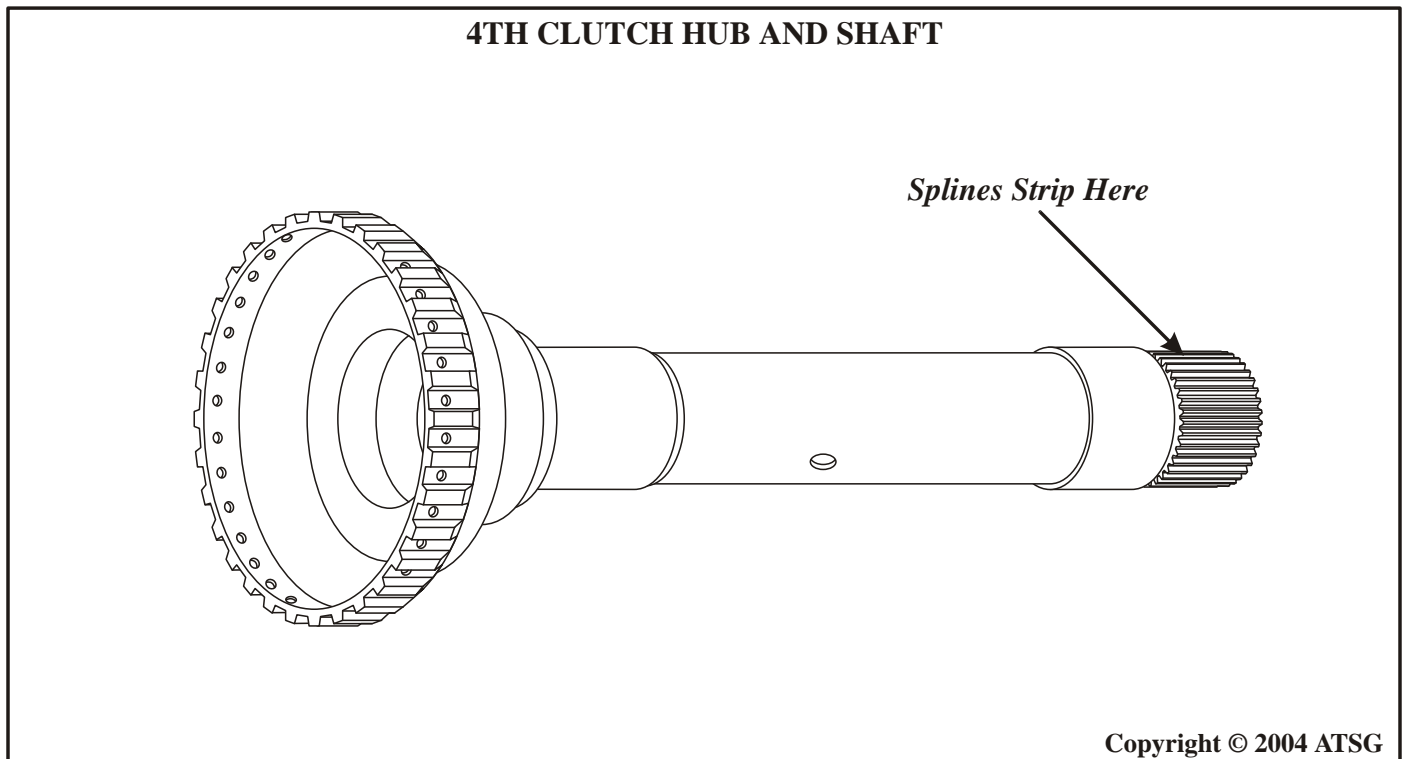
Figure 1

**CAUSE:** The cause may be, stripped splines on the 4th clutch hub and shaft where it splines into the input sun gear, as shown in Figure 1.

**CORRECTION:** Replace the 4th clutch hub and shaft assembly with a new one. Extra care should be exercised when inspecting this area on your normal overhaul, as this is a very common wear area on higher mileage units.
