Technical Service Information

VOLKSWAGEN/AUDI "01M" NO FORWARD OR SLIPS FORWARD

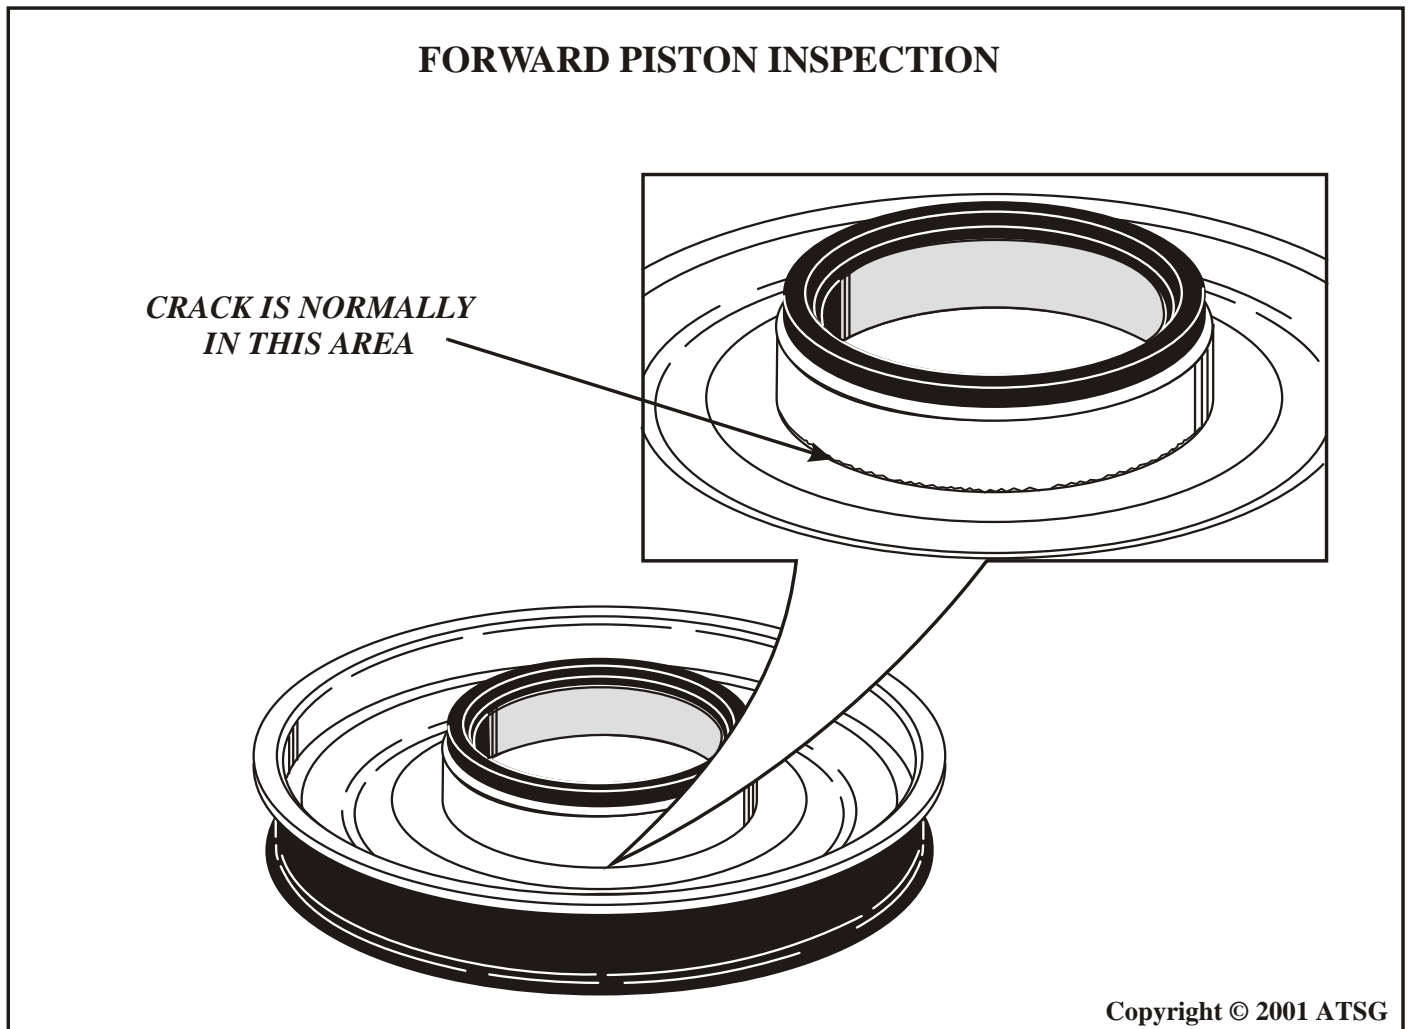
Figure 1

COMPLAINT: Before or after overhaul, vehicles equipped with the 01M transaxle may exhibit a "no forward" engagement or a slipping condition on take-off in first gear.

CAUSE: The cause may be, that the K1 (Forward) Piston is cracked, as shown in Figure 1, which can cause a loss of forward clutch pressure.

CORRECTION: Replace the K1 (Forward) Piston as part of every overhaul.

At the time of this printing, the K1 (Forward) Piston is not sold, from Volkswagen, seperatly from the complete drum assembly. Aftermarket suppliers have available a "piston kit" to service the K1 drum as well as all of the other bonded pistons.
