## NISSAN RL4FO2A AND RE4FO2A SOFT 1-2 UPSHIFT

**COMPLAINT:** Soft and/or a Slide-Bump 1-2 upshift on Nissan vehicles equipped with the RL4FO2A or the RE4FO2A transaxles.

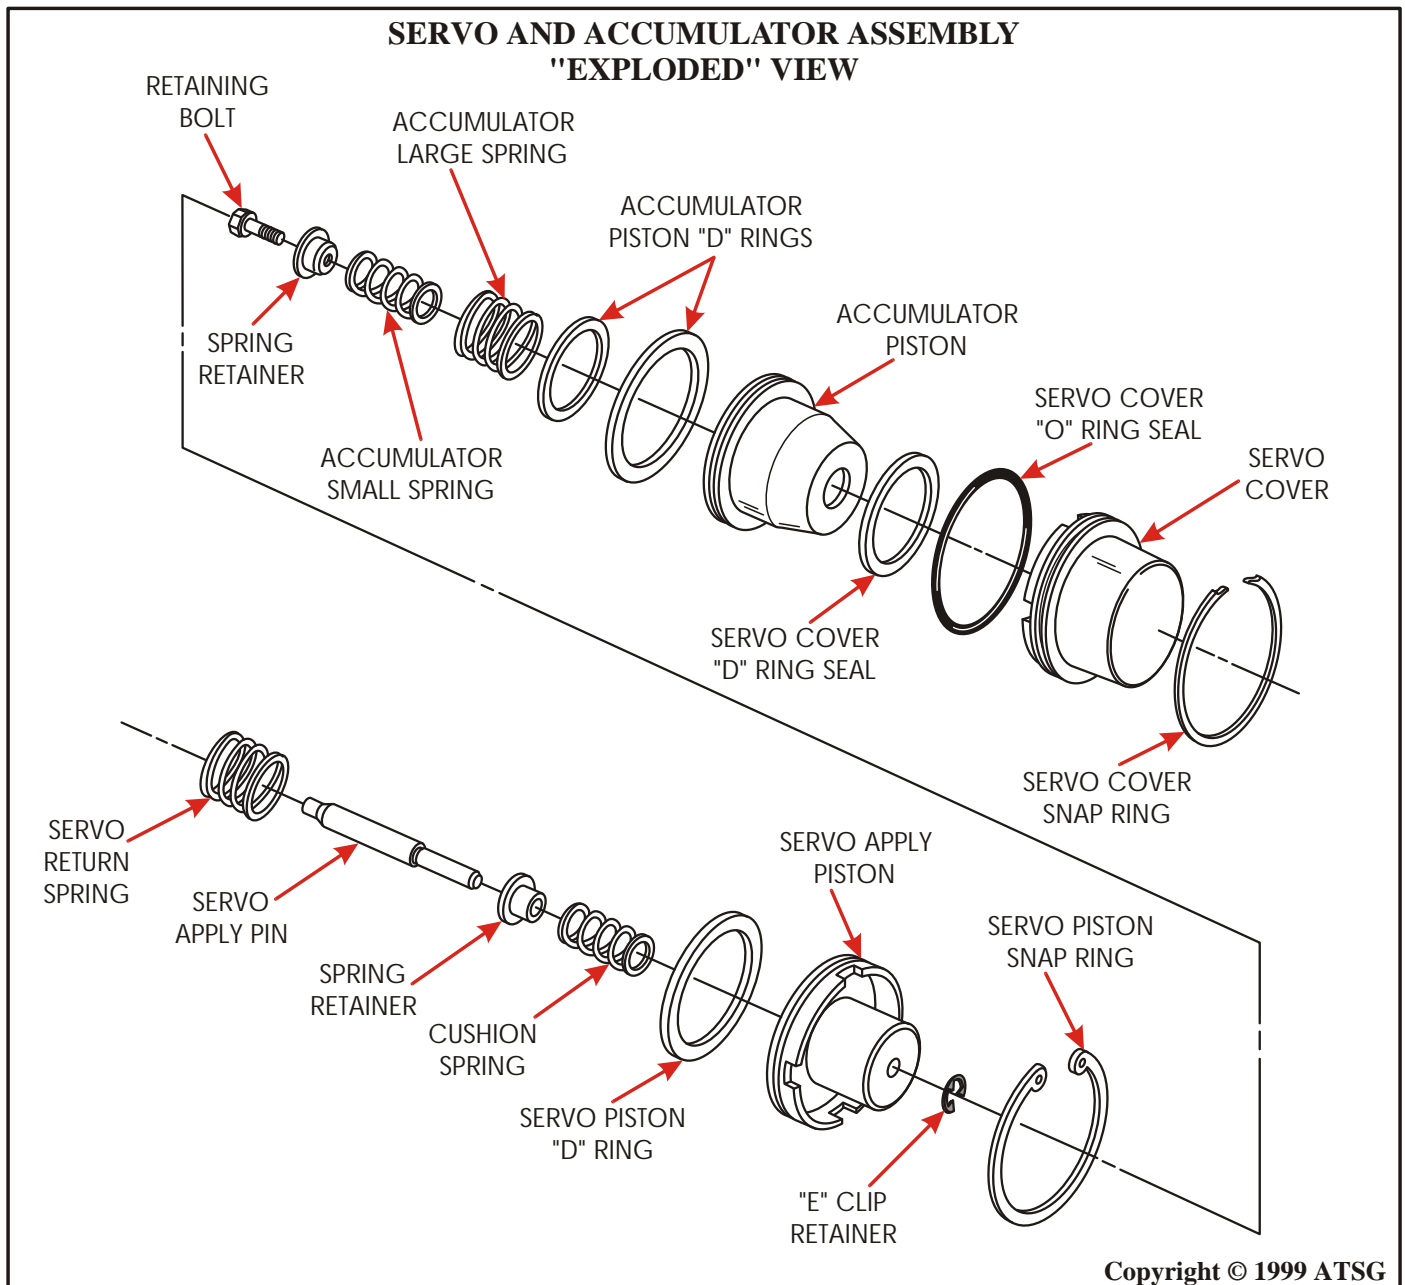
**CAUSE:** The cause may be, too much accumulator piston movement.

**CORRECTION:** Remove and discard the large diameter accumulator spring as shown in Figure 2. Use the illustrations in Figure 1 and 2, to ensure proper reassembly.
