Technical Service Information

FORD AXODE (AX4S) SLIP ON 2-3 SHIFT AND/OR NO 2-3 SHIFT

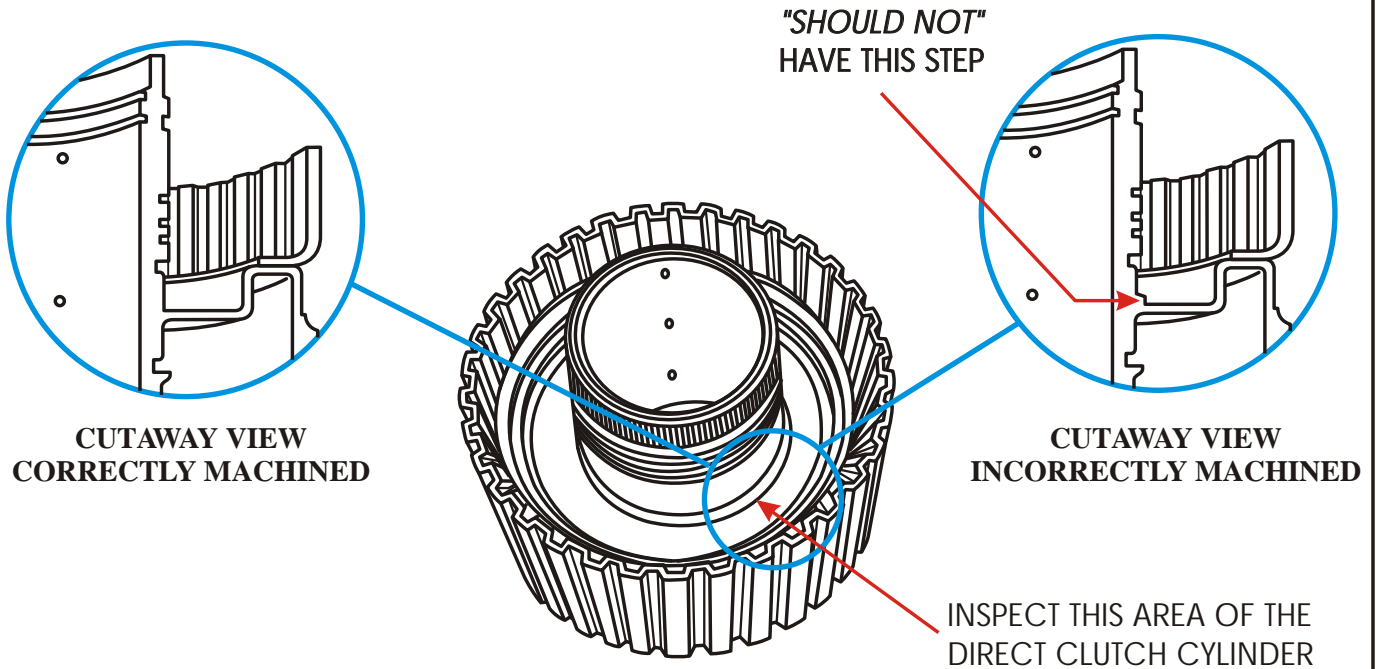
Figure 1

CAUSE: The cause may be, a mis-machined direct/intermediate clutch cylinder, as shown in Figure 1, or the direct clutch steel plates binding in the clutch cylinder due to cylinder being out of round.

DIRECT & INTERMEDIATE CLUTCH CYLINDER

CORRECTION: Inspect the direct clutch cylinder hub machining in the area shown in Figure 1, and replace clutch cylinder as necessary. Check for free movement of the steel clutch plates in the direct clutch cylinder by installing and removing the plates, and turning the plates 2-3 splines each time. Replace direct clutch cylinder as necessary. Also the 3 tabs on the servo spring retainer must fit on the outside edge of the spring as shown in Figure 2. Replace the servo spring retainer if it is bent or damaged from an incorrect installation.

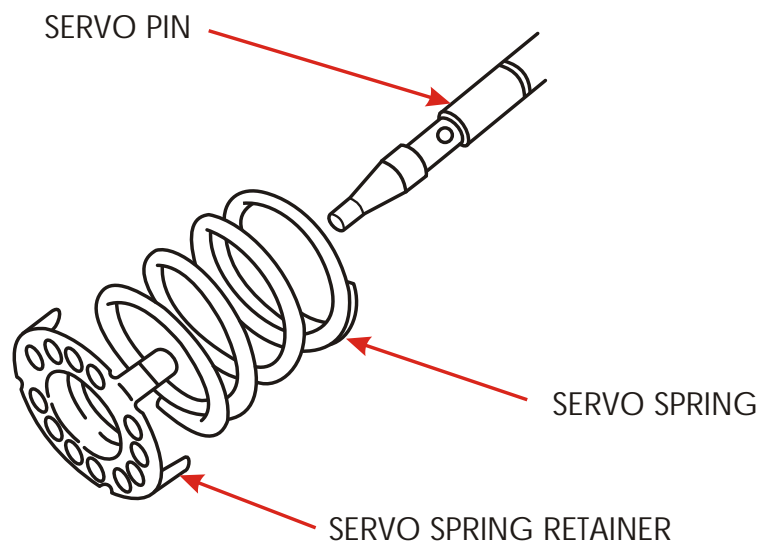
Figure 2

LOW/INTERMEDIATE SERVO
