4T60E/4T65E

TORQUE CONVERTER CLUTCH STUCK OFF

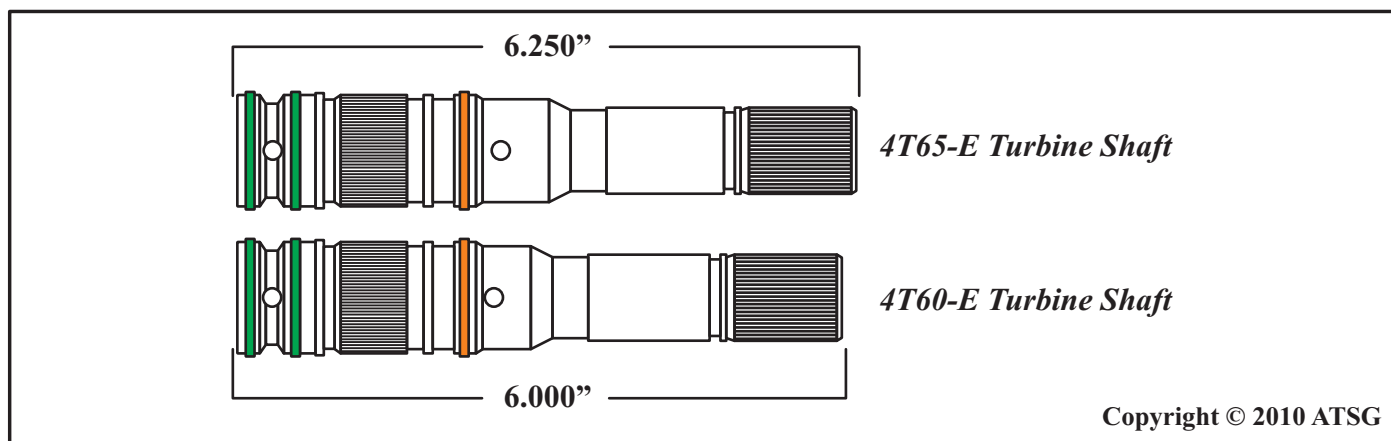
Figure 1

The two shafts in a 4T65E are dimensionally taller than the same two shafts in the 4T60E, (Refer to figures 1 and 2). When the turbine shafts are placed side by side it would appear there would be contact between the turbine and stator shafts due to the difference in the ramp of the shafts which would produce metal contamination and noise. There is no contact between the stator and turbine shaft, however, it is the location of the TCC feed orifice along with the difference in the ramped area that caused the P0741 code and the lack of TCC application, (Refer to figure 3).

CORRECTION: When the stator support or turbine shaft requires replacement in either the 4T60E or the 4T65E, care must be taken as these parts do not interchange.

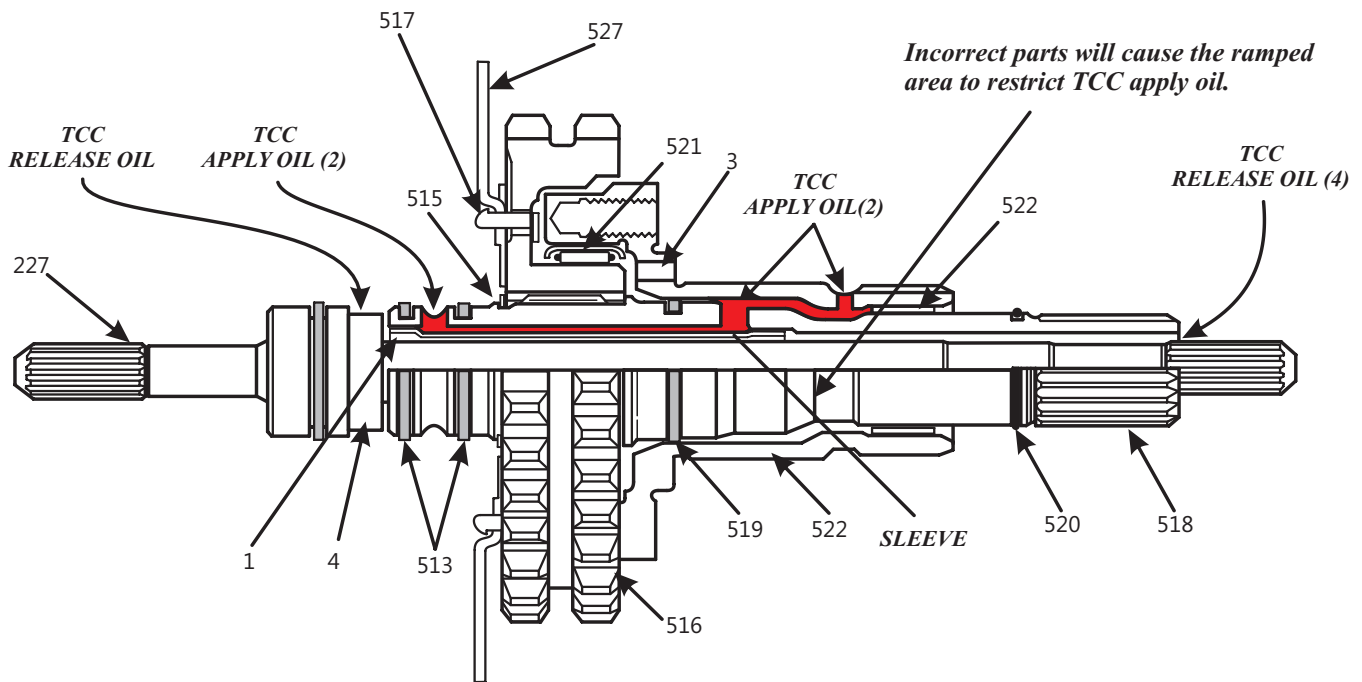
Figure 4

The longer shaft would restrict oil flow to the TCC apply circuit at the inner ramped area of the stator shaft resulting in no converter clutch apply, (Refer to figure 4).
