# **THE SEMINAR WITH MORE IN '94**

AUTOMATIC TRANSMISSION SERVICE GROUP  
9200 S. DADELAND BLVD. STE 720  
MIAMI, FLORIDA 33156  
(305) 670-4161

# TRANSMISSION SEMINAR 1994

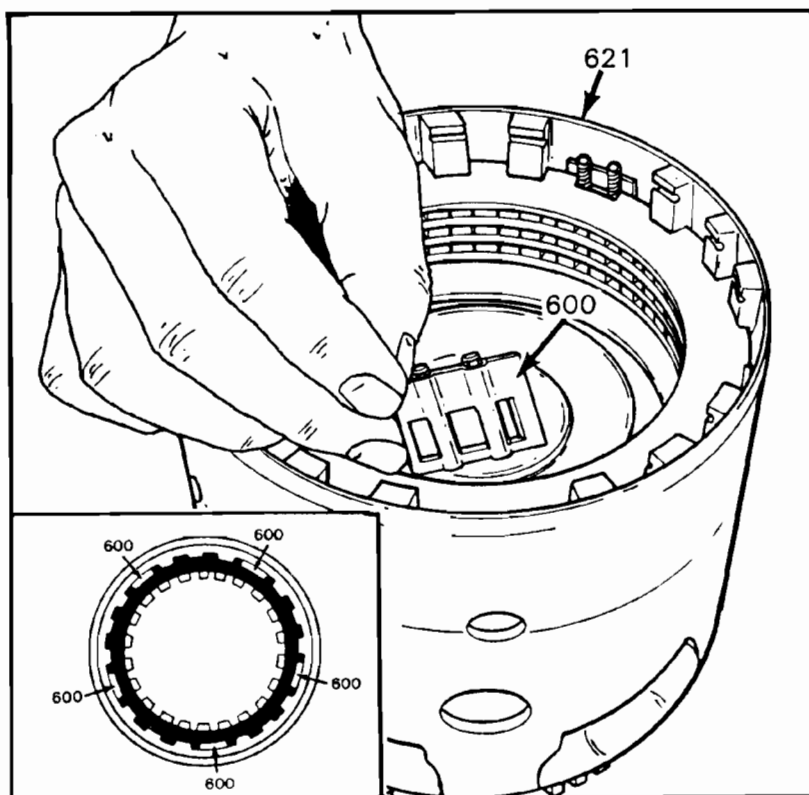
Figure 9

COMPLAINT: Premature failure of the 3-4 clutch pack and may happen in as little as 5000 miles. The vehicle may also exhibit a very soft 2-3 shift.

CAUSE: The cause may be, not enough clamping force for the 3-4 clutch pack due to the load release spring assemblies.

CORRECTION: STEP 1:  
Remove and discard the five 3-4 load release spring assemblies in the input housing and located between the steel plates and input housing, as shown in Figure 9.

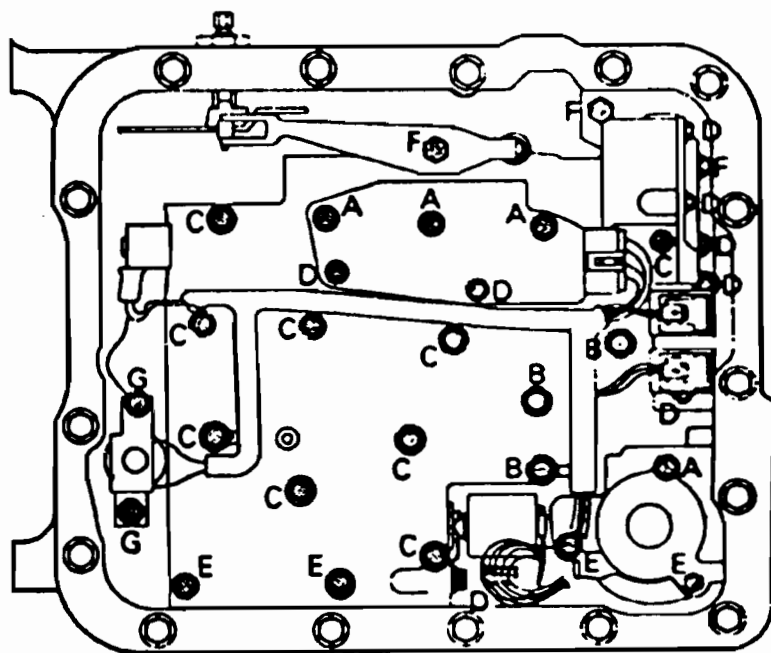
Figure 16

**CAUSE:** The cause may be valve body bolts installed in the wrong positions. Most common mix-up is bolt "B" (54.4mm long) installed in rearmost "C" position along the transmission centerline. The longer bolt in this location will now lock the sun gear shell from turning.

**CORRECTION:** Install the valve body bolts in their proper locations using the illustration and bolt chart below.

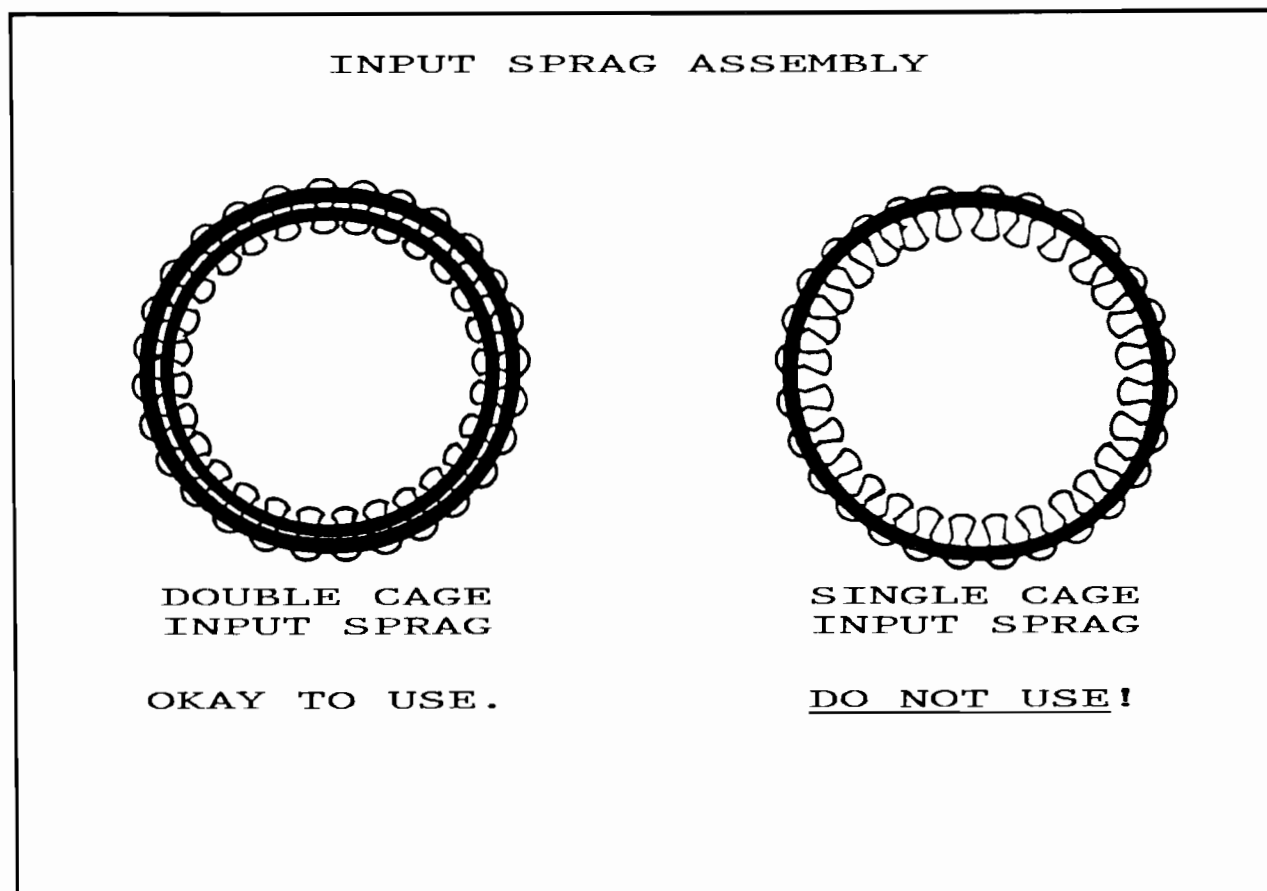
Figure 19

**COMPLAINT:** Complaints will vary depending on the failure mode of the input sprag. If the sprag failure results in "Not Holding" the complaint will be; "No Movement in the D4 Range"! If the sprag failure results "Not Freewheeling" the complaint will be; "Tie-up When Shifting Into 4th Gear"!

**CAUSE:** The cause may be the type of input sprag being used. The manufacturer is currently using an input sprag manufactured by SKF.

**CORRECTION:** Install an input sprag manufactured by BORG-WARNER. The sprags are easy to identify, as the SKF sprag Does Not use an inner cage and the BORG-WARNER sprag Does use an inner cage, as shown in Figure 19.

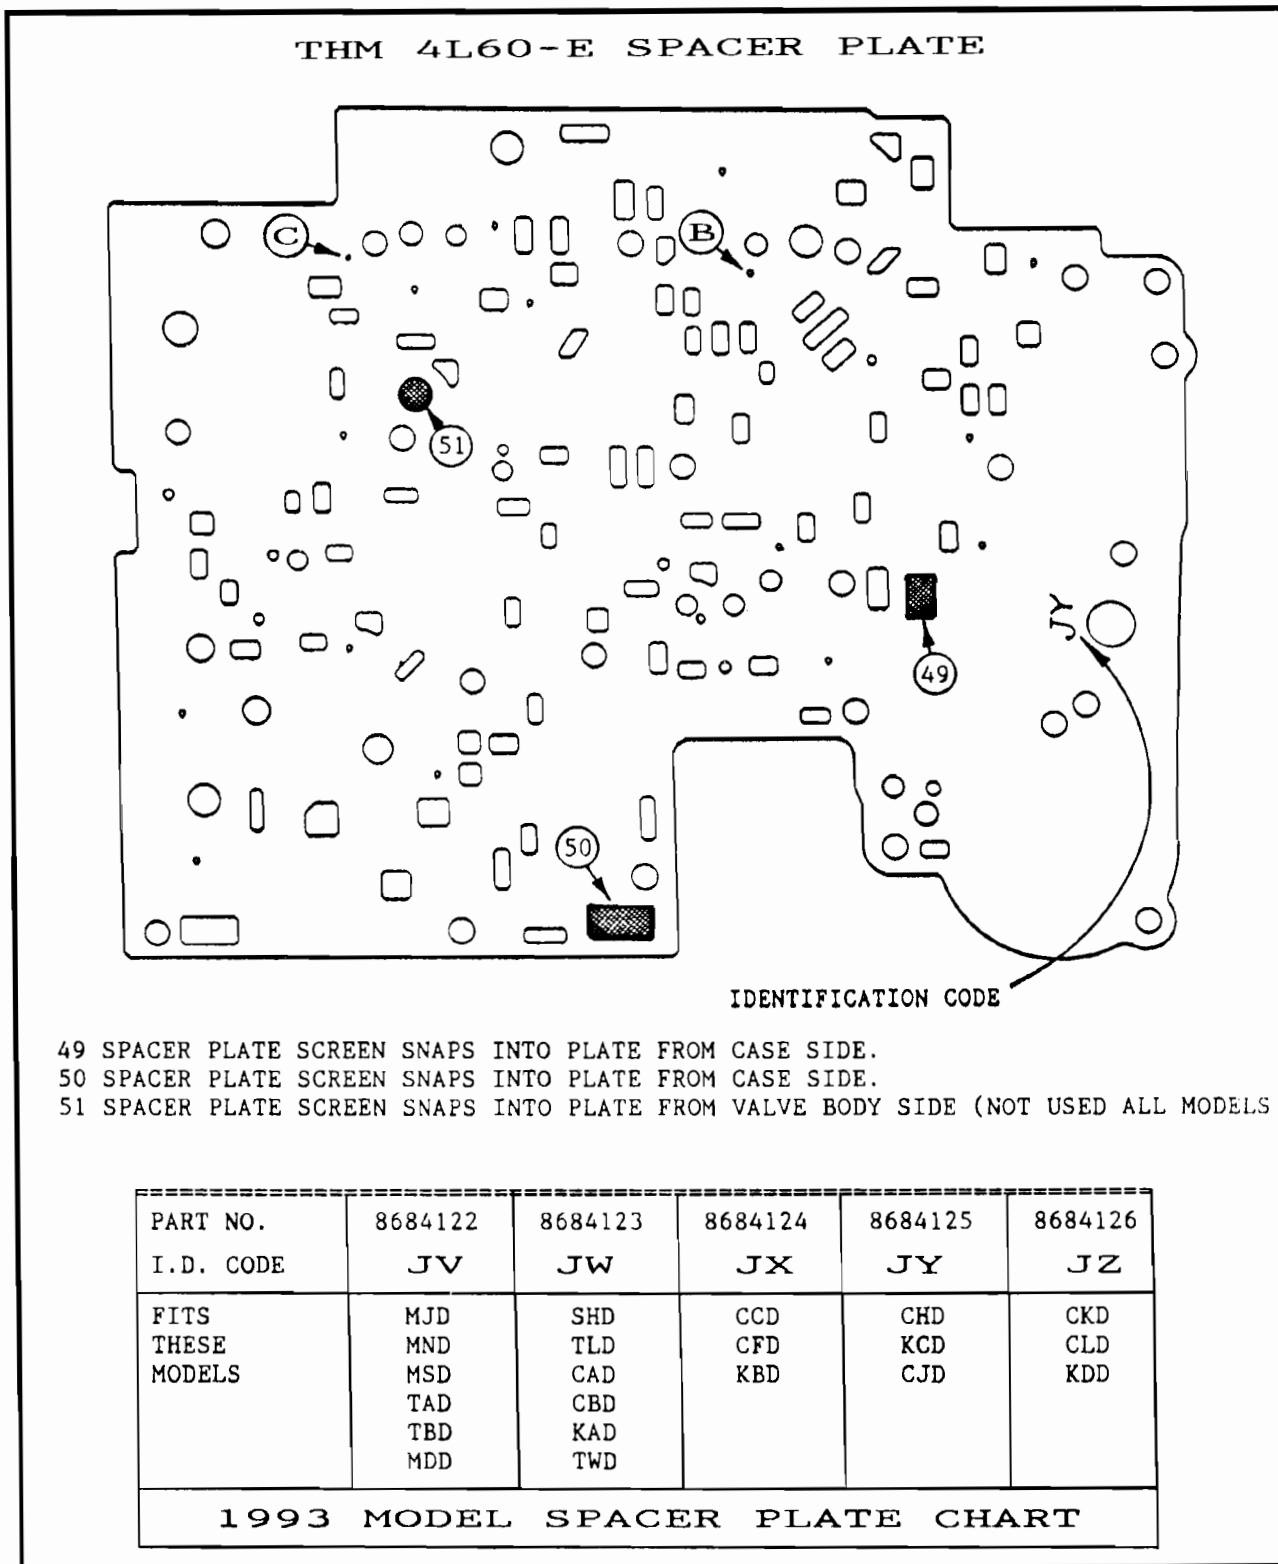
Figure 20

**CAUSE:** The cause may be a lack of volume of oil to the forward clutch and/or to the reverse input clutch.

For a delay into reverse range enlarge the hole marked "C" out to .125", as shown in Figure 20.

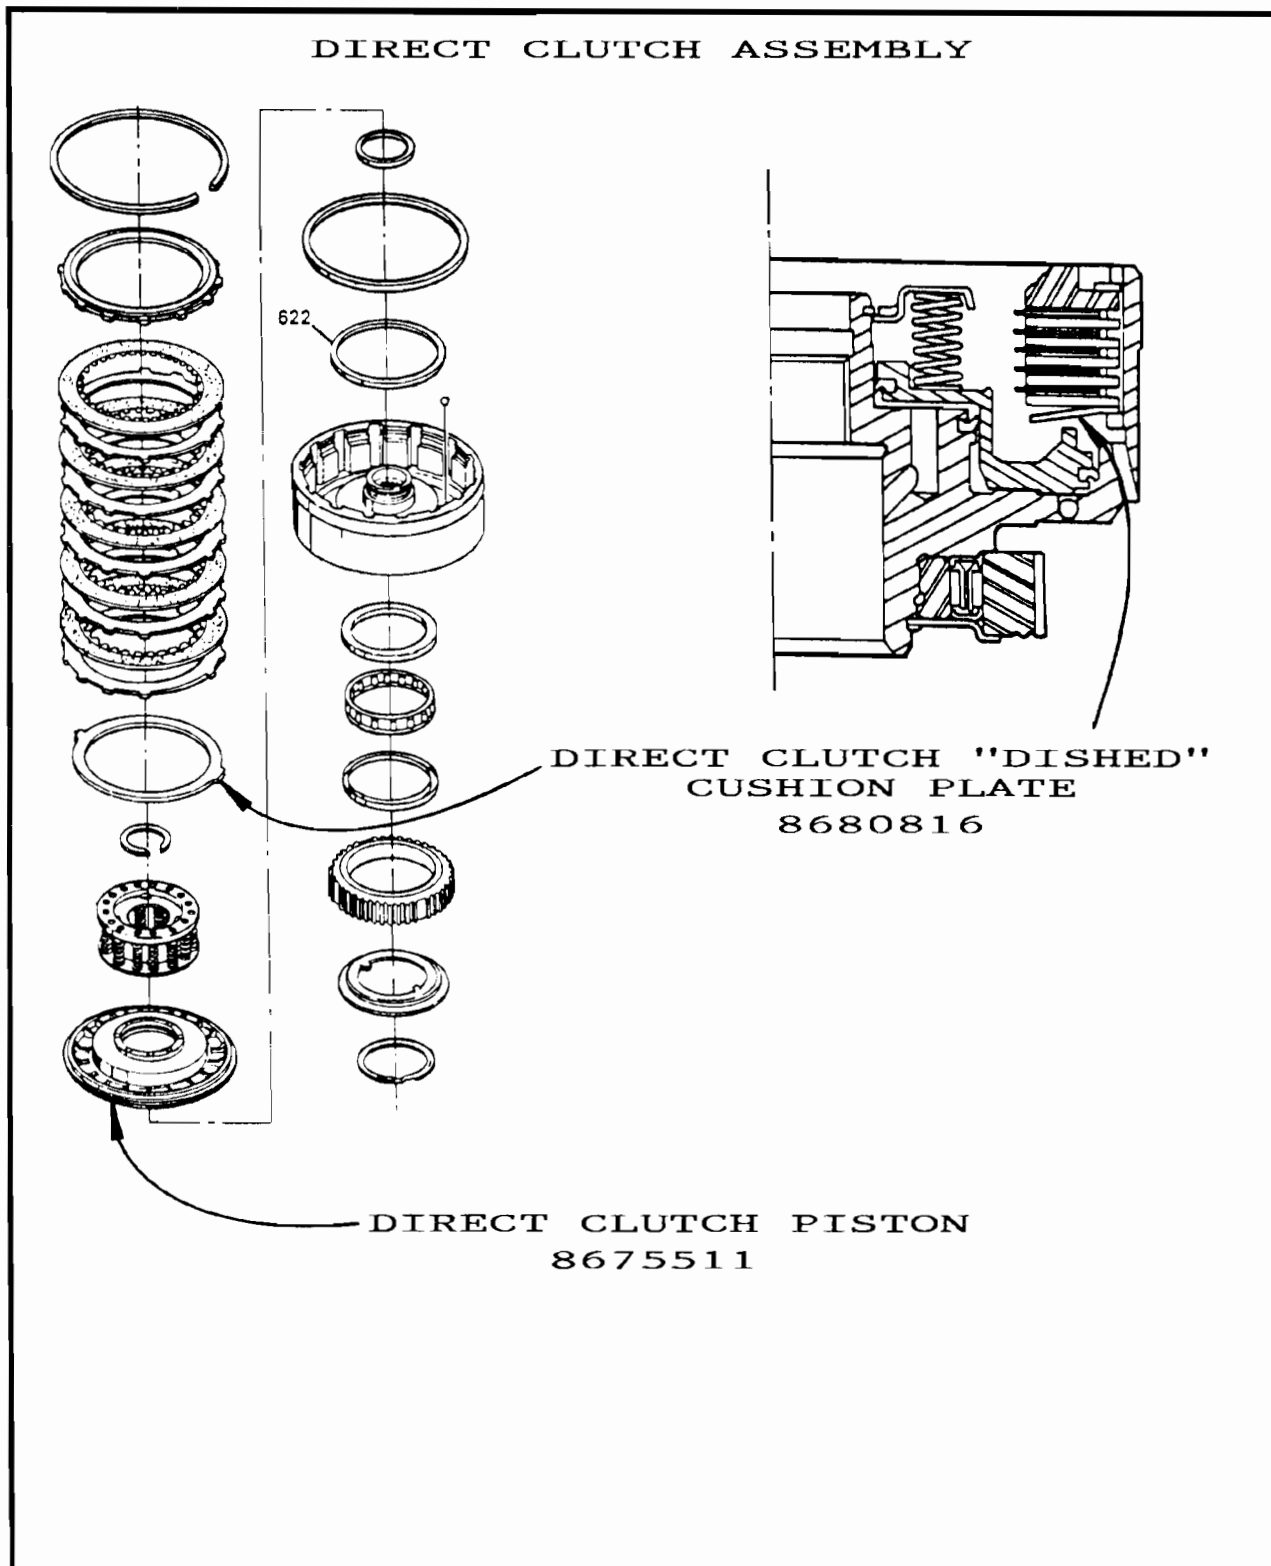
Figure 22

**CAUSE:** The cause may be a broken Direct Clutch "Dished" Cushion Plate in the direct clutch pack, and/or a broken Direct Clutch Piston.

**CORRECTION:** STEP 1:  
If the Direct Clutch Piston is broken replace it with a new one, OEM part number 8675511 (See Figure 22).

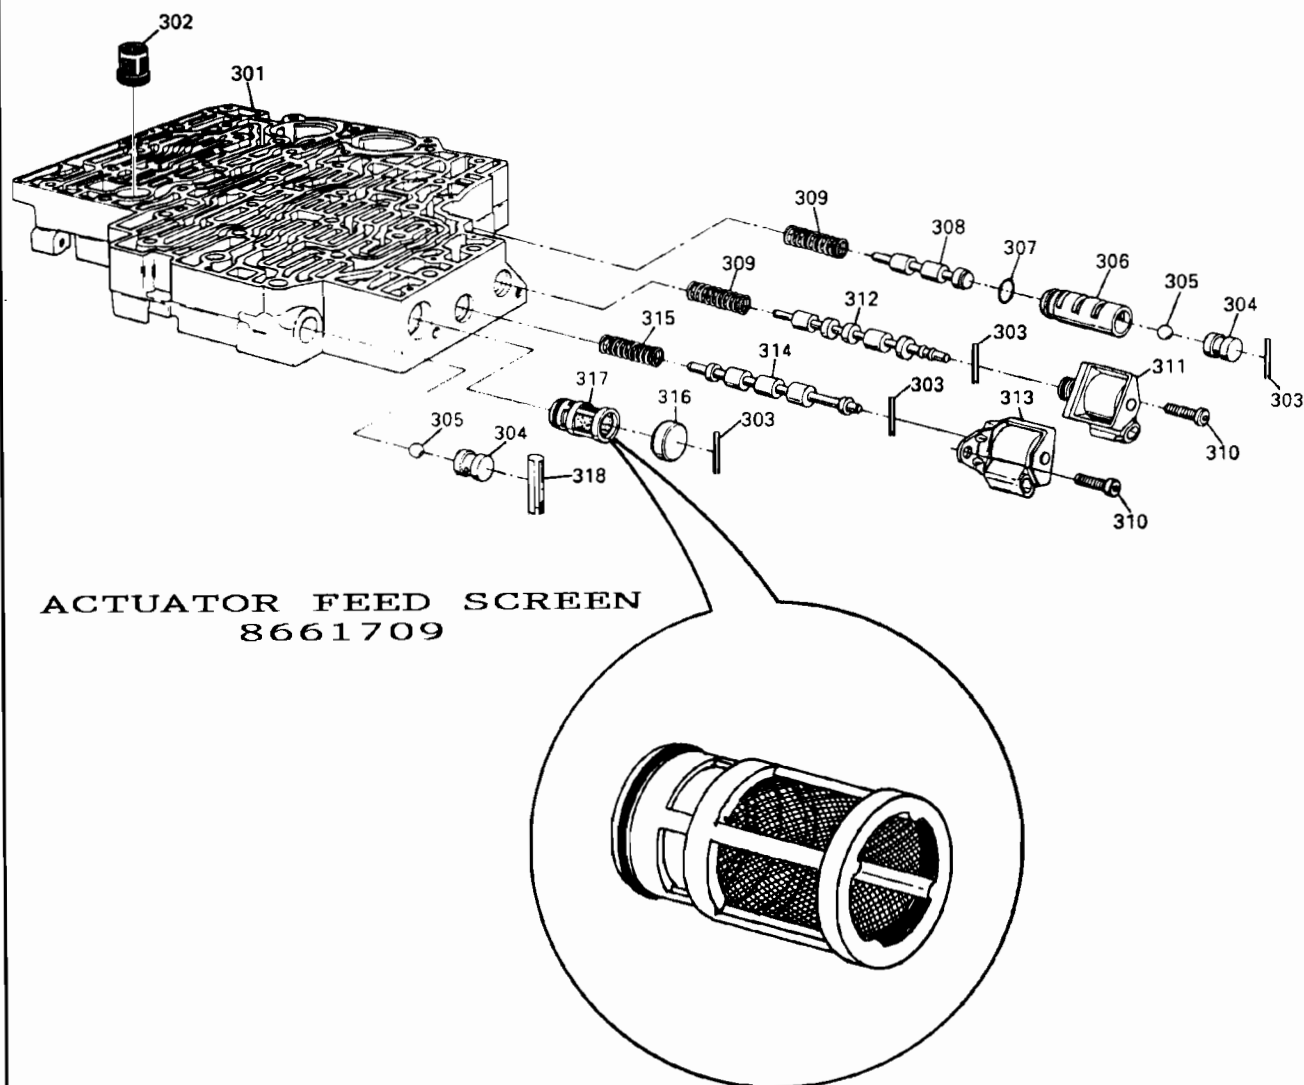
## ACTUATOR FEED SCREEN 8661709

CAUSE: For ALL of the concerns listed above, the cause may be a broken Actuator (Solenoid) Feed Screen located INSIDE of the valve body, as shown in Figure 29.

CORRECTION: Replace the Actuator Feed Screen, located INSIDE the valve body with OEM part number 8661709. Refer to Figure 29 for location. We recommend that this screen be replaced on Every rebuild and some kit suppliers are now putting this screen in the gasket set.

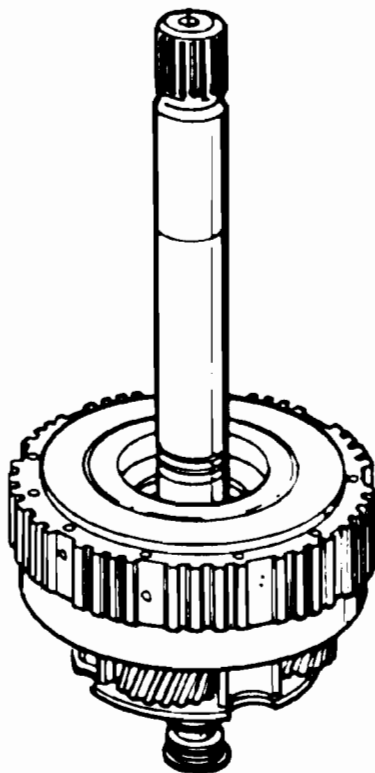
Figure 36

- COMPLAINT:** Some THM 4L80-E/4L80-EHD transmissions may exhibit a twisting or breakage of the turbine shaft and/or breaking the overdrive carrier assembly, usually "P" series cube vans.
- CAUSE:** The cause may be more torque load than the parts are capable of carrying, usually vehicle weight in heavy throttle conditions.
- CORRECTION:** There is now available from OEM, a new service package that includes a heavy duty turbine shaft and overdrive carrier assembly. Refer to Figure 36. This service package, OEM part number 24200130, should be installed in "P" series cube vans, or any vehicle carrying a lot of extra weight.
- SERVICE INFORMATION:**  
Turbine Shaft and O.D. Carrier Asm. (Heavy Duty) ..... 24200130

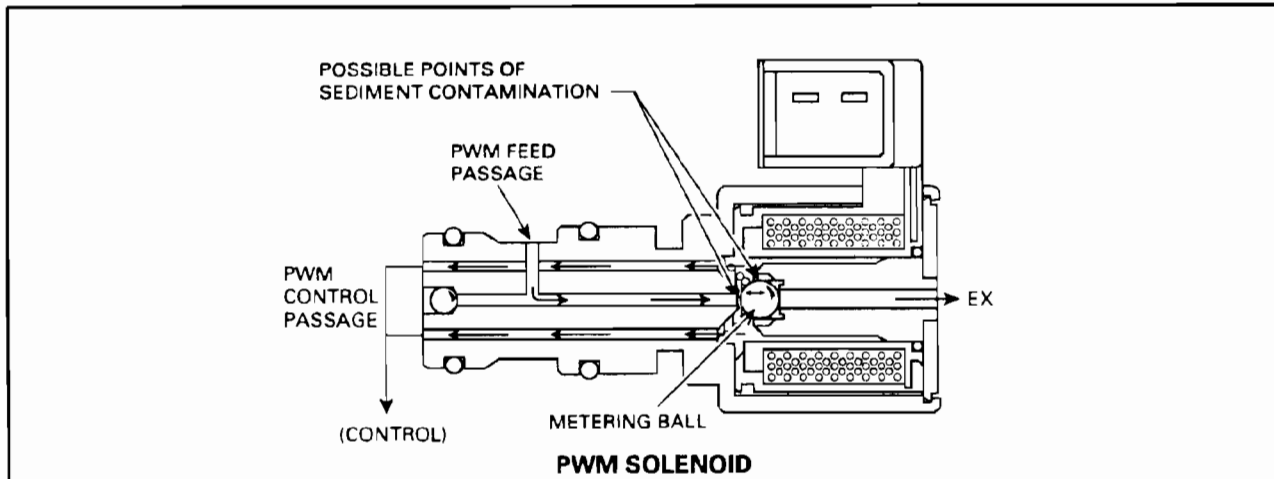
Figure 44

**COMPLAINT:** Some vehicles equipped with the THM 4T60-E transaxle built on or before January 26, 1993 (Julian Date 026) may exhibit no converter clutch apply, or a converter clutch apply shudder condition. Either one of these conditions will usually store diagnostic code 039 in the PCM memory. Vehicles built after the above Julian Date have a new design Pulse Width Modulated (PWM) Solenoid with added screens. Refer to Figure 43 for Julian Date identification. Excessive heat on torque converter may be visible when this condition exists.

**CAUSE:** The cause may be due to sediment trapped in the PWM Solenoid, and may enter the solenoid from either the control and/or feed passages and lodge in the flow path around the metering ball causing an undesired leak (See Figure 44).
