1997 SEMINAR INFORMATION

"THE RIGHT DIRECTION FOR '97"

AUTOMATIC TRANSMISSION SERVICE GROUP
9200 S. DADELAND BLVD.
SUITE 720
MIAMI, FL 33156
(305) 670-4161

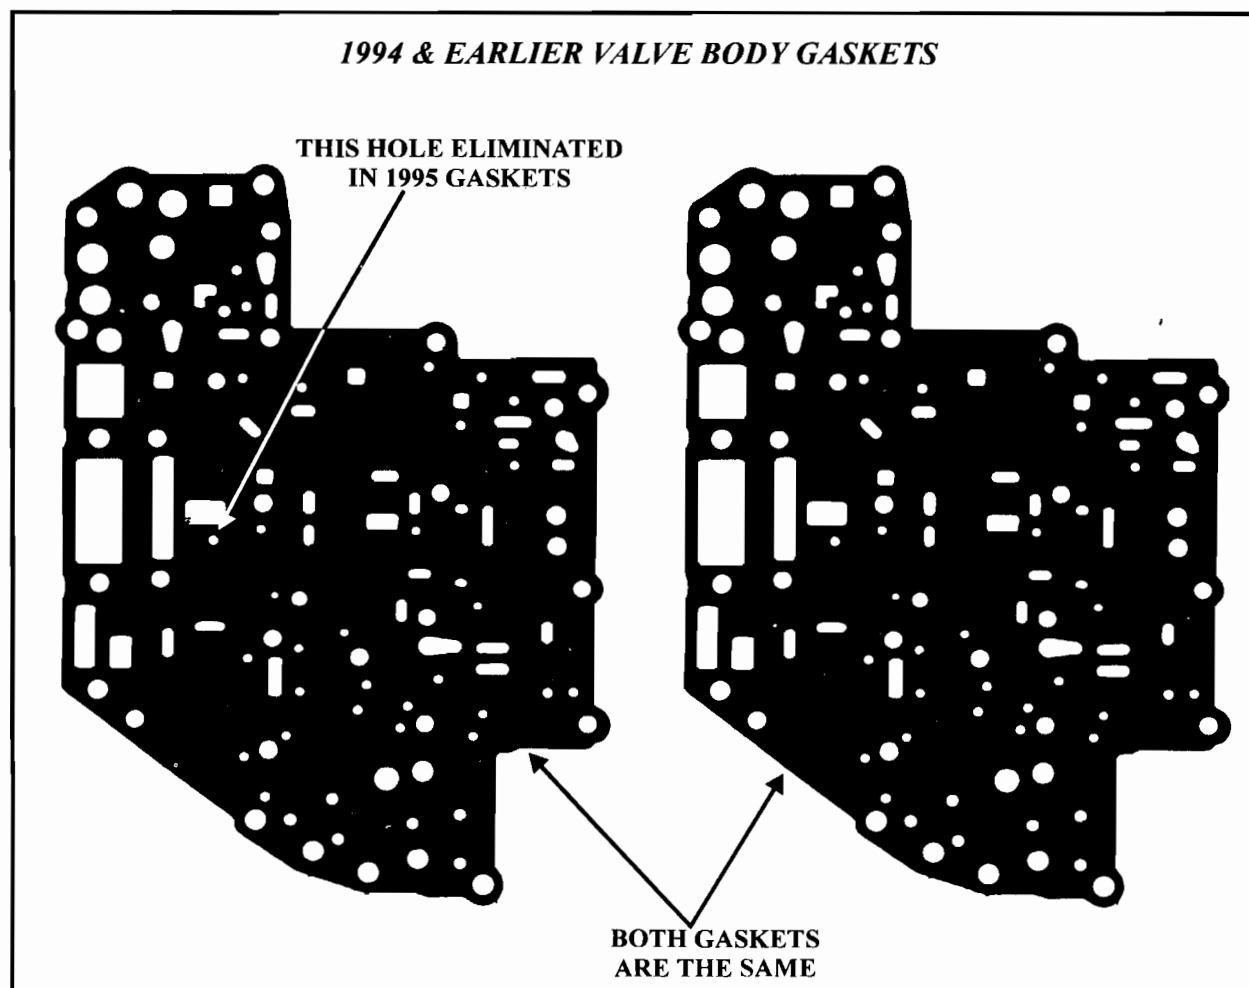
Figure 1

CAUSE: The valve body gaskets used in 1994 (Refer to Figure 1) and earlier MX17 transaxles found in GEO METRO, SUZUKI SWIFT and DAIHATSU CHARADE automobiles **CANNOT** be used in 1995 models. In 1995 the valve body gaskets changed (Refer to Figure 2) and if used in the 1994 and earlier models, will cause the above complaint.

CORRECTION: Match the valve body gaskets to the spacer plate to insure that the correct valve body gaskets have been installed.

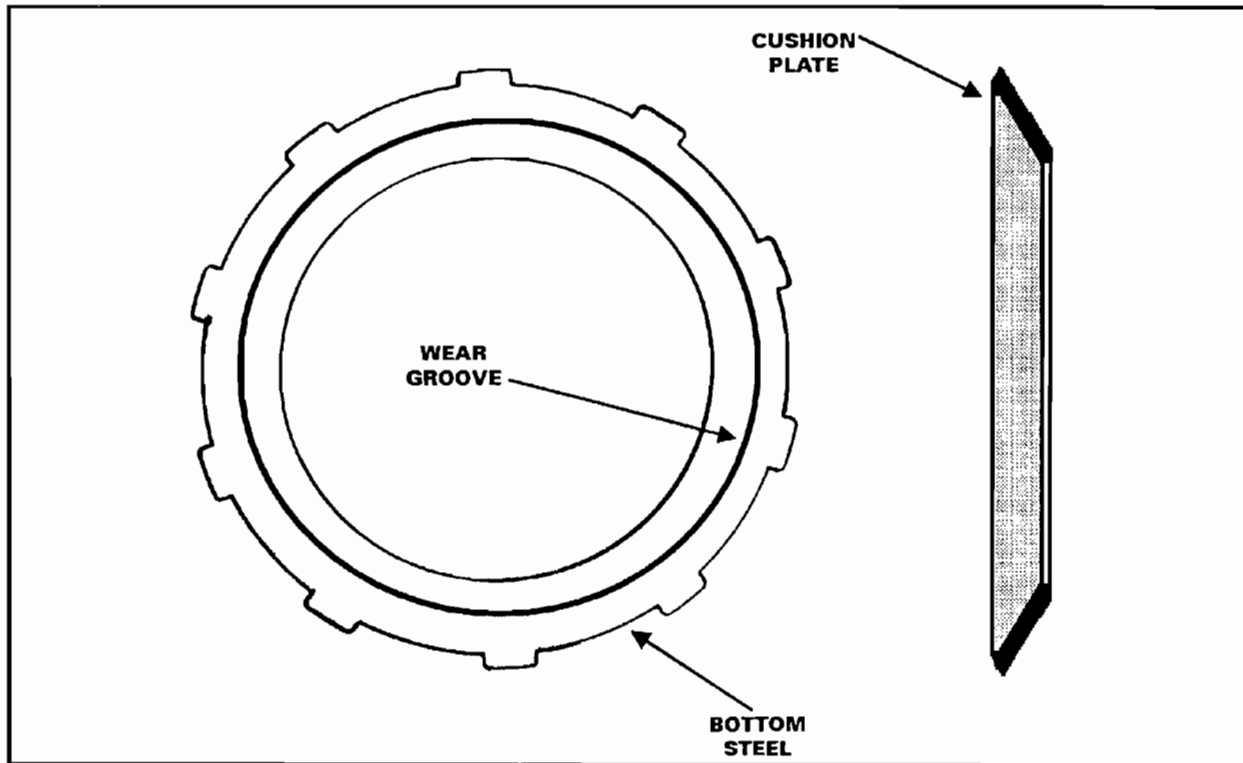
Figure 1

CAUSE: The bottom steel plate in each clutch pack will have a groove cut into it by the dished belleville spring on top of the clutch piston, which will increase clutch clearance or cause the belleville spring to get caught in groove worn into the bottom steel plate, resulting in the harsh shift complaint. (Refer to Figure 1)
The groove worn into the steel plate may as deep as .013" which will result in a failure to FULLY COMPRESS the belleville spring causing the spring to not fully cushion the clutch pack on the shift.

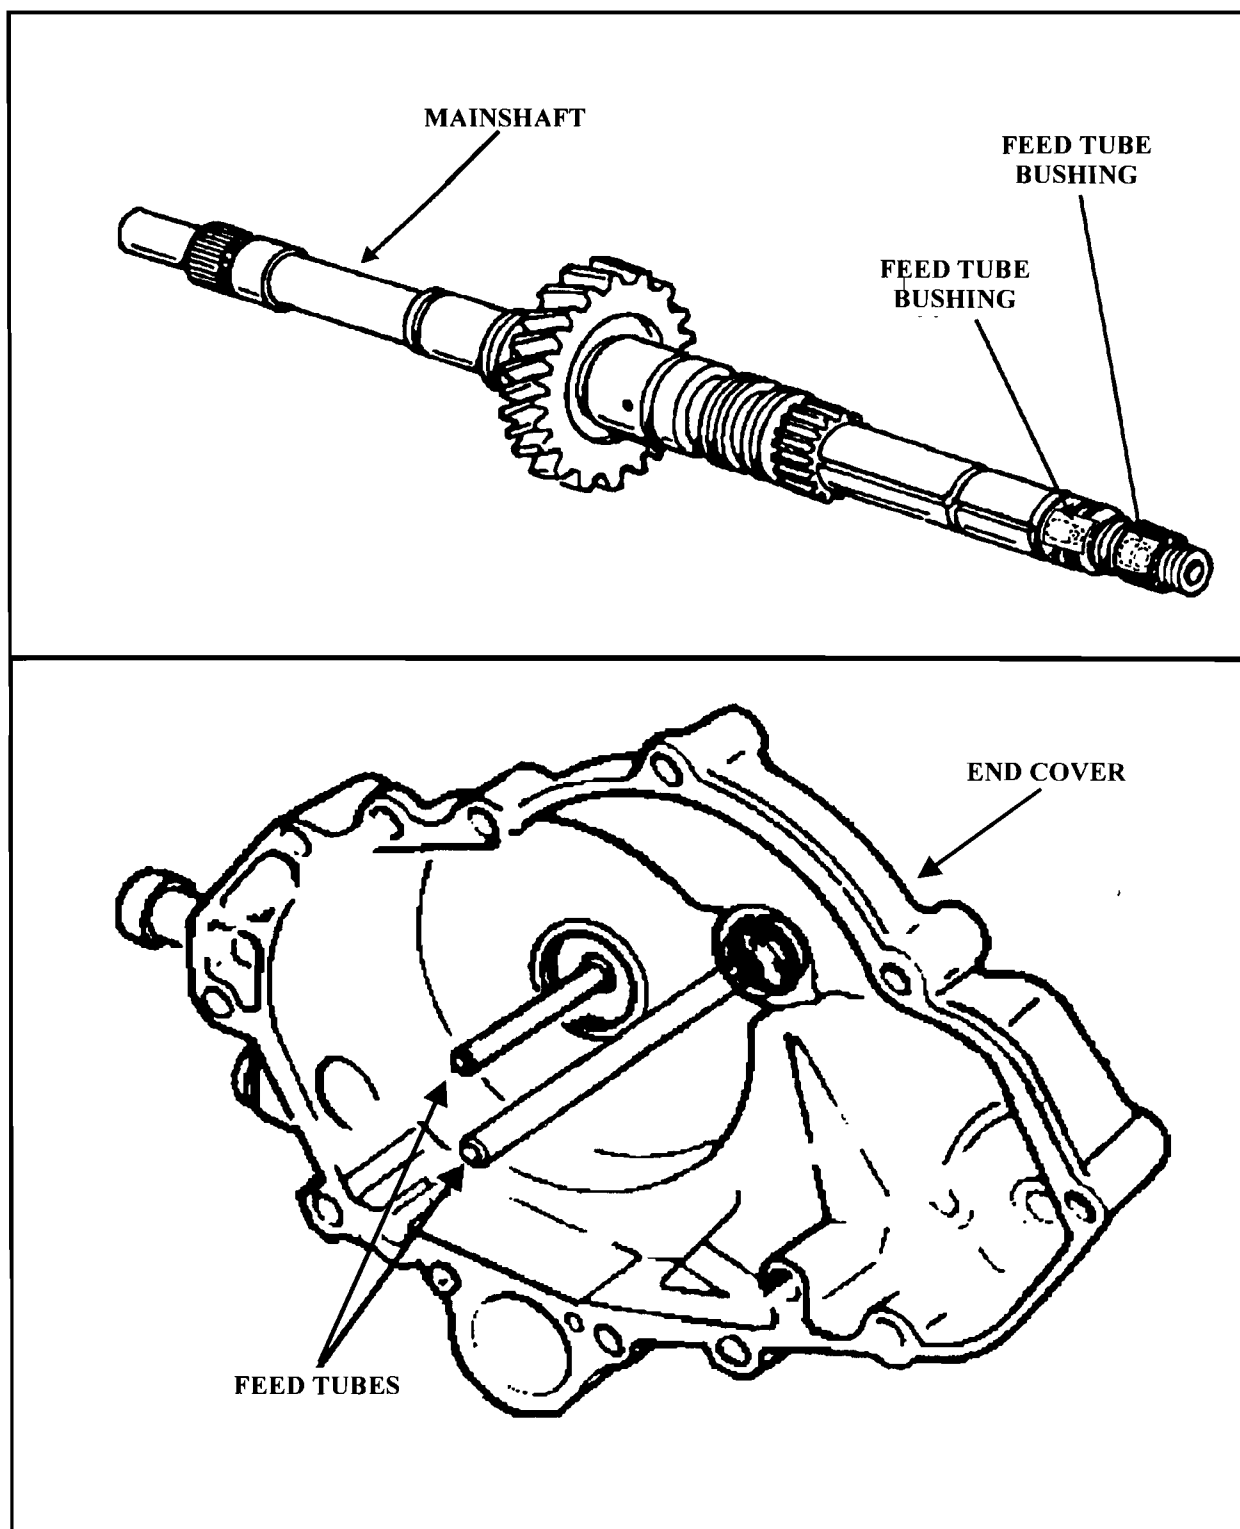
Figure 1

CAUSE: The cause may be worn or missing feed tube bushings that are located down in the center of the main, counter and secondary shafts. (Refer to Figure 1)

CORRECTION: These bushing can be replaced with new bushings, but, this can be a difficult operation due to the difficulty in removing the old bushings and being certain that the new bushings are not damaged during installation and that they are installed at the ***CORRECT HEIGHT*** so that none of the lube holes in the shafts are blocked.

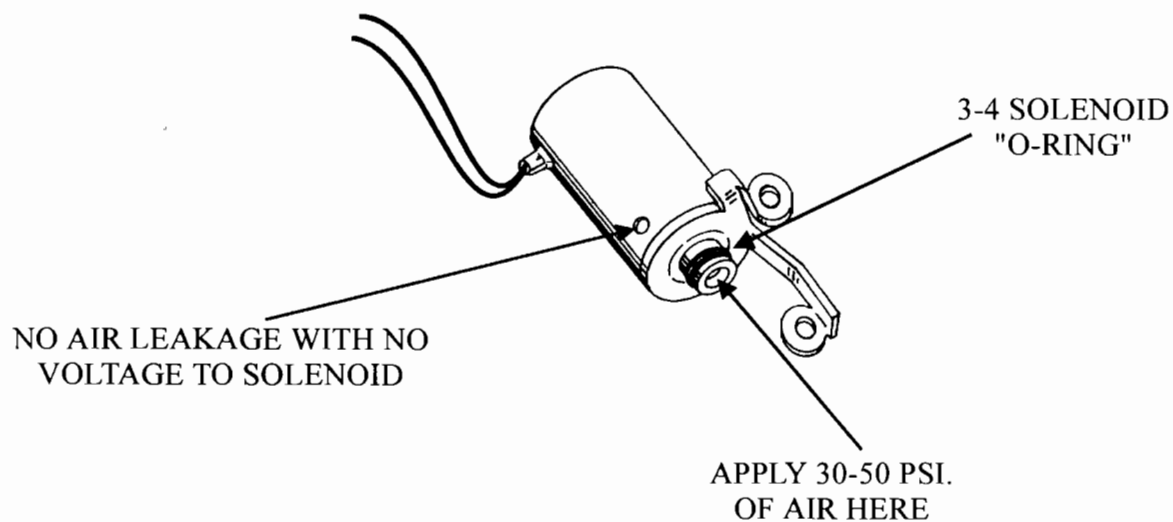
CAUSE: The cause may be, the 3-4 shift solenoid is partially stuck open, the 3-4 shift solenoid "O-ring" is damaged or the 3-4 shift valve bore plug is leaking. This may cause the 3-4 shift valve to **block** Coast Clutch apply oil and to exhaust Servo Release oil. Computer strategy, while in 3rd gear under 25MPH., commands the 1-2 solenoid **off** which in turn **blocks** Servo apply oil. At speeds above 25MPH., while in 3rd gear, computer strategy commands the 1-2 solenoid to be **on** which turns **on** Servo apply pressure in preparation for the upshift to 4th gear. When 1-2 solenoid application occurs, while in 3rd gear above 25 MPH., drum speed or pulse generator output may drop because of the lack of Servo Release oil. When the computer recognizes that Pulse Generator input or drum speed has dropped it may turn the 1-2 solenoid **off**. This on and off cycling of the 1-2 solenoid may continue until the upshift to 4th occurs.

APPLY AIR PRESSURE HERE, WITH THE 3-4 SOLENOID REMOVED,
TO CHECK THE 3-4 SHIFT VALVE BORE PLUG FOR LEAKS

CORRECTION: Refer to Figure 1 to identify the 3-4 shift solenoid placement and to check its mechanical function. Apply air pressure to the end of the solenoid as shown in Figure 1 to ensure that the 3-4 shift solenoid is closed and check the O-ring for damage. With the 3-4 solenoid removed, air check the 3-4 shift valve through the hole where the 3-4 solenoid is placed and ensure that there is no air leakage from the bore plug. Refer to Figure 2 for 3-4 shift valve and bore plug location.

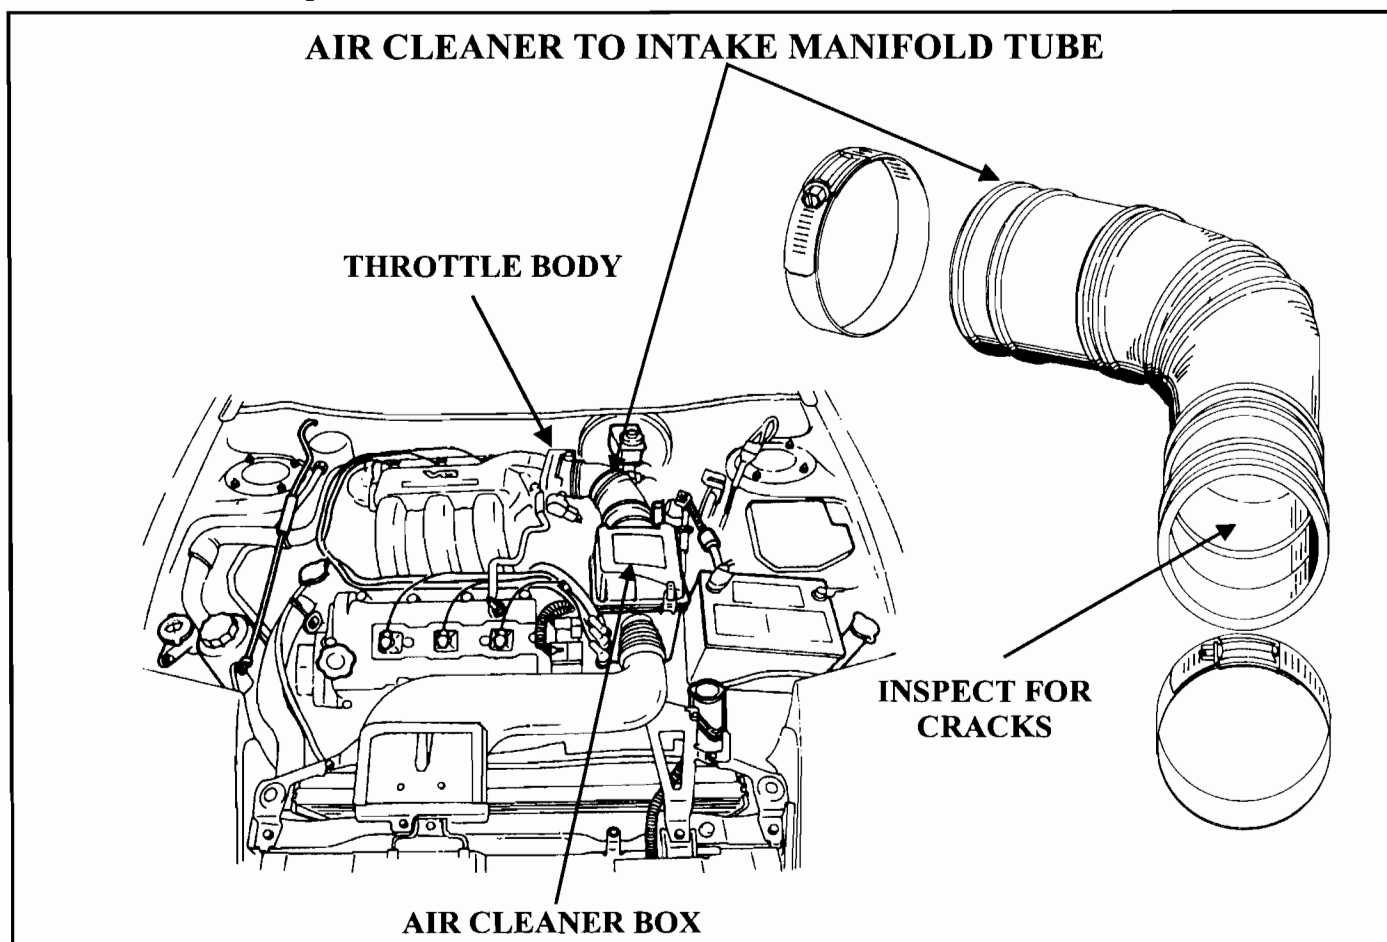
Figure 1

CAUSE: The cause may be a cracked "Air Cleaner To Intake Manifold Tube" allowing cold air to rush into the "Throttle Body" and "Mass Air Flow Sensor" causing the engine to stumble and die. This normally happens only in the Drive position because when Drive is selected the engine and transmission shift towards the firewall, stretching the tube apart. When Reverse is selected the engine and transmission are shifted away from the firewall, sealing up the cracks in the tube.

CORRECTION: Remove the "Air Cleaner To Intake Manifold Tube," located between the throttle body and the air cleaner box, and inspect for cracks as shown in Figure 1. If cracks are found, duct tape can be used as a temporary fix until the tube can be replaced. Secure hose clamps and make sure that all engine and transmission mounts are good.

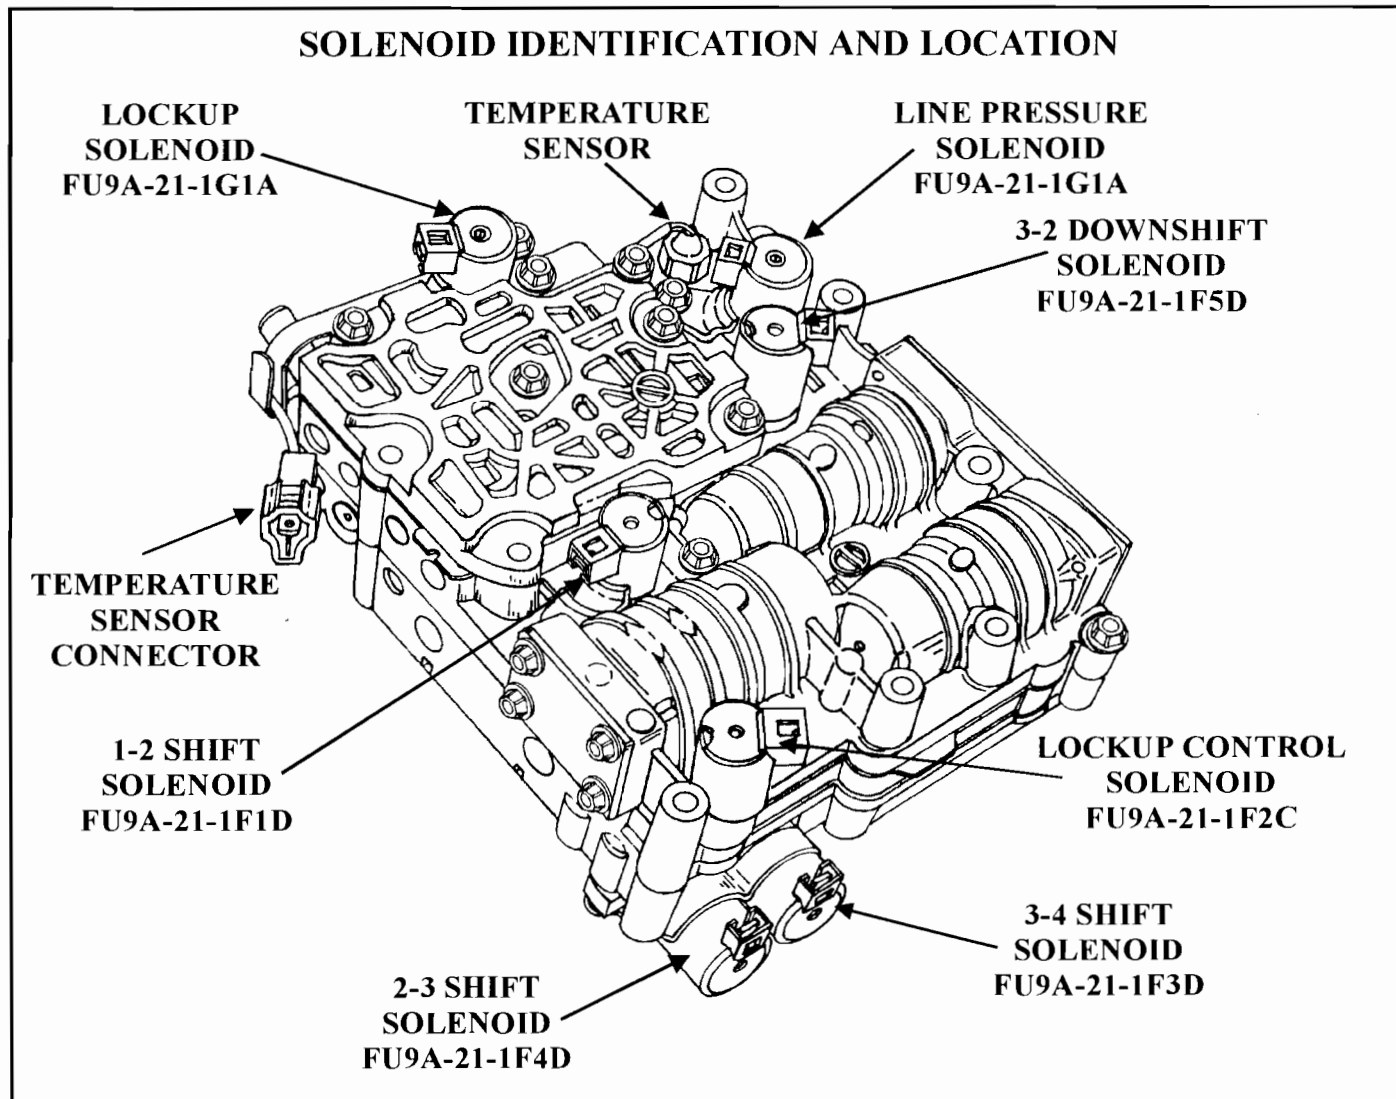
Figure 1
Automatic Transmission Service Group

CAUSE: The cause may be that the wire harness conduit, or protective coating, was removed and solenoid harness connectors may now be attached to the wrong solenoid.

CORRECTION: Refer to Figure 1 for solenoid identification and location on the valve body, and the Mazda part numbers. Refer to Figure 2 for wire color, harness and solenoid connector color and terminal identification.

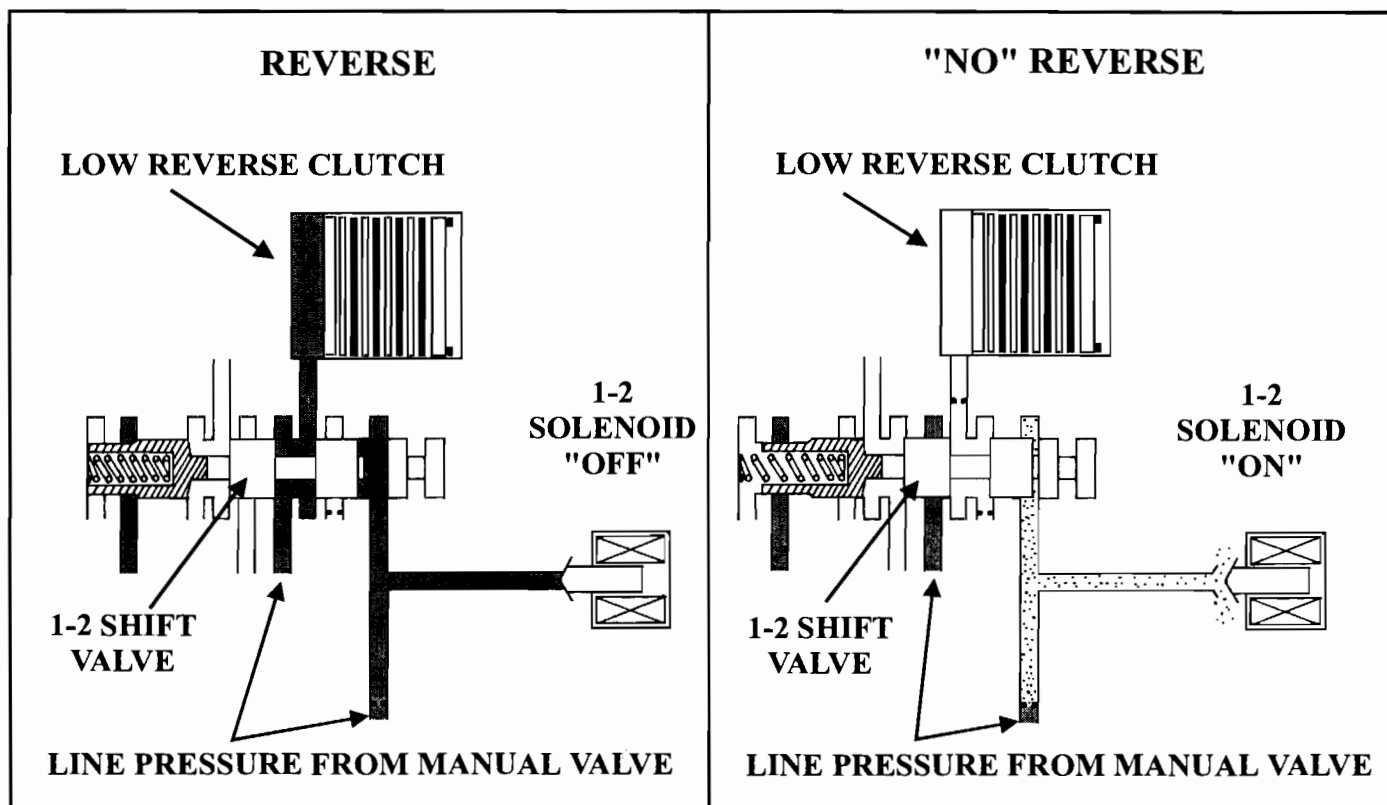
Figure 1

1. A faulty "Vehicle Speed Sensor," signaling the computer that the vehicle is in motion. At that point the computer may apply the 1-2 shift solenoid and block the passage to the "Low Reverse Clutch." (See Figure 1)
2. A stuck 1-2 shift valve or "leaky" bore plug at the end of the 1-2 shift valve, allowing the 1-2 shift valve to block the passage to the "Low Reverse Clutch." (See Figure 1) **NOTE: This may also cause 2nd gear starts in Drive.**
3. A 1-2 solenoid that is stuck open, allowing the 1-2 shift valve to block the passage to the "Low Reverse Clutch." (See Figure 1) **NOTE: This may also cause 2nd gear starts in Drive.**
4. A Low Reverse or Reverse clutch failure.

1. Replace the Vehicle Speed Sensor.
2. Inspect the 1-2 shift valve as shown in Figure 3 for free movement in its bore. Air check the 1-2 shift valve, from the hole where the 1-2 shift solenoid is placed. Listen for the sound of the 1-2 shift valve snapping back and forth and ensure **no** air leakage from the bore plug at the end of the 1-2 shift valve line up.
3. Apply air pressure to the 1-2 shift solenoid, as shown in Figure 4, and ensure that there is **no** leakage when there is no voltage applied to the solenoid, replace if necessary. **NOTE: It may be necessary to apply 12 volts to the solenoid several times to ensure that the solenoid is closing every time the voltage is removed.** Inspect the O-ring on the solenoid and replace if necessary.
4. Inspect Low Reverse or Reverse clutch assembly's for wear and repair as needed.

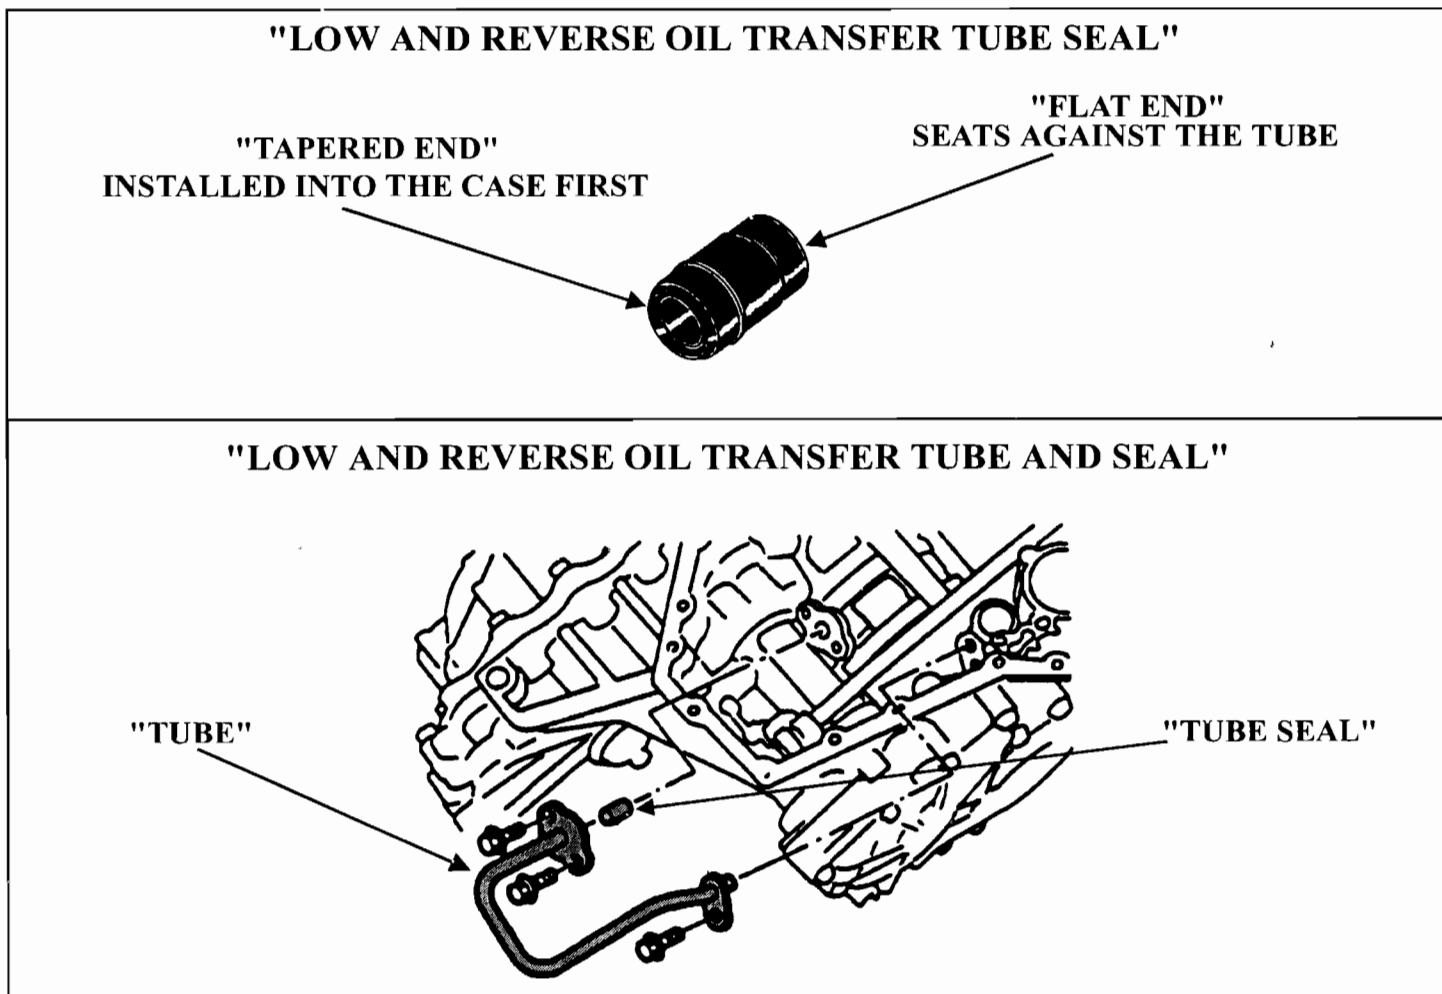
Figure 1

CAUSE: The cause may be, during overhaul the tube seal for the "Low and Reverse" oil transfer tube was damaged on disassembly and not replaced or the tube seal was installed backwards. The "Low and Reverse" oil transfer tube is located under the valve body and is attached to the case with three bolts. NOTE: The tube seal normally will *not* fall out of the case, when the tube is removed and is *not* always provided in overhaul kits.

"LOW AND REVERSE OIL TRANSFER TUBE SEAL"(FORD#).....F3XY-7G085-A

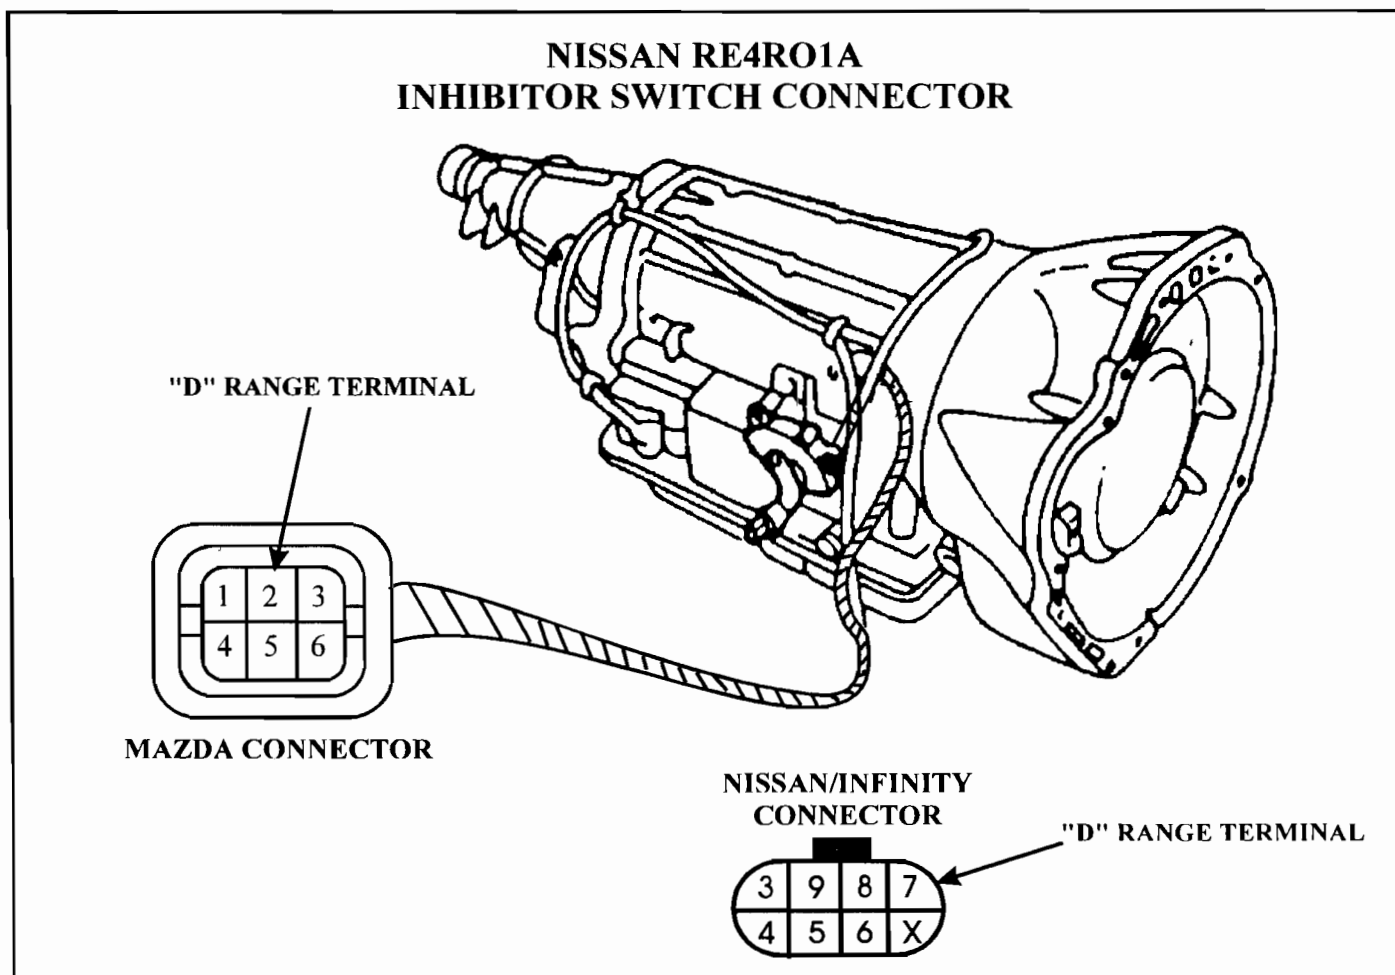
Figure 1

CAUSE: The cause may be, a loose or broken, "D" range signal wire to the inhibitor switch, a bent or corroded pin in the harness connector, or a defective inhibitor switch.

CORRECTION: Check the inhibitor switch and the connectors for any bent and/or corroded pins. If the connectors and pins are good, inspect the wires in the harness from the computer to the inhibitor switch, for any opens or shorts to ground with your DVOM. Refer to Figures 1 and 2 for locations of the inhibitor switch and views of the connectors on the RE4R01A and RE4F04A.

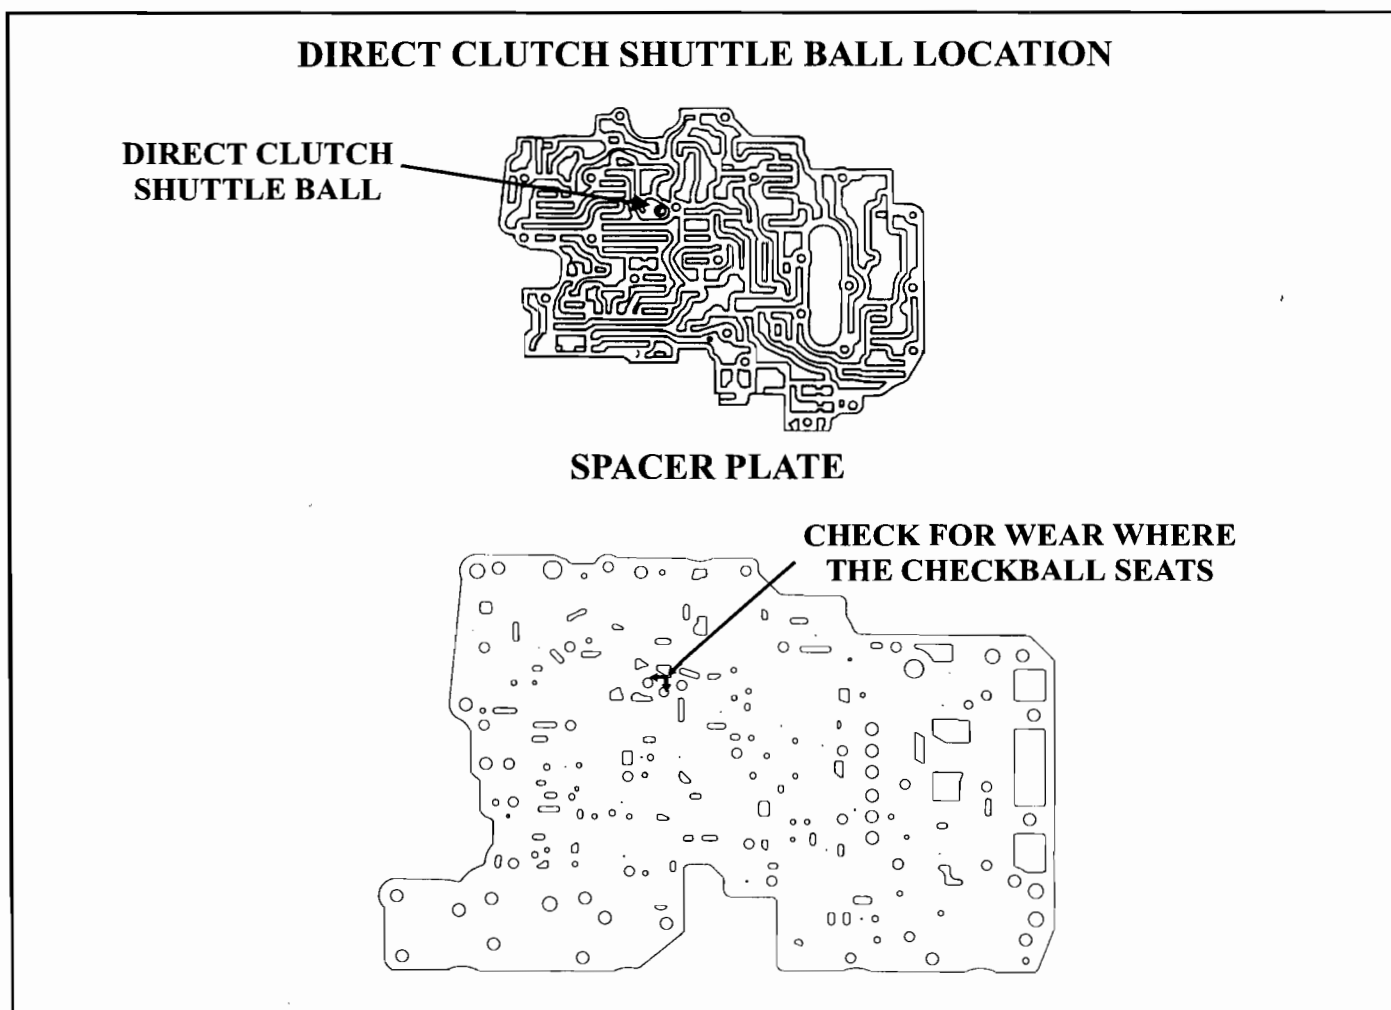
Figure 1

CAUSE: The cause may be:
A worn spacer plate, where the direct clutch shuttle ball seats, causing a loss of direct clutch pressure. (See Figure 1)

CORRECTION: Replace the spacer plate.

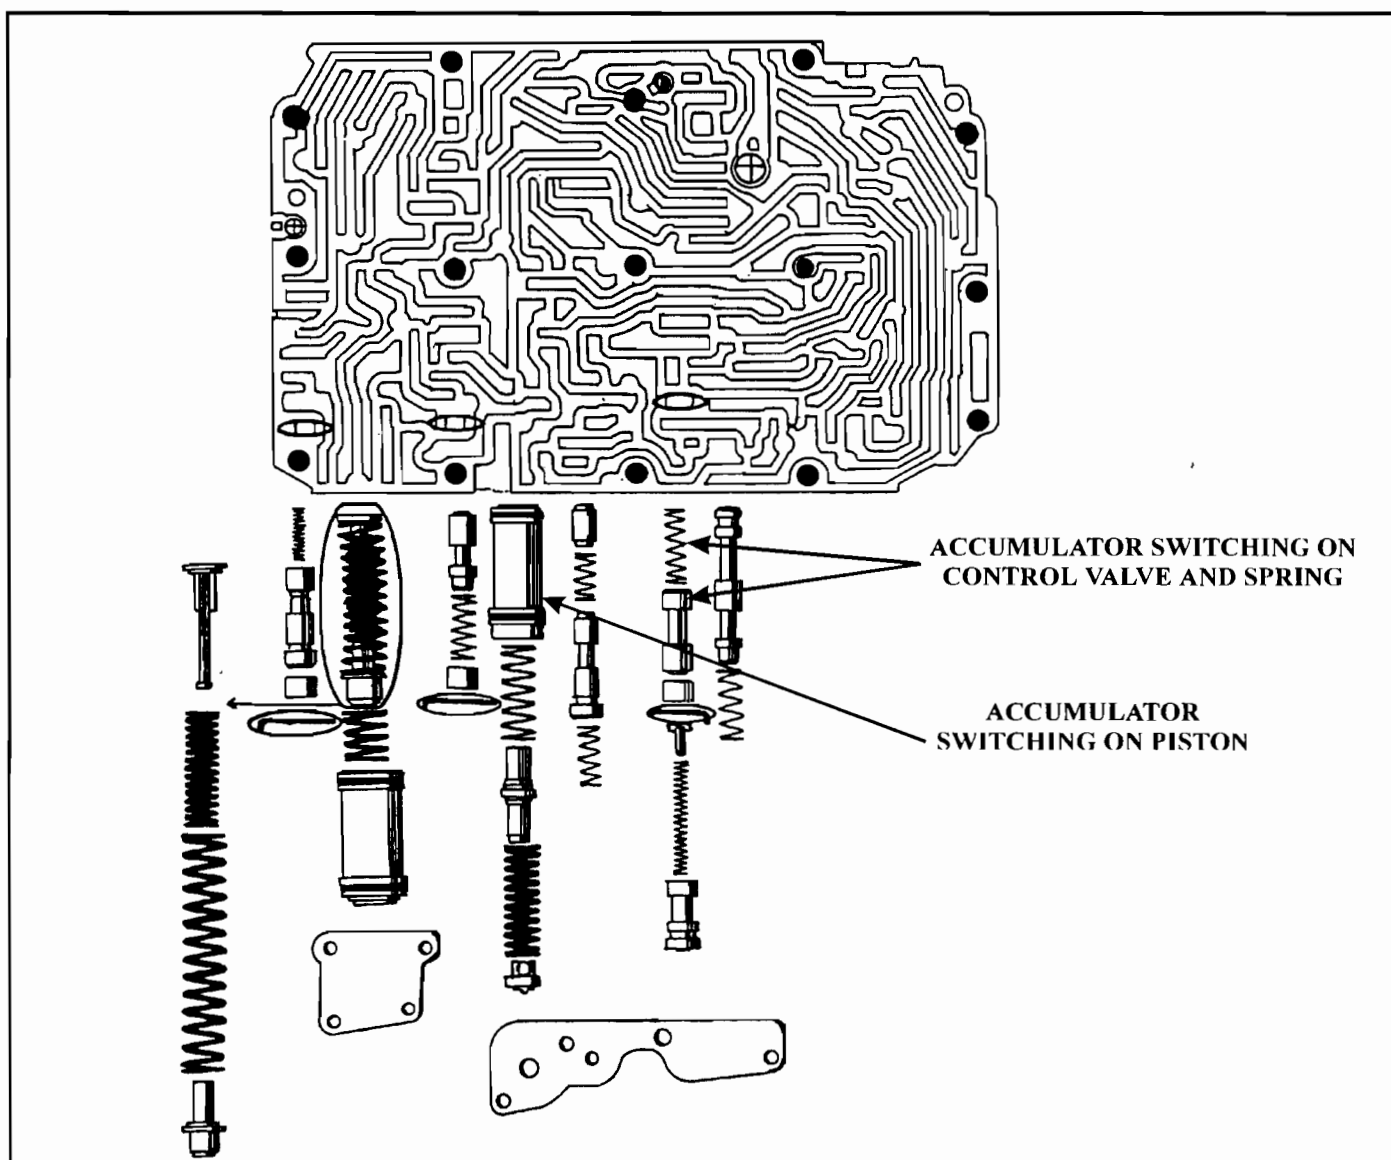
Figure 1

CAUSE: The cause may be, a stuck or sticking *Accumulator Switching On Control Valve*, a collapsed or broken *Accumulator Switching On Control Valve Spring*, a missing, cut, or leaking seal ring on the accumulator piston, or a cracked *Accumulator Switching On Piston* (See Figure 1).

CORRECTION: Remove and disassemble the valve body. Inspect and replace as necessary, the parts and concerns listed above, as shown in Figure 1.
