Technical Service Information

THM 4L60 (700-R4) NEW FRONT PUMP BODY

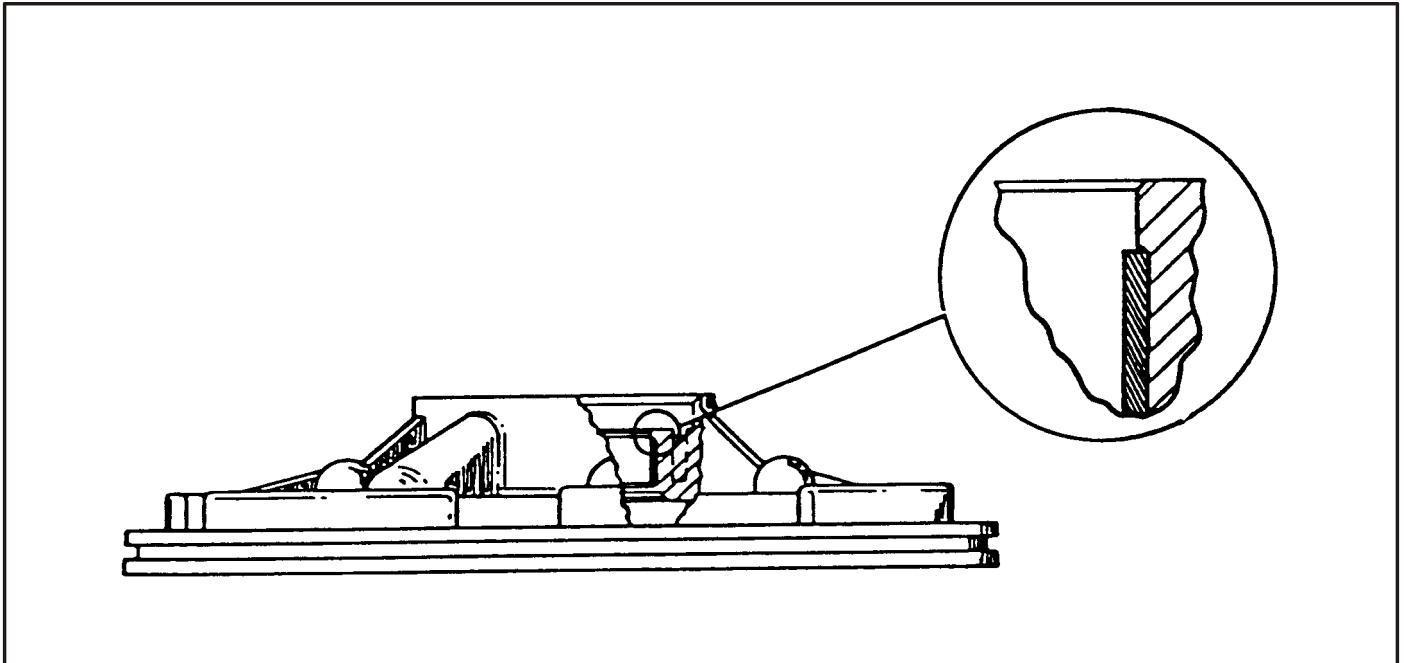
Figure 1

Beginning January 9, 1987 (Julian Date 009), there was a machined step added to the pump bushing bore in the pump body, to prevent the bushing from "Walking" towards the front pump seal (See Figure 1).

Because of the step added to the bore in the pump body, removal and installation procedures must be revised. The bushing must now be "Pressed Out" towards the pump rotor side, and "Pressed In" from the pump rotor side.

Care must be used when pressing the new bushing in, so as not to exert too much pressure, and break the added step in the pump bushing bore. Refer to Figure 1.
