Technical Service Information

FORD F4EAT

SLIPPING IN 2ND AND 4TH AND/OR NO 2ND AND 4TH

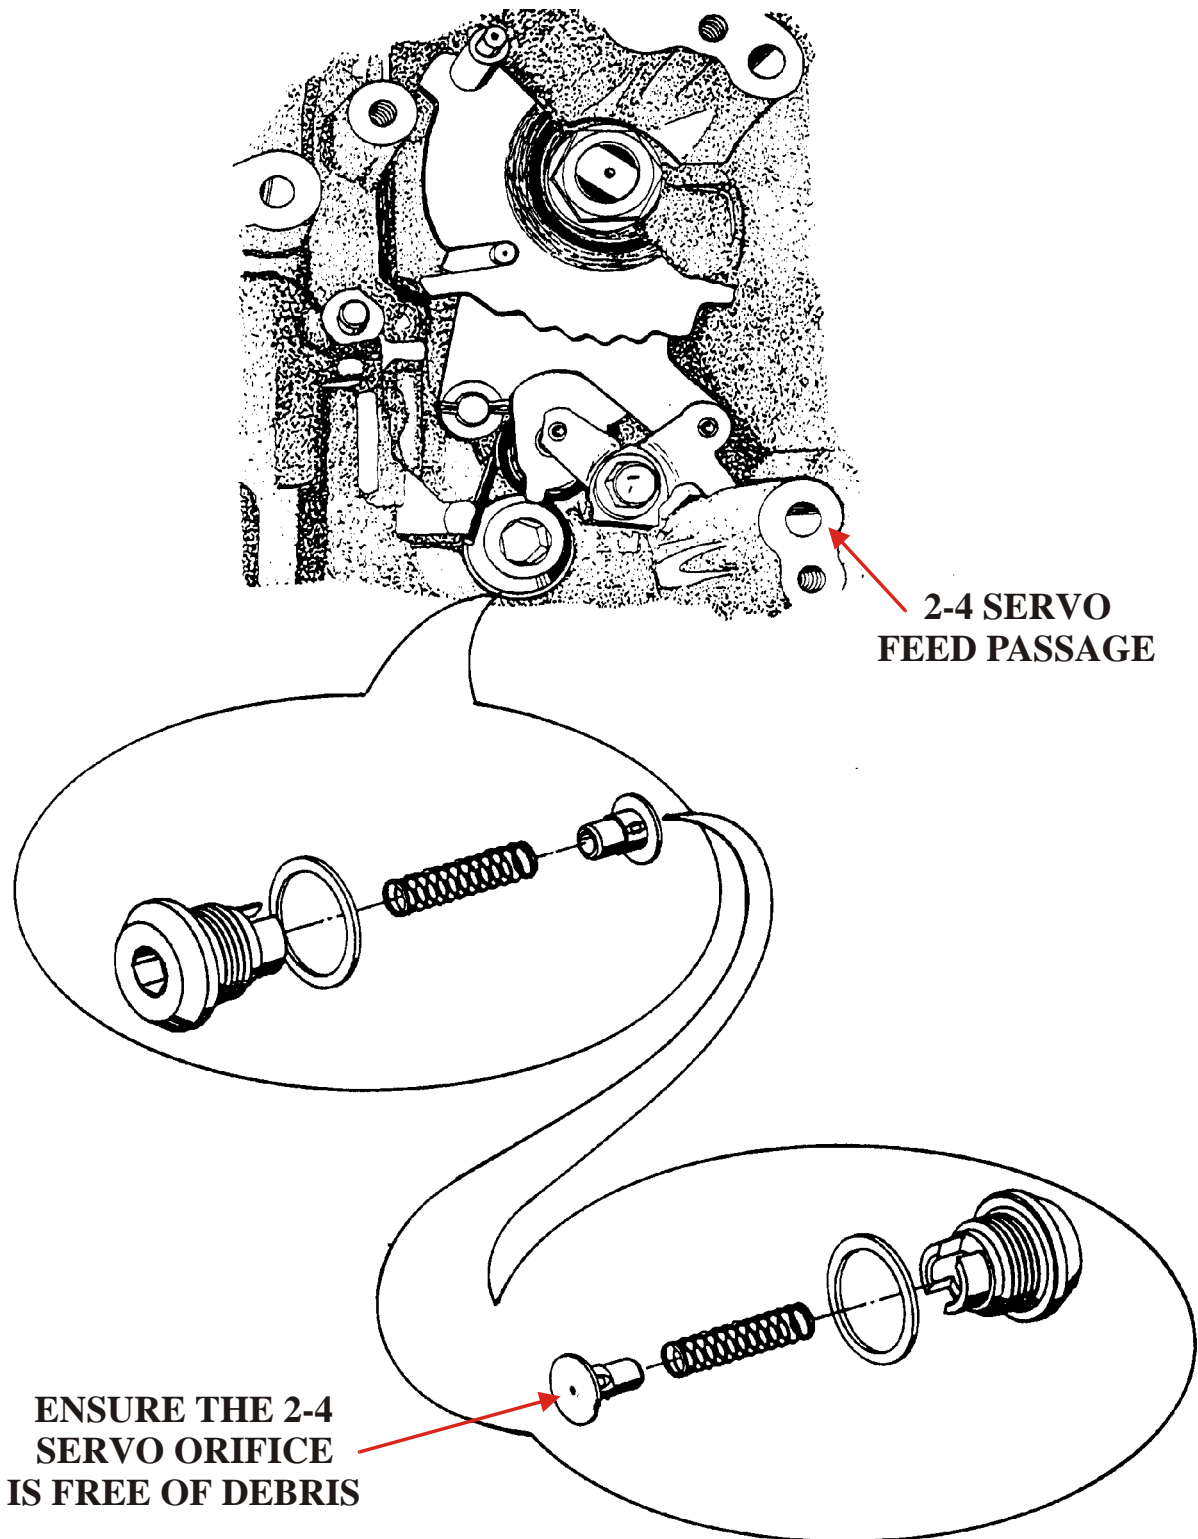
CAUSE: The cause may be a clogged or partially clogged 2-4 servo feed orifice. The 2-4 servo feed orifice is only .038" in diameter, and will not tolerate much debris before the slipping condition will exist. If the 2-4 servo orifice becomes totally closed, there will be NO 2nd gear, and NO 4th gear.
Another cause for NO 2nd and NO 4th gears could be a checkball that has been installed in the wrong location in the Premain valve body, as shown in Figure 2.

2-4 SERVO ORIFICE LOCATION

CORRECTION: Remove the 2-4 servo feed orifice assembly using a 10mm Hex socket. Refer to Figure 1 for the location in the case. Thoroughly clean the 2-4 servo orifice and all case passages with clean solvent. The spring in this assembly is larger on one end, and the larger end goes into the Hex bolt (See Figure 1).
Also ensure that you have only TWO .243" diameter checkballs installed into the Premain valve body, in the locations shown in Figure 2.
