# Technical Service Information

## **MERCEDES 722.3 /.4 HARSH REVERSE AFTER REBUILD CHECK VALVE IN PUMP IS OK**

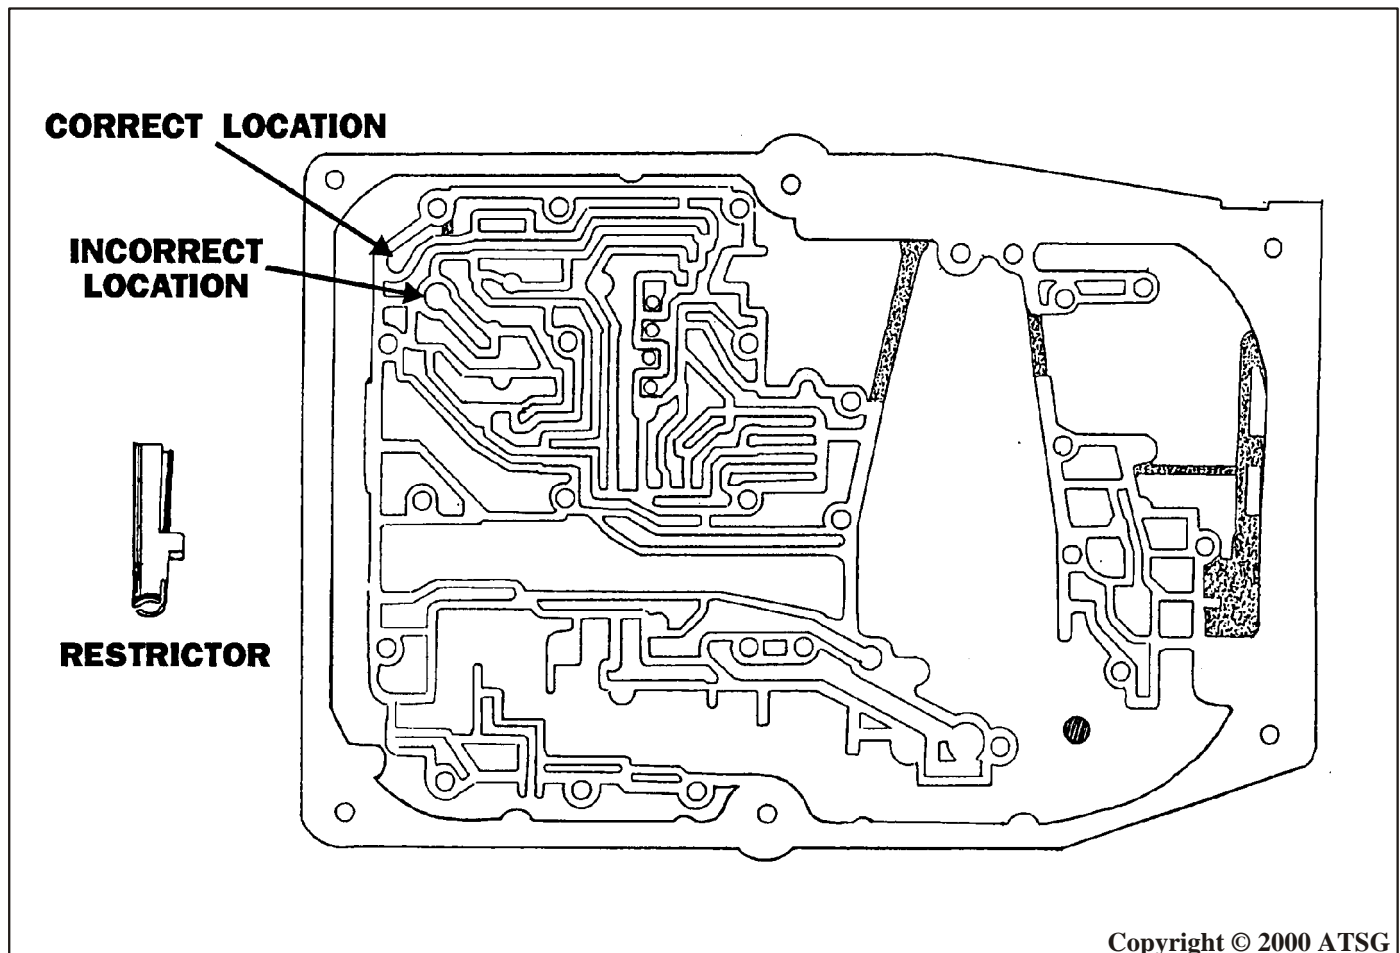
**COMPLAINT:** Some 190 series transmissions may experience a harsh reverse engagement into reverse after an overhaul. All of the forward ranges are ok and modulating pressure is within specifications.

**CAUSE:** The reverse feed passage is unrestricted, allowing too much oil volume to the reverse clutches.

**CORRECTION:** Install the Mercedes tapered oil restrictor (Part # 123 277 0319) into the transmission case as shown in figure 1. Note that the restrictor goes in tapered end first and fits snug in the case.
