Technical Service Information

CHRYSLER A518 SERIES NO OR LATE THIRD GEAR

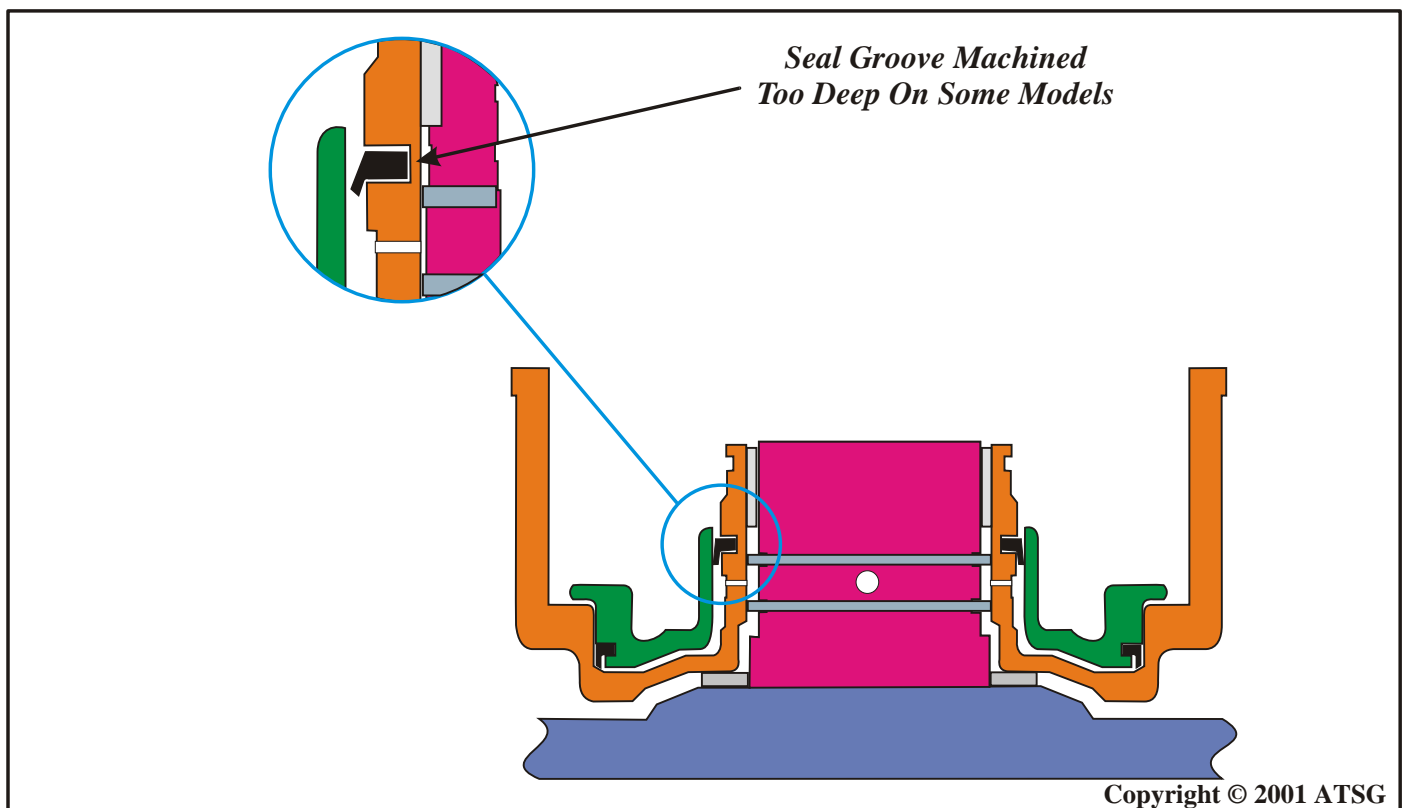
Figure 1

CAUSE: Some direct clutch drums had the inner seal groove cut too deep. This allows for the inner seal to be swallowed up into the groove causing poor retention of fluid (See Figure 1). Another possibility is the outer lip seal being worn due to a poor finish of the drum, in the contact area

CORRECTION: Replace the inner lip seal with a larger radial base. Aftermarket sources such as TransTec/Freudenberg-NOK and Precision International produce a wider base seal to accommodate the deeper groove. Also Shift Technology Products packages an inner lip seal in their K500-618 kit. Replace the outer lip seal, after polishing the drum surface, in the contact area of the outer lip seal.
