# Technical Service Information

## **FORD E4OD PREMATURE OVERDRIVE CLUTCH FAILURE (INCREASED CAPACITY)**

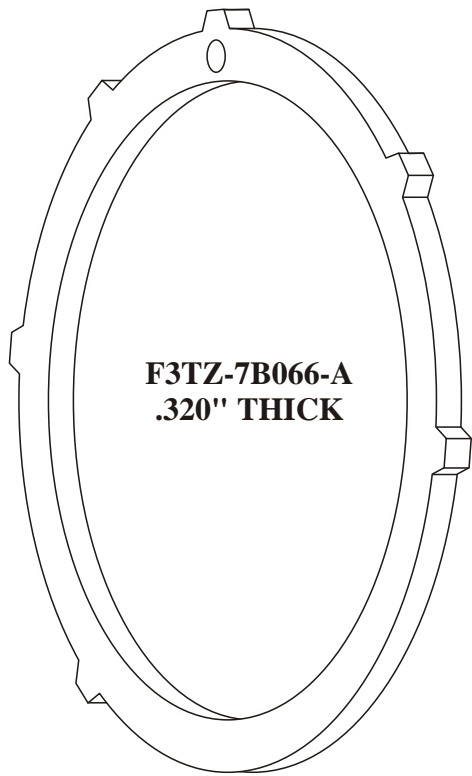
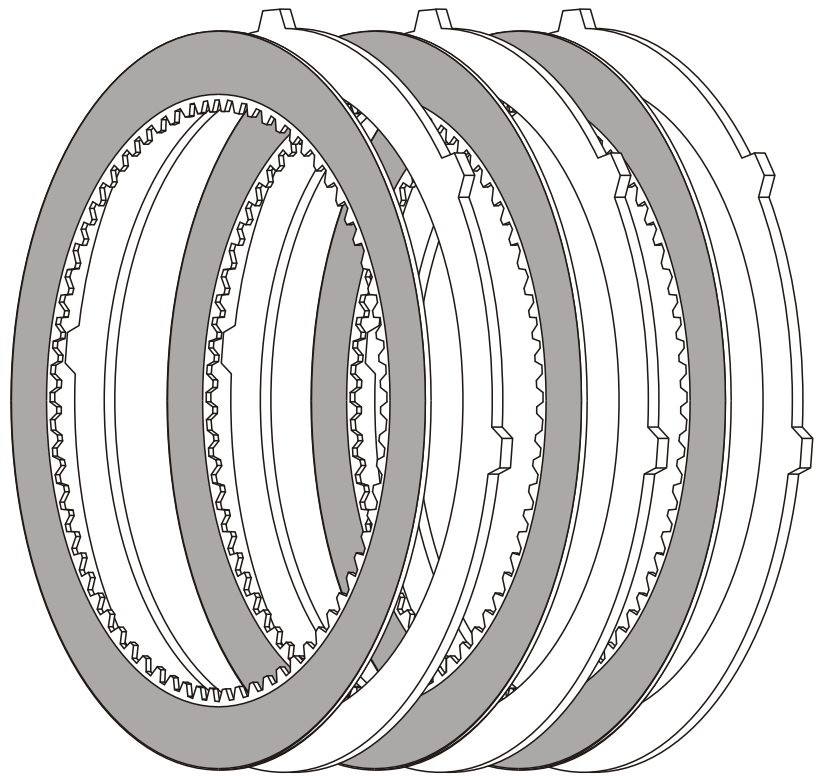
## E4OD 3 PLATE OVERDRIVE CLUTCH STACK-UP

**COMPLAINT:** Some vehicles equipped with the E4OD transmission may exhibit premature failure of the overdrive clutches, especially heavier loaded vehicles.

**CAUSE:** The cause may be, not enough clutch capacity for the overdrive clutch.

**CORRECTION:** Install 3 clutches in the overdrive clutch pack by purchasing a thinner, .320" thick backing plate, to replace the previous .490" thick backing plate. The 3 clutch backing plate is available under OEM part number F3TZ-7B066-A. Refer to Figure 1 for both 2 clutch and 3 clutch stack-ups.
