Technical Service Information

TOYOTA A40 SERIES HARSH 1-2 SHIFT

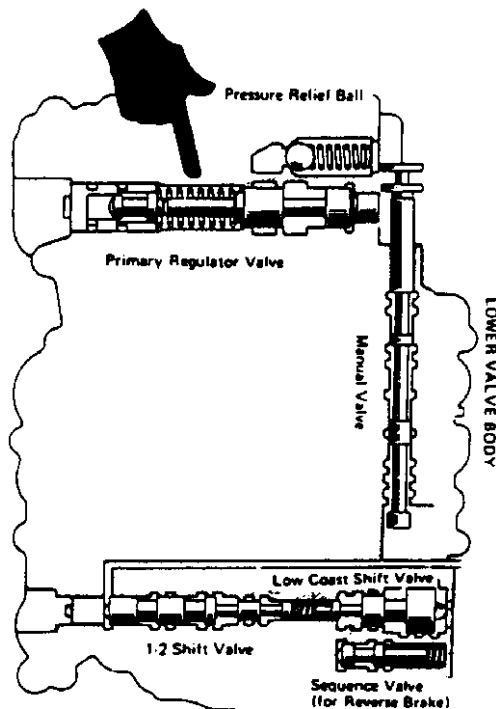
Figure 1

COMPLAINT: Harsh 1-2 shift.

CAUSE: Missing or mis-positioned check ball. High line pressure.

CORRECTION: Install check-ball in proper location or replace Primary Valve Spring with a new spring, part # 90501-18028.
