# Technical Service Information

## 2004 & LATER CADILLAC TPMS WARNING LAMP ILLUMINATED

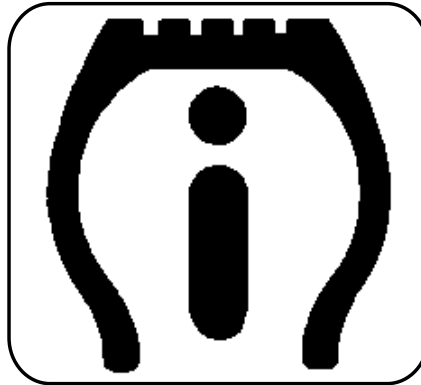
Figure 1

**COMPLAINT:** Transmission repairs have been completed on a 2004 Cadillac Deville, after delivery of the car to the customer, the car comes back to shop with a complaint of a warning lamp that is on which was not on prior to repairs. It is the Tire Pressure Monitoring System Warning Lamp, (Refer to Figure 1).

A scan of all areas of the PCM reveals no codes stored. However, when the Body Control Module (BCM) is scanned, codes C0750 and C0755 are found indicating there is a problem with the left and right front tire pressure monitors.

## TIRE PRESSURE MONITORING SYSTEM WARNING LAMP

**CORRECTION:** Anytime wheels are rotated, tires changed, balanced or tire pressures are incorrect, the system must be reprogrammed. To reprogram, either a capable scan tool is required or the keyless entry key fob along with a magnet, which is Kent-Moore Tool J-41760 as shown in Figure 3, is needed to accomplish a manual reprogramming.

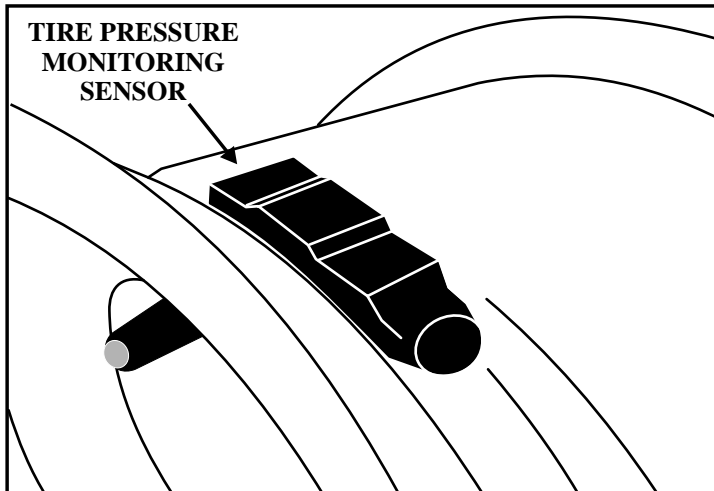
Figure 2

**CAUSE:** During the re-assembly of the vehicle, the left and right front wheels were switched to opposite sides. This action caused the Tire Pressure Monitoring System Sensors in each of those wheels (Refer to Figure 2) to alert the TPMS, turn on the warning lamp and store the above mentioned codes. This occurs because this is a Direct TPMS system, in other words it is a stand alone system whose only purpose is to monitor tire pressures.
