MAZDA N4A-EL NO FOURTH GEAR

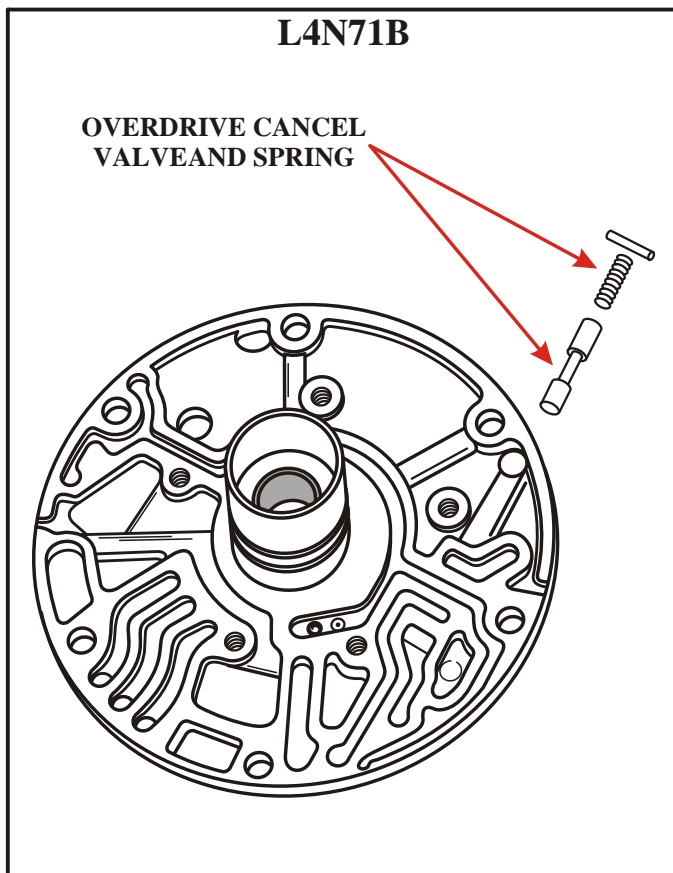
Figure 1

CAUSE: The cause may be, a 4N71B drum support mistakenly installed into the N4A-EL unit. The drum supports are the same, except the 4N71B support has an O.D. cancel valve line-up, and the N4A-EL has a "dummy" plug. If the 4N71B support is used, the valve will stroke exhausting 4th gear oil. The O.D. cancel valve and spring are completely interchangeable with the solid plug (See Figures 1 and 2).

CORRECTION: Install the solid plug into the drum support, as shown in Figure 1.
