Technical Service Information

FORD 5R55W/S TICKING OR RATTLING NOISE FROM BELLHOUSING

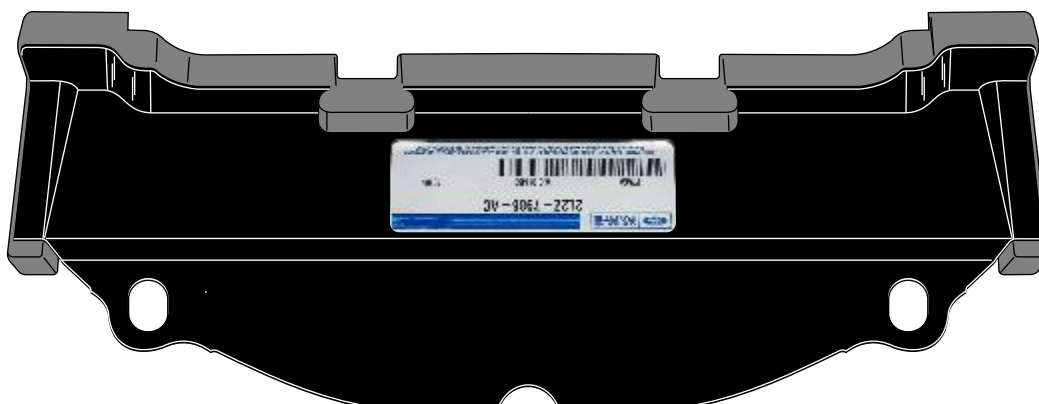
Figure 1

COMPLAINT: Explorer and Mountaineer models equipped with the 5R55W/S transmissions may exhibit a ticking or rattling noise coming from the bellhousing of the transmission. This noise can be commonly mistaken as a cracked flywheel or a mis-alignment of the flex-plate to the torque converter.

CAUSE: The cause may be, the plate between the engine block and the bellhousing is flexing, with increased engine rpm, causing the noise.

CORRECTION: Ford Motor Company has released a new style inspection plate, which is located at the bottom of the bellhousing, that has foam rubber to insulate the plate between the engine and transmission to keep it from flexing. Replace the inspection plate with new design as shown in Figure 1.

INSPECTION PLATE.....2L2Z-7986-AC
