FORD CD4E PREMATURE REVERSE DRUM BUSHING FAILURE

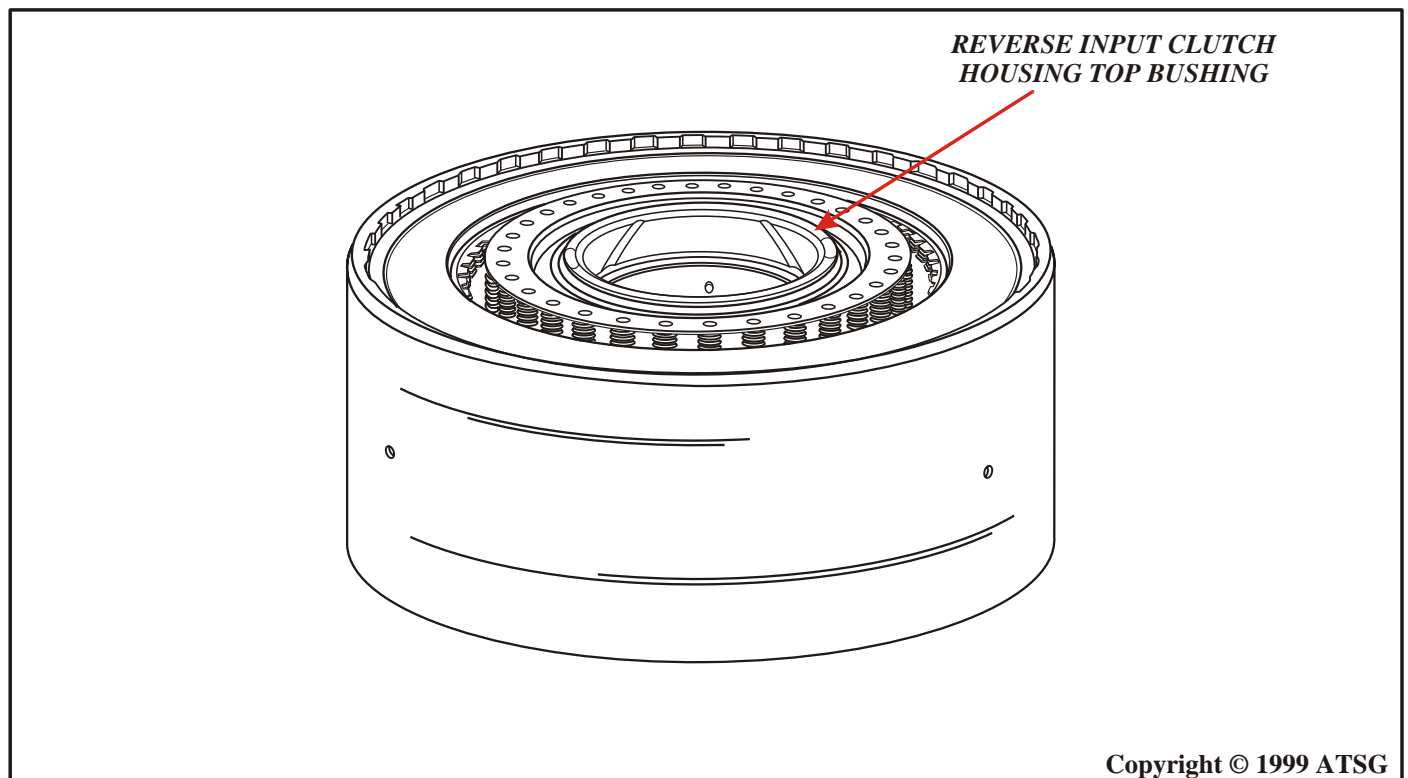
Figure 1

COMPLAINT: After overhaul, a vehicle equipped with a CD4E transaxle exhibits premature failure of the top bushing in the reverse input housing (See Figure 1), and apparently due to lack of lubrication. Because of the bushing failure, the ring area in the reverse input housing may be grooved, and the sealing rings on the forward/coast/direct housing may be worn.

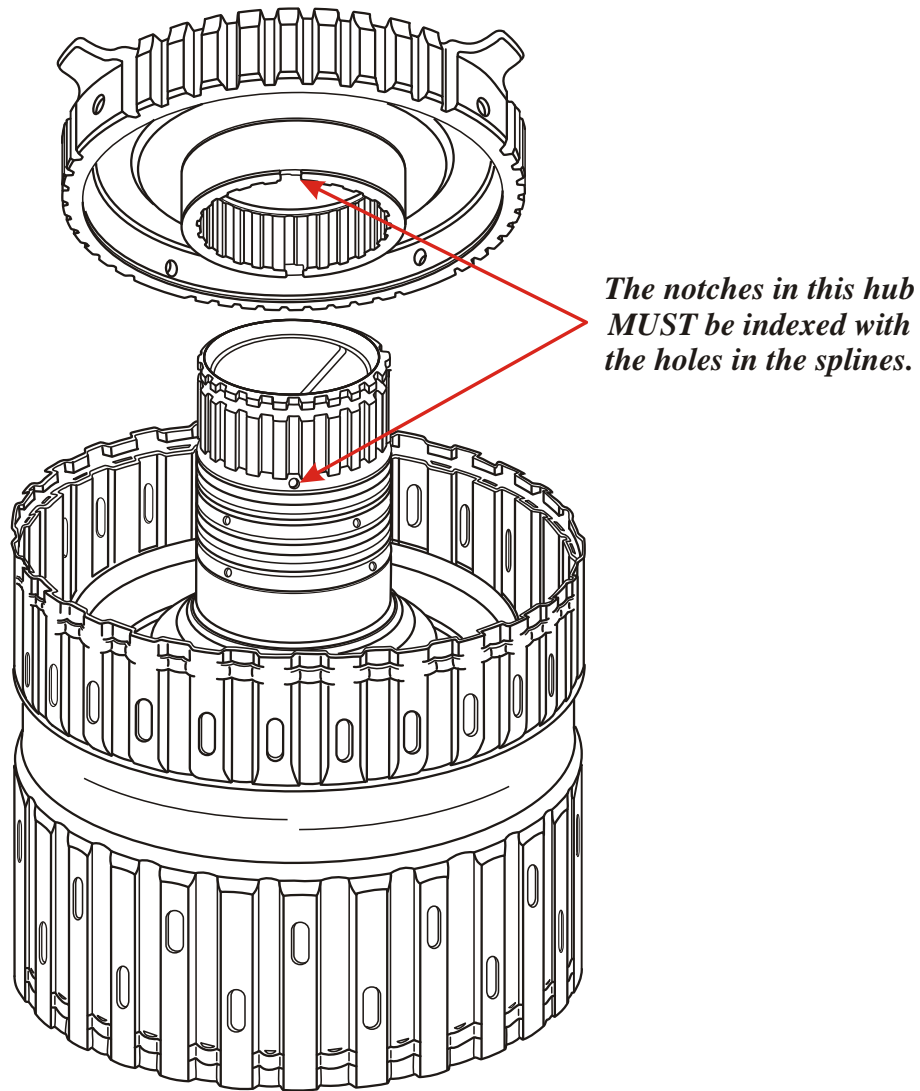
CAUSE: The cause may be, mis-assembly of the reverse input clutch hub onto the splines of the forward/coast/direct clutch housing. The reverse input clutch hub has 2 slots machined 180 degrees apart on the bottom of the hub, as shown in Figure 2. These slots *must* be indexed over the two lubrication holes 180 degrees apart in the splines of the forward clutch housing, as shown in Figure 2. If the slots are not lined up with the lube holes in the splines, premature failure of the reverse input housing bushing will be the result.

CORRECTION: Identify and locate the slots in the reverse input clutch hub and ensure that the slots are aligned with the lubrication holes in the splines of the forward/coast/direct clutch drum during the assembly process. Refer to Figure 2 for correct assembly.
