Technical Service Information

THM 4L60-E

DELAYED ENGAGEMENT IN DRIVE AND/OR REVERSE

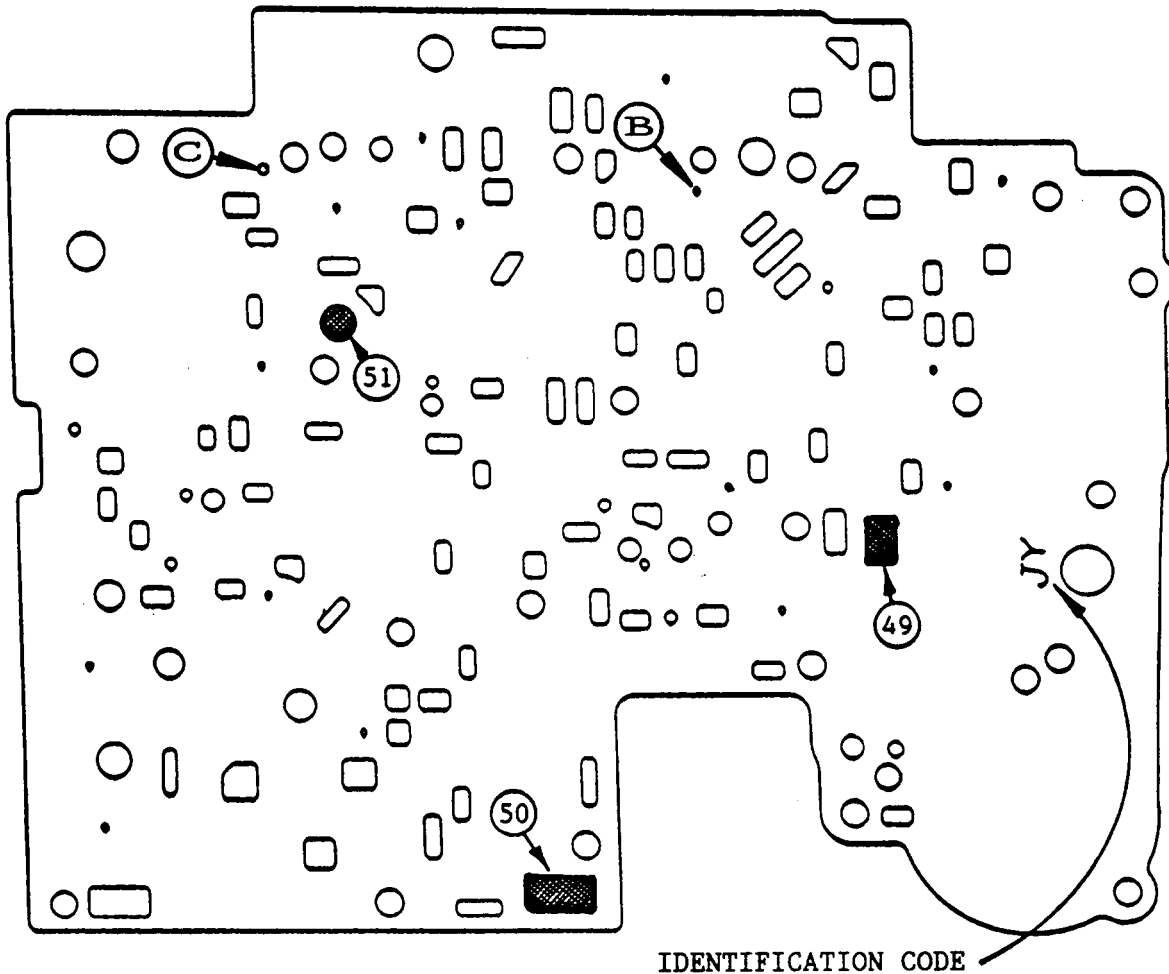
Figure 1

COMPLAINT: Delayed engagement when manual shift lever is placed in either drive and/or the reverse position.

CAUSE: The cause may be lack of volume of oil to either the forward clutch pack or the reverse input clutch pack.

CORRECTION: For a delay when placed in a forward gear, drill the hole in spacer plate marked "B" out to .125" diameter as shown in Figure 1.

For a delay when placed into reverse gear, drill the hole in spacer plate marked "C" out to .125" diameter as shown in Figure 1.

FOR A DELAY FORWARD DRILL HOLE "B" OUT TO .125" DIAMETER.
 FOR A DELAY TO REVERSE DRILL HOLE "C" OUT TO .125" DIAMETER.
