Technical Service Information

VOLKSWAGEN/AUDI ZF5HP19FL/FLA NO REVERSE

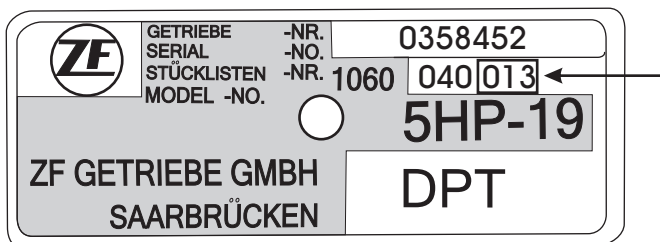
TAG AND MODEL IDENTIFICATION

The last three digits on the tag will identify the part number needed listed in Service Information for the correct D clutch housing

The part number for the D clutch housing according to the tag identification shown above is 1060 373 002

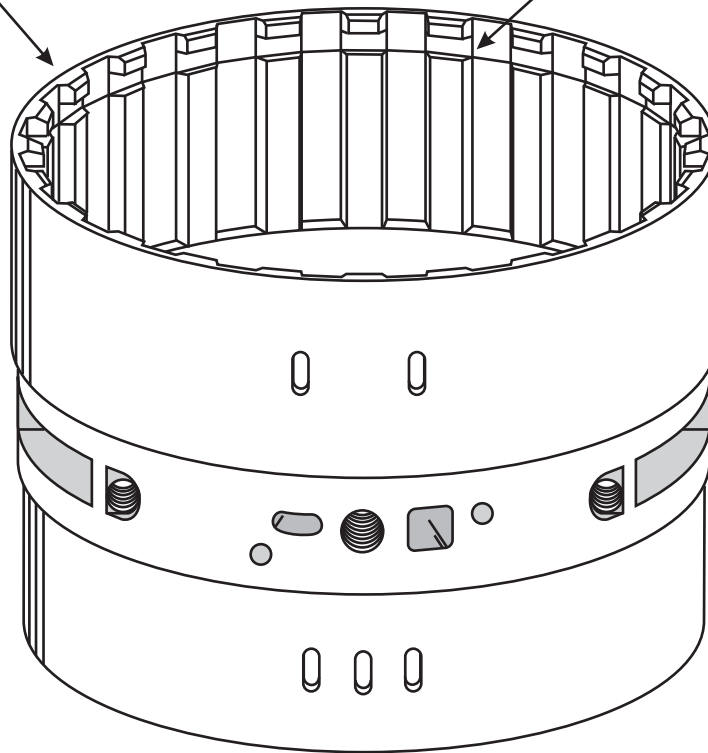
Figure 2

CAUSE: The cause may be, a broken D clutch housing, as shown in Figure 2, causing no application of the D clutch which is the Low Reverse Clutch.

The top of the snap ring area of the housing breaks

CORRECTION: Replace the D clutch housing with the correct part number, based on the tag number located in Figure 1.

The snap ring groove depth has been redesigned to help prevent breaking
