# Technical Service Information

## FORD AXOD-E PREMATURE PLANETARY FAILURE

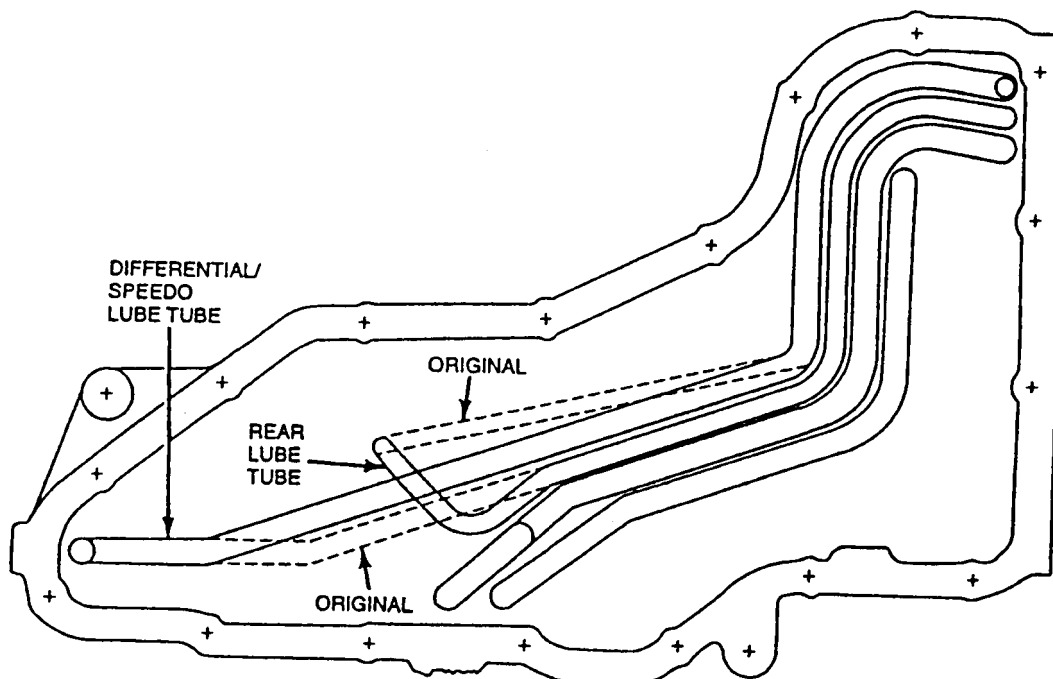
Figure 1

**COMPLAINT:** Front planetary and gear train failure with no visible reason.

**CAUSE:** The cause may be, a limited volume of lube oil to the front planetary due to hydraulic control system demands.

**CORRECTION:** Install a new crossover rear lube tube, OEM number F2DZ-7G084-A, and a new differential/speed0 lube tube, OEM number F2DZ-7G086-A, that will increase the volume of lube to the front planetary. The rear lube tube and the differential/speed0 lube tube, Figure 1, have been reversed in the transaxle case. This requires the rear lube tube to "Cross-Over" the differential/speed0 lube tube. This crossover will allow for a larger volume of uninterrupted lube to the front planetary.  
This change has been incorporated in mid-year 1992 for ALL AXOD-E transaxles.
