Technical Service Information

FORD AX4N ENGINE STALLS IN ANY GEAR

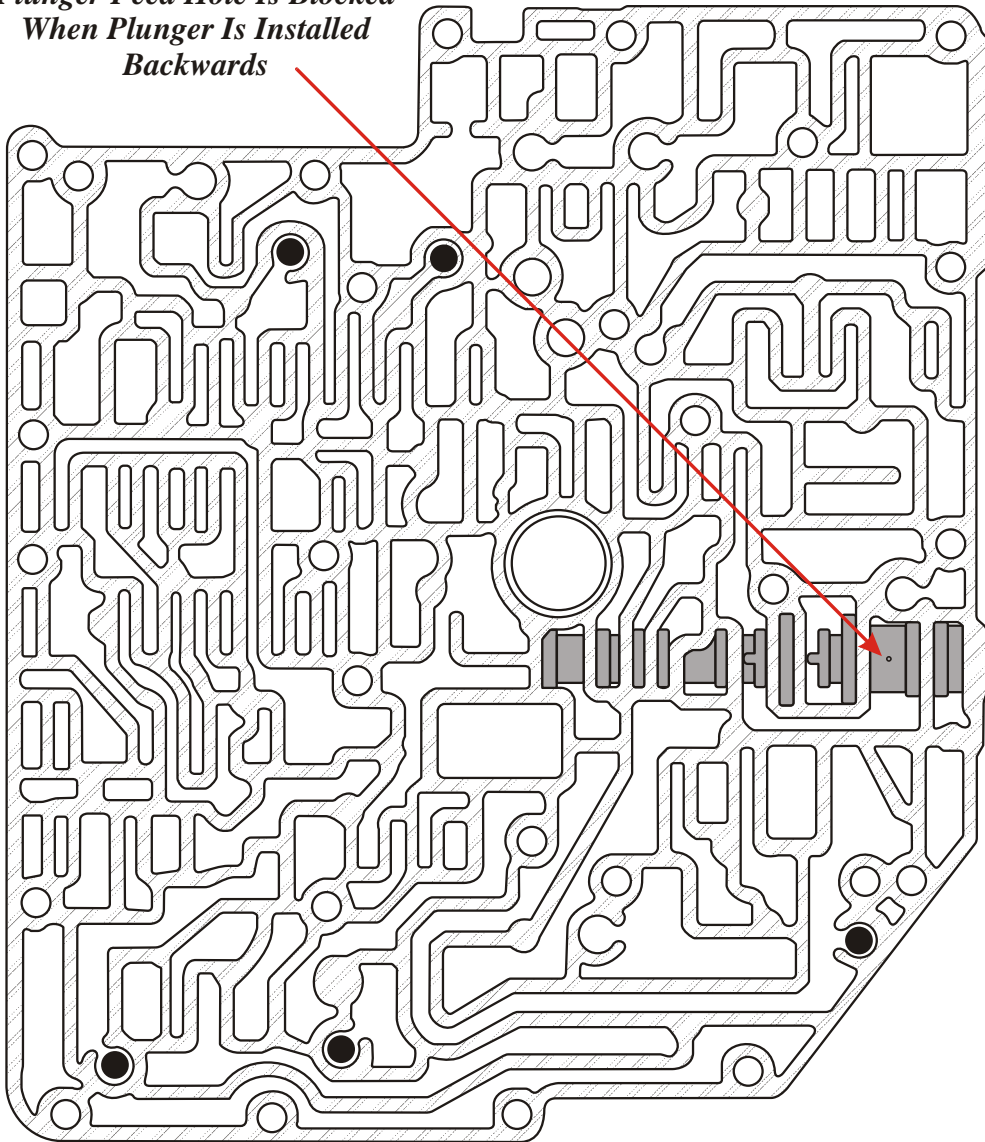
Figure 1

When the spring and/or plunger are installed backwards, the plunger blocks the feed hole in the plunger sleeve, which in turn causes the balance of the valve to be lost, as shown in Figure 1. This allows the bypass clutch control valve to stroke to a position that will allow all converter clutch release oil to be exhausted. This of course will allow the converter clutch to be applied, and the engine will stall as soon as the manual shift lever is moved out of Park or Neutral.

*Plunger Feed Hole Is Blocked
When Plunger Is Installed
Backwards*

THIS IS "CORRECT" ASSEMBLY

CORRECTION: Install the Bypass Clutch Control Valve, Plunger, Spring and Sleeve, as shown in the "*Correct*" illustrations in Figures 1 and 2.

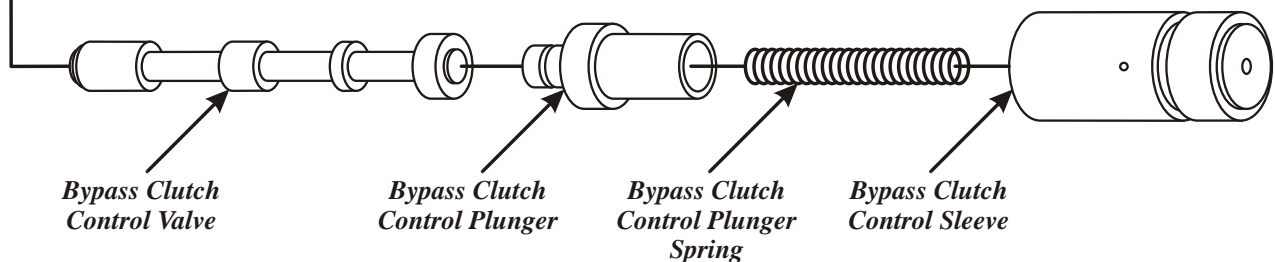
Figure 2

THIS IS "*CORRECT*" ASSEMBLY
