Technical Service Information

CHRYSLER A604 DELAYED ENGAGEMENT INTO REVERSE

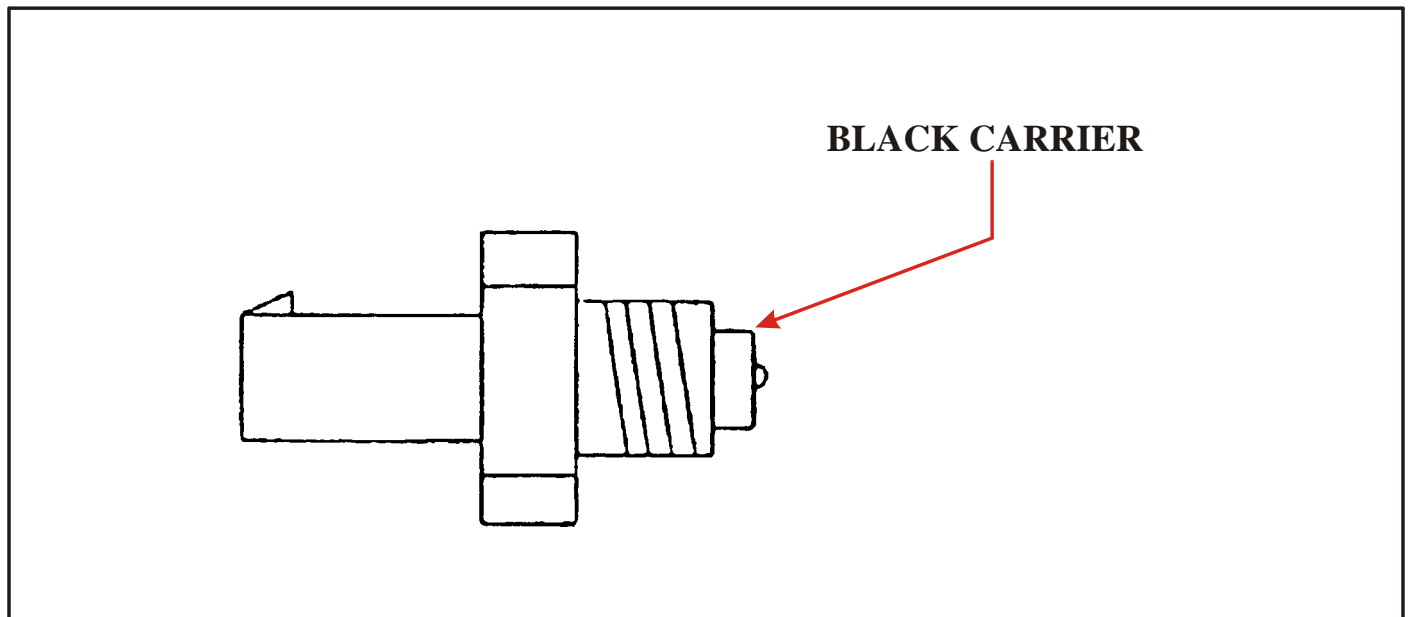
Figure 1

COMPLAINT: Some 1990 vehicles with the A604 Transaxle that were built before January 1, 1990, transaxle date code K xxx 03 84 xxxx may have complaints of intermittent delayed or harsh engagements and occasional default into limp mode or second gear operation only. This can be accompanied by fault codes 22, 37, and 39.

CAUSE: The PRNDL switch may fail to send a consistent signal to the controller. The vehicle may pass the shift lever status test when using a scanner because of the intermittent nature of the failure.

CORRECTION: If the transaxle build date is before date code K xxx 03 84 xxxx, replace the PRNDL switch and washer with part numbers 5234393 and 2408143. Also replace the neutral switch and washer with part numbers 5234319 and 5234023. These parts have been updated and can be identified by the black plastic carrier that extends into the transmission (SEE FIGURE 1).
