Technical Service Information

THM 4L80-E TROUBLE CODES 24 AND/OR 72 INTERMITTENT LOSS OF SPEEDOMETER OPERATION

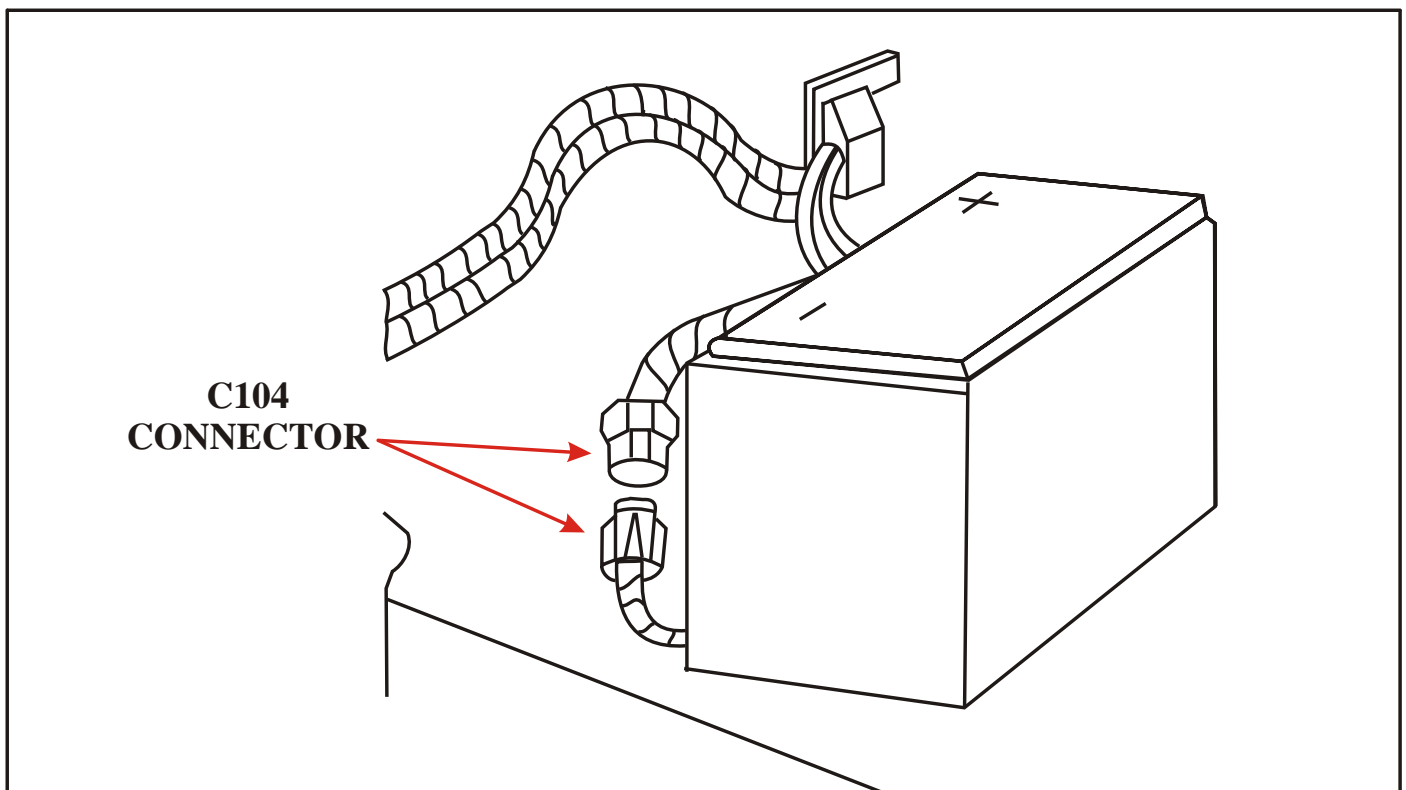
Figure 1

COMPLAINT: 1991-1995 General Motors "C" & "K" Trucks and "G" Vans may exhibit an intermittent loss of vehicle speed signal, causing codes 24 and/or 72 to be stored. The ABS warning lamps may be illuminated as a result of the loss of speedometer operation (See Figure 1).

CAUSE: The C104 connector coming from the TOSS (VSS) is located next to the battery and is subject to corrosion. This corrosion interferes with the raw signal input to the speed buffer resulting in the above complaint.

CORRECTION: Clean and repair the C104 connector. Weather proof the connector to avoid future corrosion possibilities (See Figure 1).

TIP: This cause can be detected with a resistance check of the TOSS circuit. Disconnect the Speed Buffer connector and place your ohm meter across the Lt. Green/Black and the Purple/White wires found in the Speed Buffer Connector. With an ohmmeter connected to the TOSS circuit, perform a wiggle test while making certain 1200 to 1500 ohms remains constant on the ohmmeter
