Technical Service Information

THM 4L60-E SOFT 1-2 SHIFT, 1994 MODELS

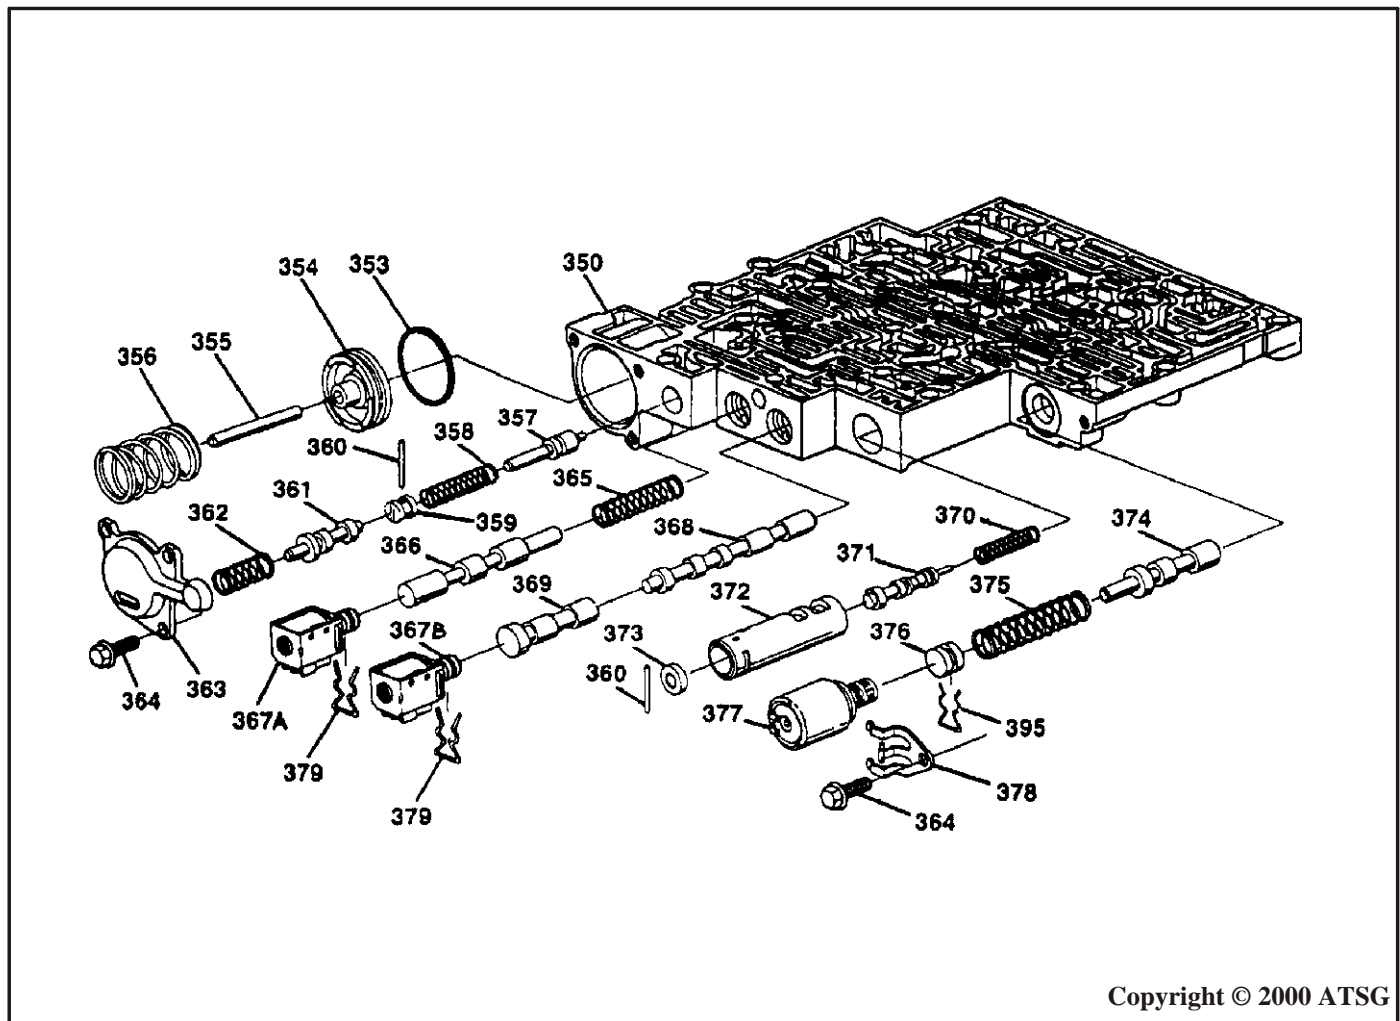
CHANGE: Some 1994 model vehicles, equipped with the THM 4L60-E transmission may exhibit a soft 1-2 upshift condition.

REASON: The cause may be, calibration of the 1-2 accumulator valve in the valve body.

There is now available a new calibration service package consisting of a 1-2 accumulator valve, valve spring, and 1-2 accumulator valve bushing for the valve body. These are items 370, 371, and 372, as shown in Figure 1 below. This new service package is available under OEM part number 24202698.

1-2 Accumulator Valve Service Package 24202698
