# Technical Service Information

## THM 4L60 (700-R4) NO 3-4 SHIFT

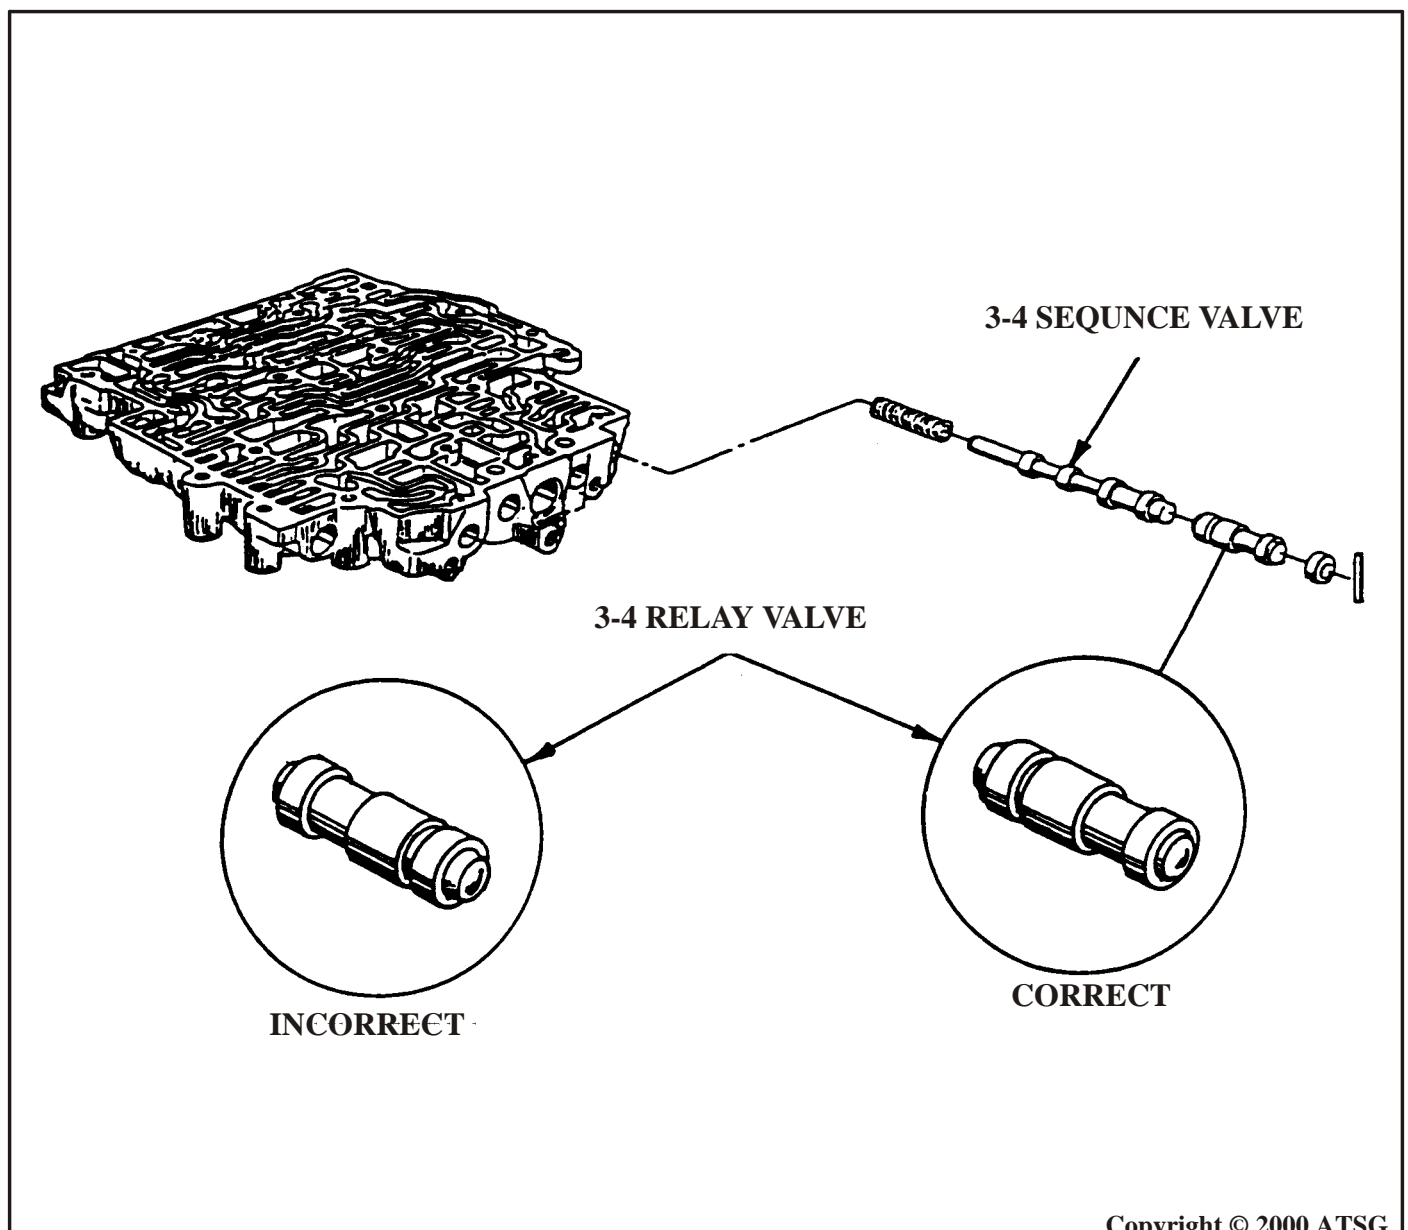
Figure 1

**COMPLAINT:** No 3-4 shift on any THM 700-R4 transmission.

**CAUSE:** The cause may be that you have installed the 3-4 relay valve in backwards. The 3-4 relay valve is located in front of the 4-3 sequence valve in the valve body (See Figure 1).

**CORRECTION:** Install the 3-4 relay valve correctly (See Figure 1).
