Technical Service Information

THM 4T80-E TURBINE SHAFT SPEED SENSOR CHANGES

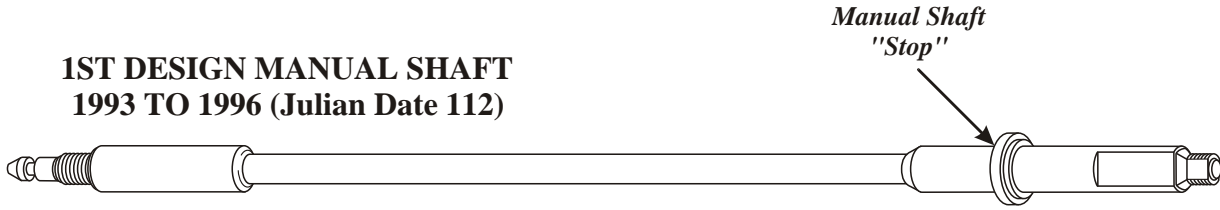
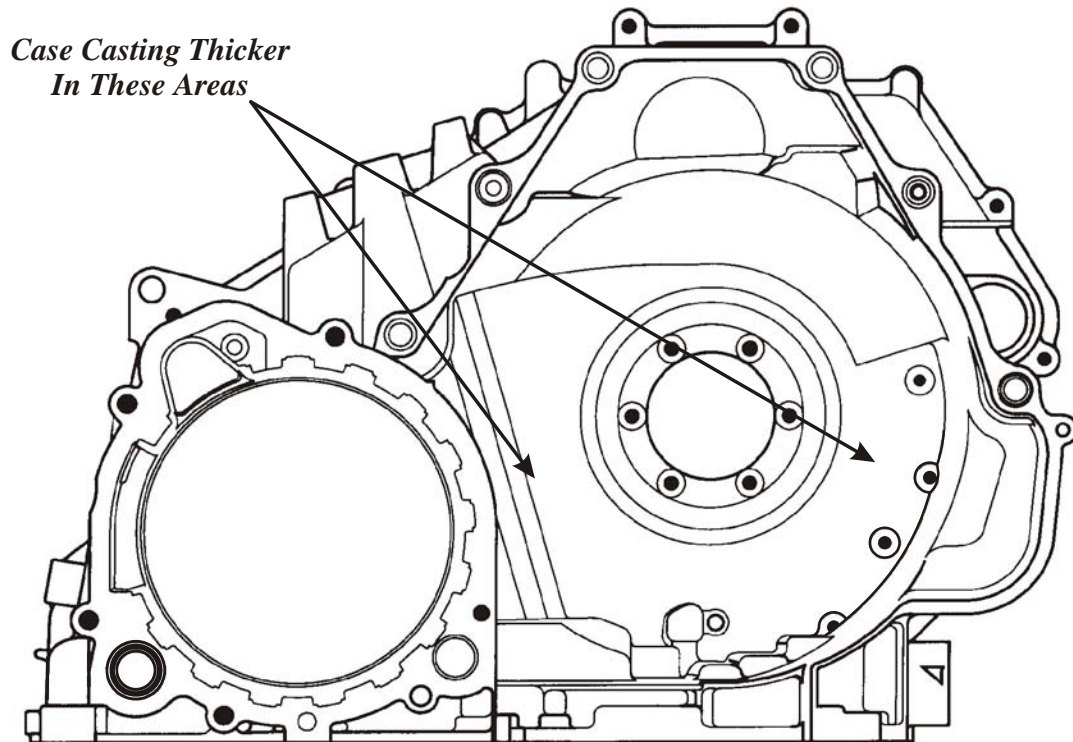
Figure 1

- (1) TRANSAXLE CASE - Thicker casting in the front seal area to help eliminate possible cracks and leakage and revised machining in the manual shaft seal bore area (See Figure 1).
- (2) MANUAL SHAFT - New design manual shaft has groove cut in shaft, to accept the bump on bottom of the turbine speed sensor wiring bracket, to locate and hold the manual shaft in the proper location in case (See Figure 1).
- (3) TURBINE SPEED SENSOR - Now manufactured with the bump on the bottom of turbine speed sensor wiring harness bracket, to position and retain manual shaft. The 1st design parts are shown in Figure 2 and the 2nd design parts are shown in Figure 3.

**1ST DESIGN MANUAL SHAFT
1993 TO 1996 (Julian Date 112)**

**2ND DESIGN MANUAL SHAFT
1996 (Julian Date 113) TO 2003**

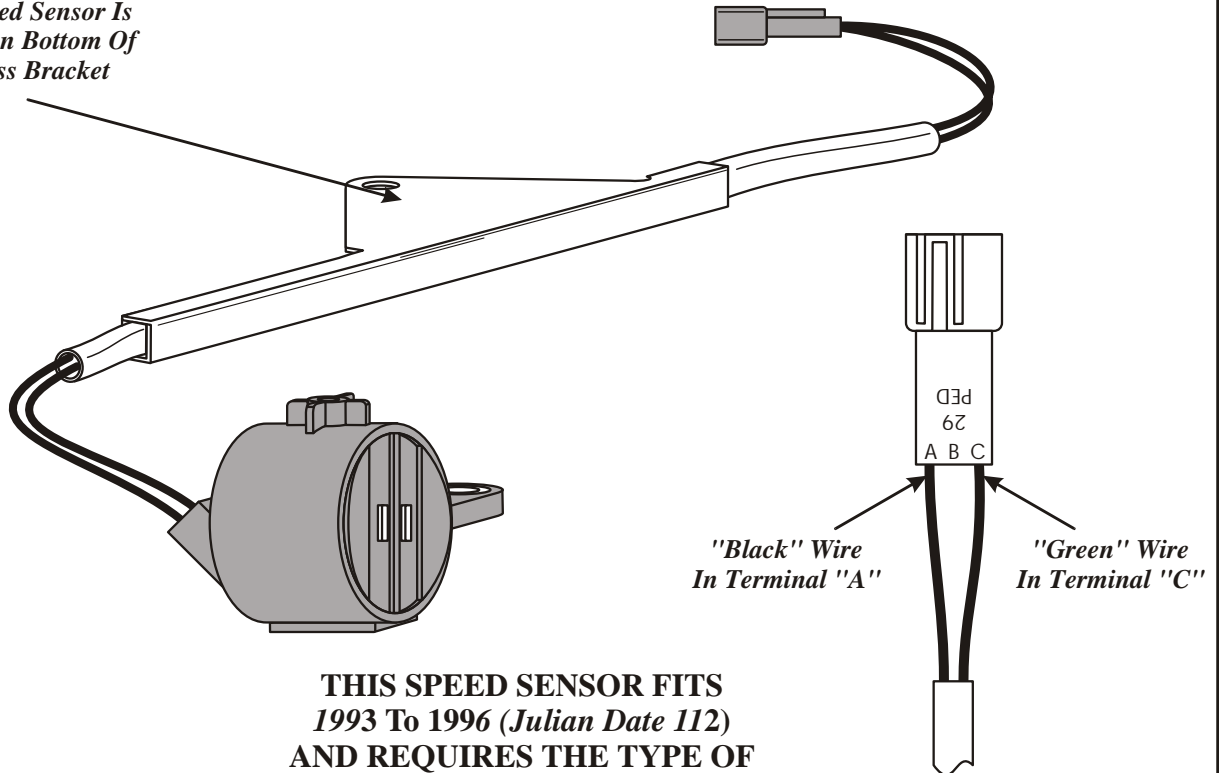
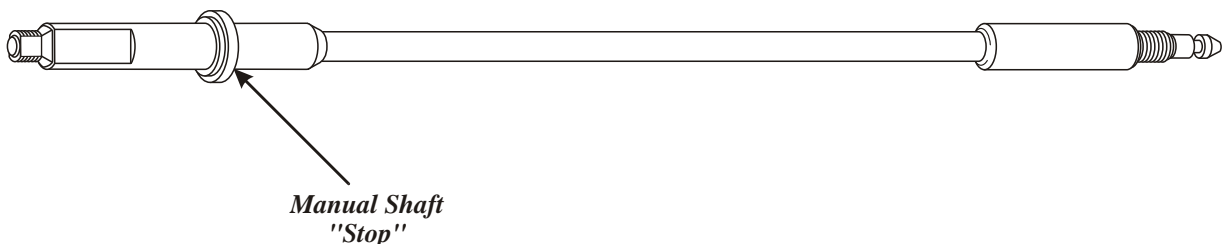
Figure 2

THM 4T80-E 1ST DESIGN TURBINE SHAFT SPEED SENSOR OEM PART NUMBER 24209654

*This Speed Sensor Is
"Flat" On Bottom Of
Harness Bracket*

**THIS SPEED SENSOR FITS
1993 To 1996 (Julian Date 112)
AND REQUIRES THE TYPE OF
MANUAL SHAFT SHOWN BELOW**

If it becomes necessary to replace the turbine speed sensor, ensure that your new sensor has the wires in terminals "A" and "C", as shown here. We have had some reports that the new sensor came with the green wire in terminal "B" and had to be moved to terminal "C". We have also had some reports of the black wire being in terminal "A" and the green wire being in terminal "B" on both sides of the connecting harness. Ensure that your wires match on both sides of connector, regardless of where they are located.

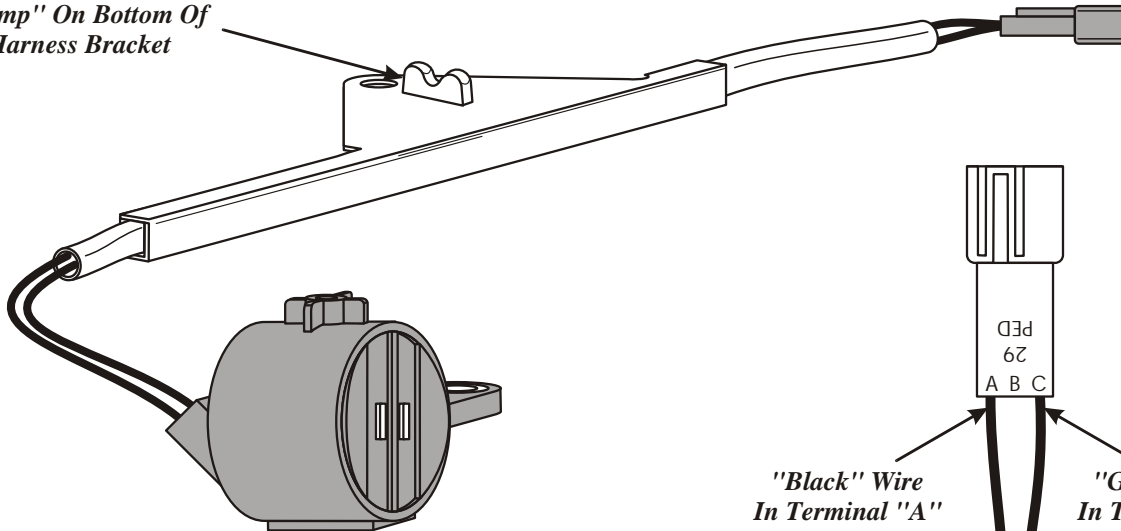
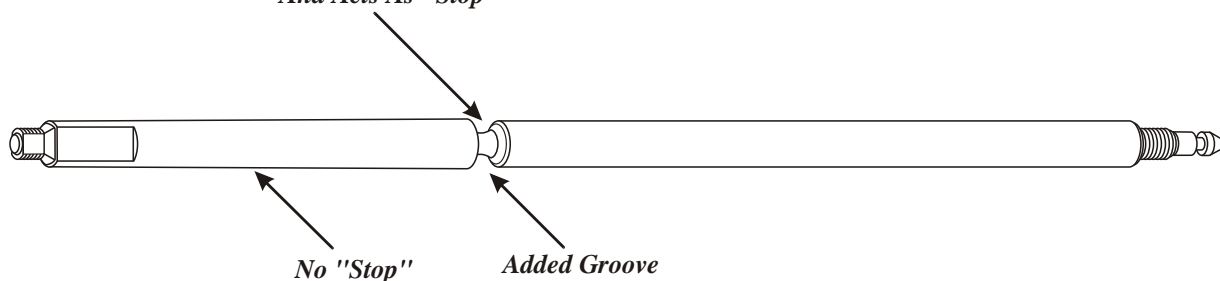
Figure 3

THM 4T80-E 2ND DESIGN TURBINE SHAFT SPEED SENSOR OEM PART NUMBER 24207491

*This Speed Sensor Has
"Bump" On Bottom Of
Harness Bracket*

**THIS SPEED SENSOR FITS
1996 (Julian Date 113) TO CURRENT
AND IS "MANDATORY" FOR
THESE MODELS AS TRANSAXLE
IS EQUIPPED WITH THE MANUAL
SHAFT SHOWN BELOW**

*"Bump" On Bottom Of Harness Bracket
Fits Into Groove In Manual Shaft And
Positions Manual Shaft In Case
And Acts As "Stop"*

If it becomes necessary to replace the turbine speed sensor, ensure that your new sensor has the wires in terminals "A" and "C", as shown here. We have had some reports that the new sensor came with the green wire in terminal "B" and had to be moved to terminal "C". We have also had some reports of the black wire being in terminal "A" and the green wire being in terminal "B" on both sides of the connecting harness. Ensure that your wires match on both sides of connector, regardless of where they are located.
