# Technical Service Information

## **FORD AX4S 1-2 NEUTRAL 1999 & UP MODELS**

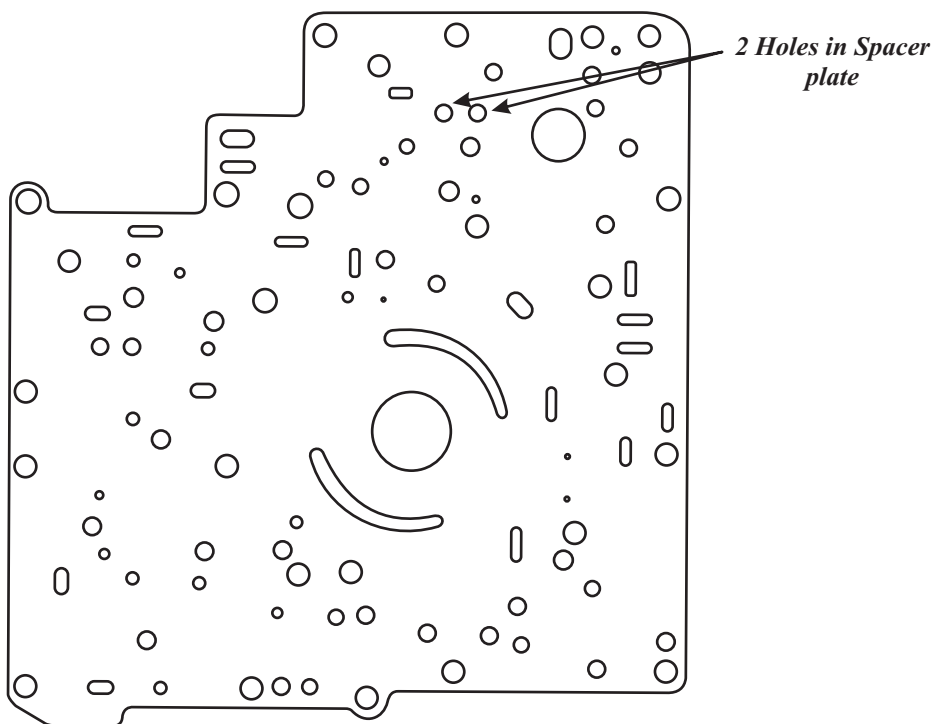
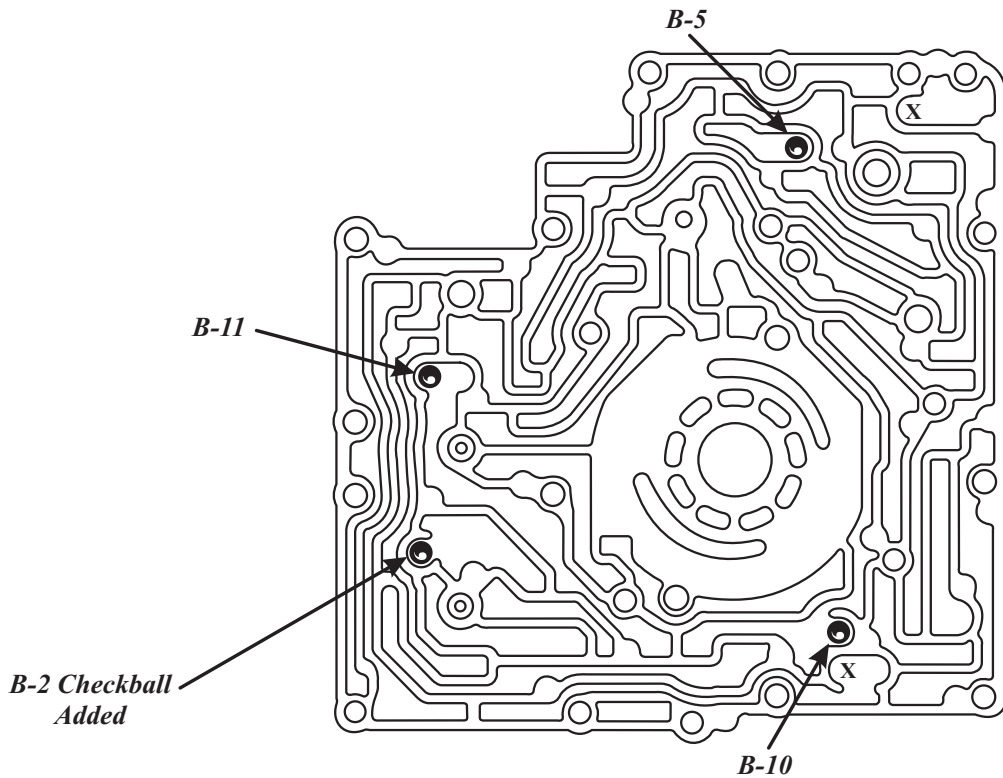
**CAUSE:** The cause may be, during overhaul, the pump had to be replaced, because of typical pump shaft bearing and rotor failure, and a replacement pump body with a 98 and earlier spacer plate was used. The 1999 and up pump plate requires 3 check balls, and when the B5 check ball is left out when using the previous design spacer plate, L12 pressure will be lost at the manual valve, thru the Reverse circuit.

## 92-98 SPACER PLATE

## CHECKBALL LOCATIONS 92-98 MODELS "ONLY"

**CORRECTION:** Refer to Figure 1 to identify the previous design Pump body and Pump spacer plate, and Refer to Figure 2 to identify the 1999 and Up design Pump body and Pump Spacer plate and ensure that the correct plate and checkball locations are used.

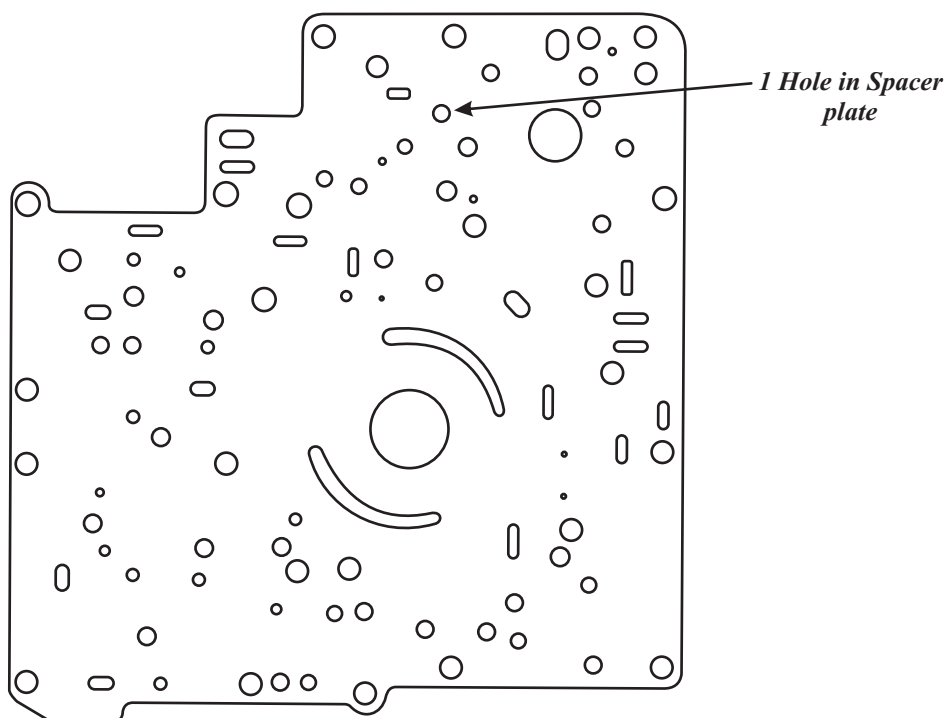
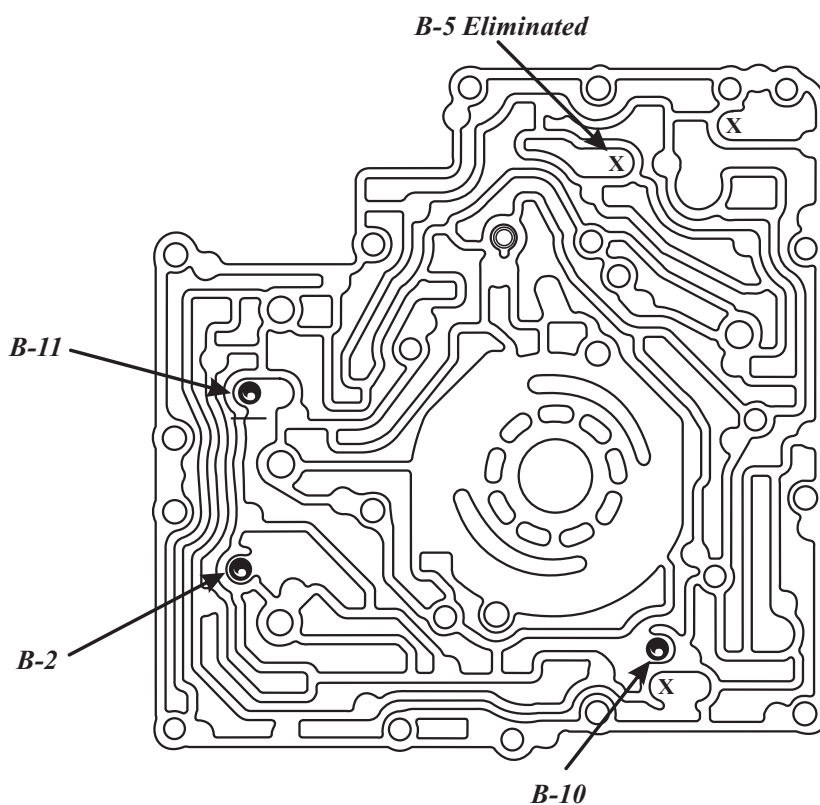
Figure 2

## 1999 AND LATER SPACER PLATE

## CHECKBALL LOCATIONS 1999 AND LATER "ONLY"
