Technical Service Information

FORD 5R110W "TorqShift" HARSH FORWARD ENGAGEMENT

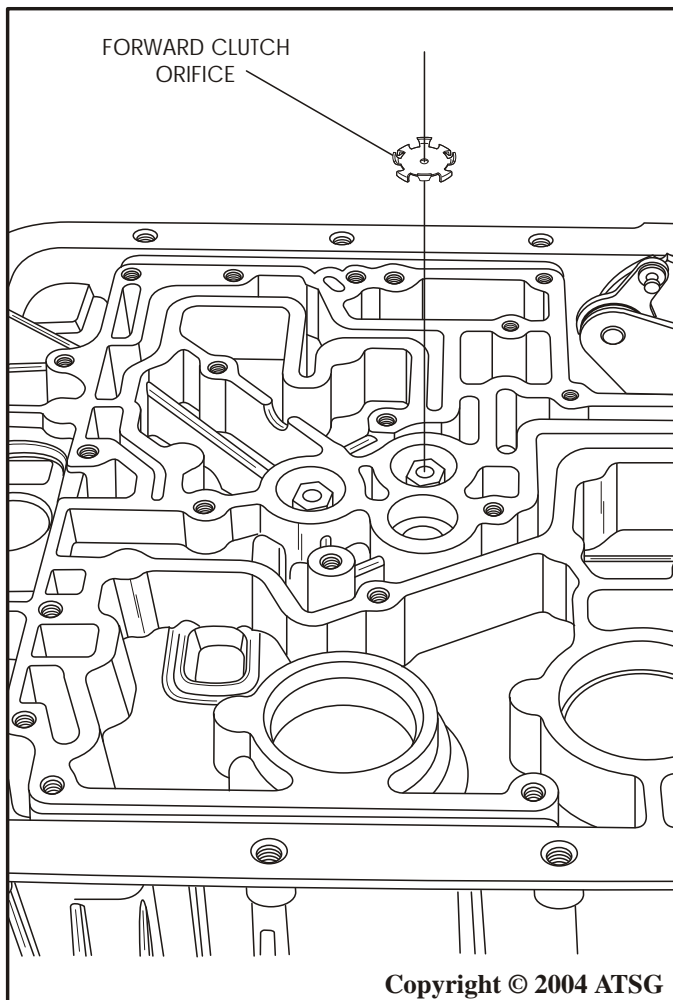
CAUSE: The cause may be, the forward clutch orifice missing, or misplaced into the intermediate clutch feed instead of the forward clutch feed. (See Figure 1 and 2).
