Technical Service Information

JR403E SLIPS IN 2ND, 3RD, 4TH GEAR AND/OR NO UPSHIFTS, OR FALLS OUT OF 4TH HOT

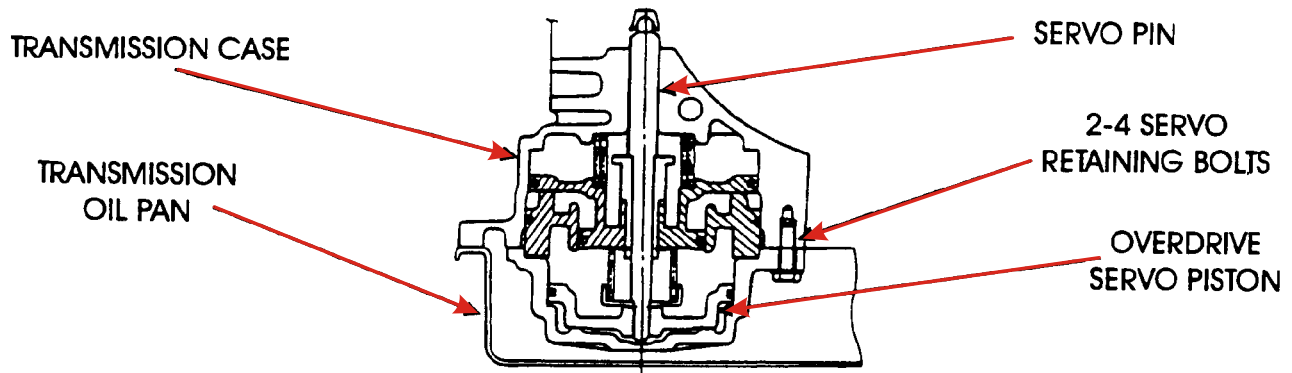
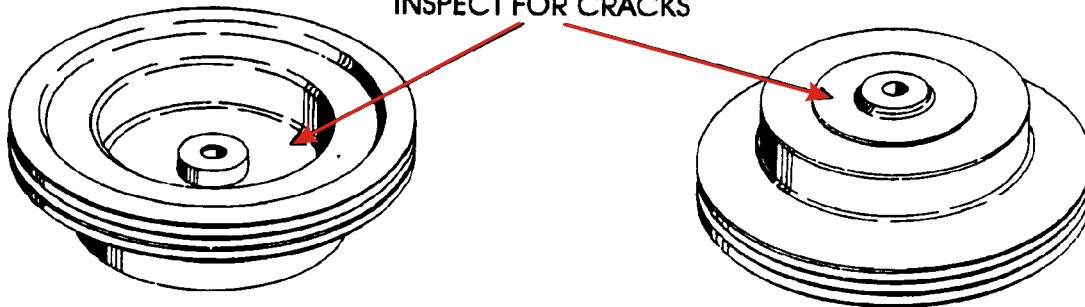
Figure 1

CAUSE: The cause may be, the bolts that retain the servo assembly to the main case were fractured and allowed the servo assembly to fall out of it’s bore and to rest on the oil pan. This action could result in “Major” pressure losses to the servo and could cause an alignment problem with the servo pin and the O.D. servo piston causing it to possibly crack (See Figure 1).

2-4 SERVO ASSEMBLY

OVERDRIVE SERVO PISTON

INSPECT FOR CRACKS

CORRECTION: There is now available from Isuzu, Grade 9 servo retaining bolts to replace the previous Grade 7 retaining bolts, and should be replaced on every JR403-E transmission regardless of the vehicle in which it is found. They are available under Isuzu part number 8-97 107-000-0. Check and replace the overdrive servo piston as necessary (See Figure 1).

Servo Retaining Bolts (Isuzu Part No.)	8-97107-000-0
Overdrive Servo Piston (Isuzu Part No.)	97039481
