Technical Service Information

BMW/2000 AND LATER ISUZU 4L30E NO REVERSE, BINDS IN 2ND

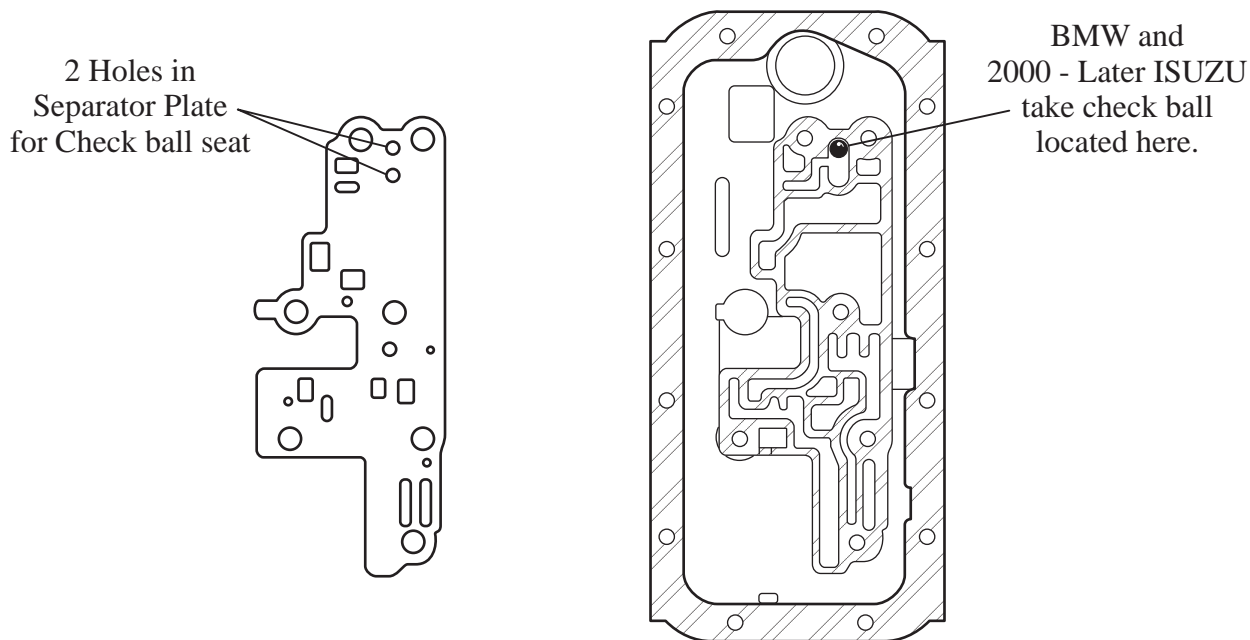
Figure 1

CAUSE: One cause may be a missing check ball in the adapter case housing.

ADAPTER HOUSING CHECK BALL LOCATION AND SEPARATOR PLATE ID.

CORRECTION: Install the check ball in the adapter housing.

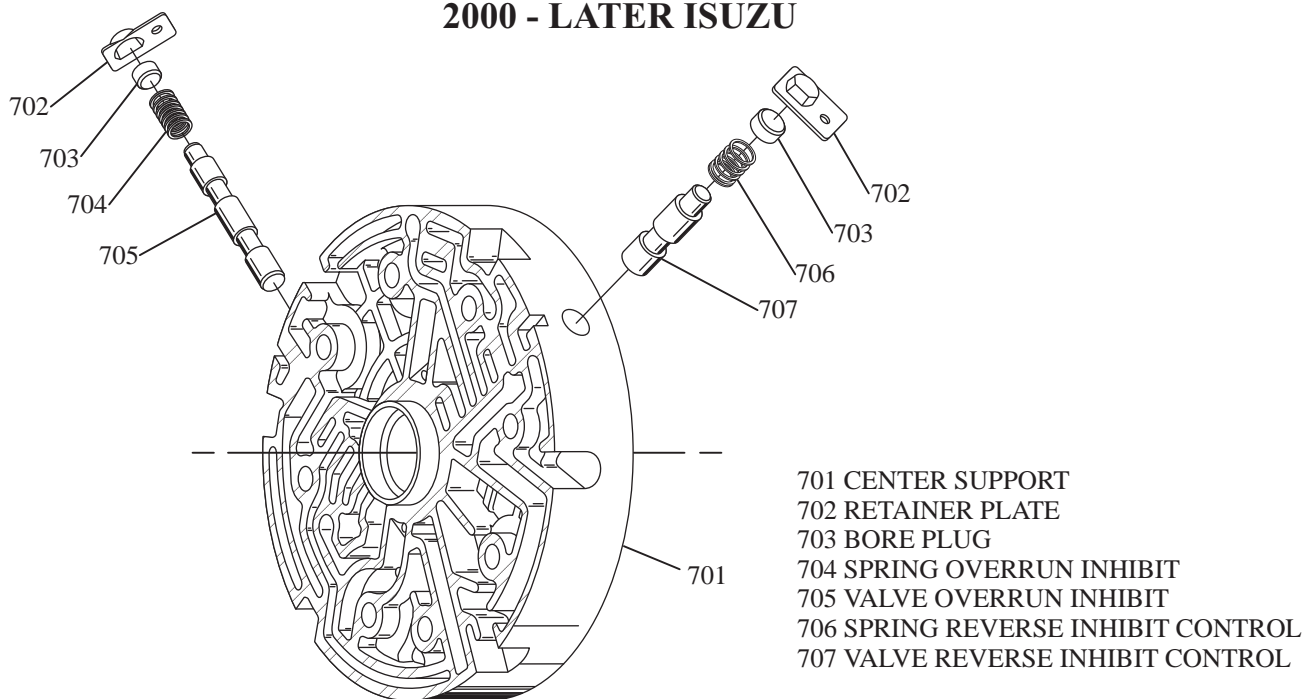
Figure 2

CENTER SUPPORT ASSEMBLY BMW AND 2000 - LATER ISUZU

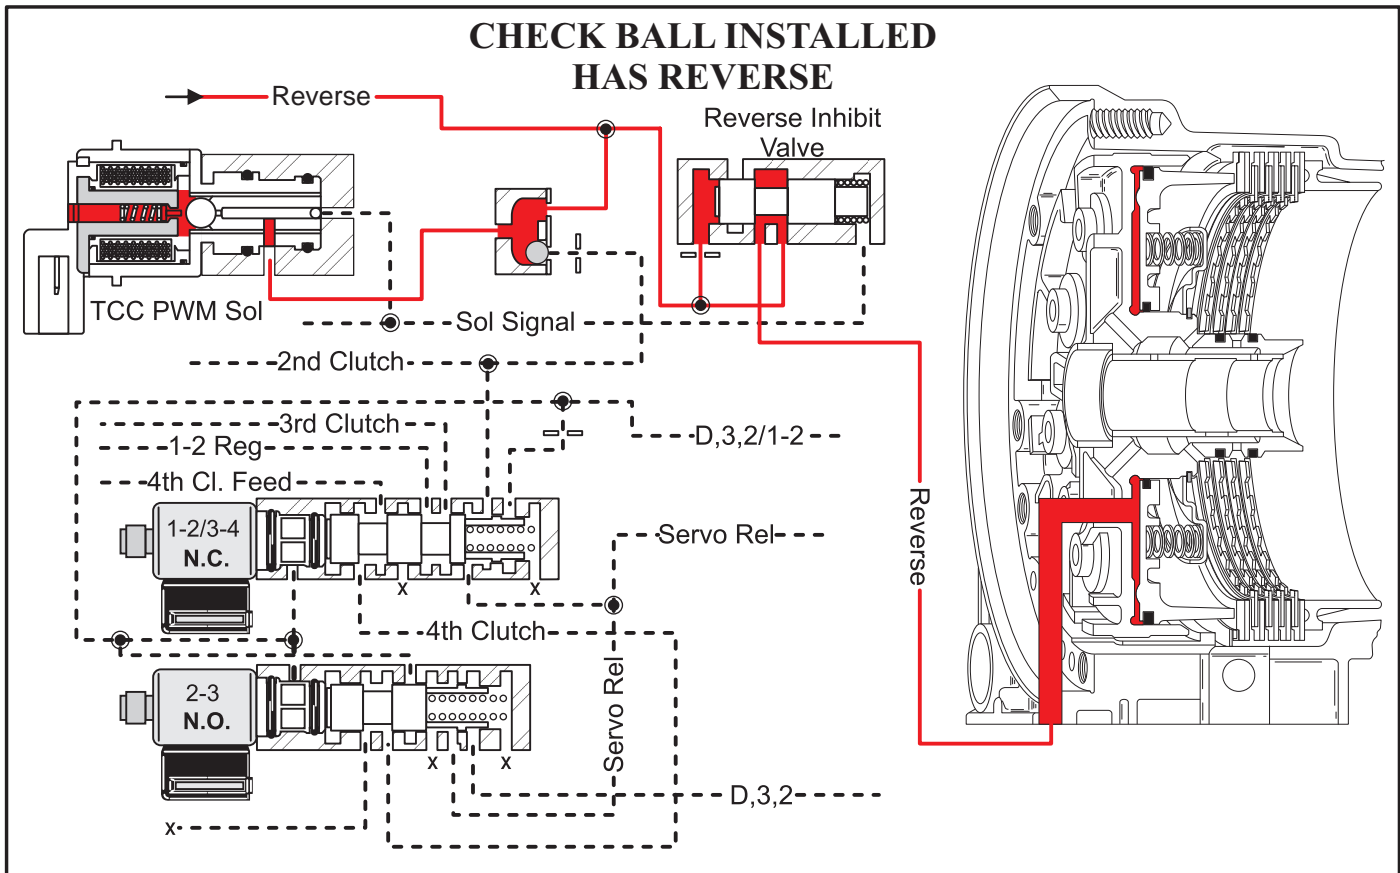
Figure 3 shows the ball properly installed in the adapter housing. Note the ball seats against the separator plate and forces oil into the reverse clutch circuit, through the reverse inhibit valve then applying the reverse clutch, while at the same time blocking oil from entering the 2nd clutch circuit.

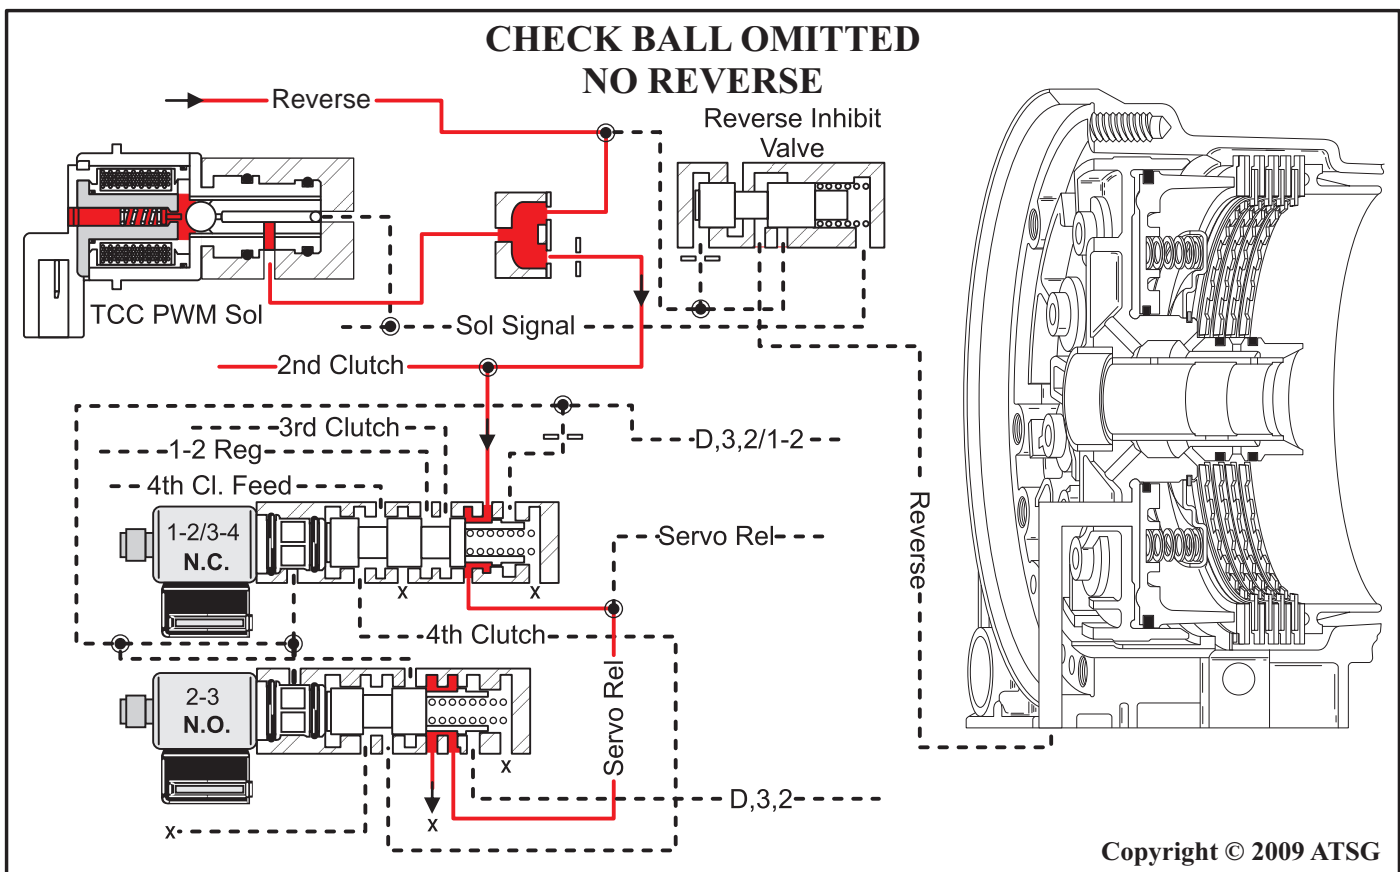
Figure 4 shows a missing check ball in the housing. With no check ball to seat against the plate, reverse oil pressure passes into the 2nd clutch circuit. Oil pressure flows through the 1-2/3-4 shift valve and exhausts at the 2-3 shift valve giving the neutral condition.

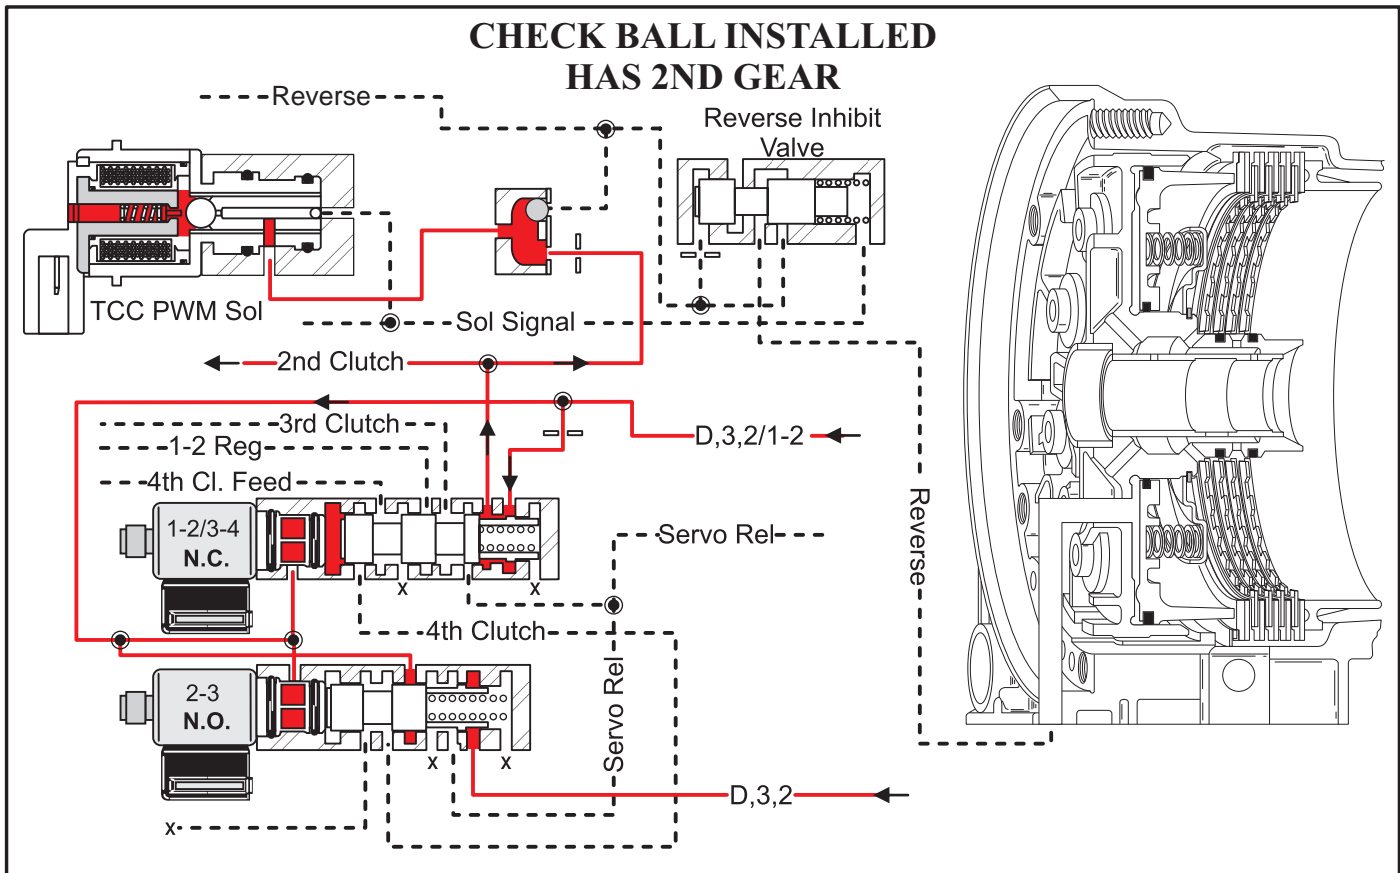
Figure 5 shows the ball properly installed in 2nd gear. Note the ball seats against the plate, and blocks oil from entering the reverse clutch circuit.

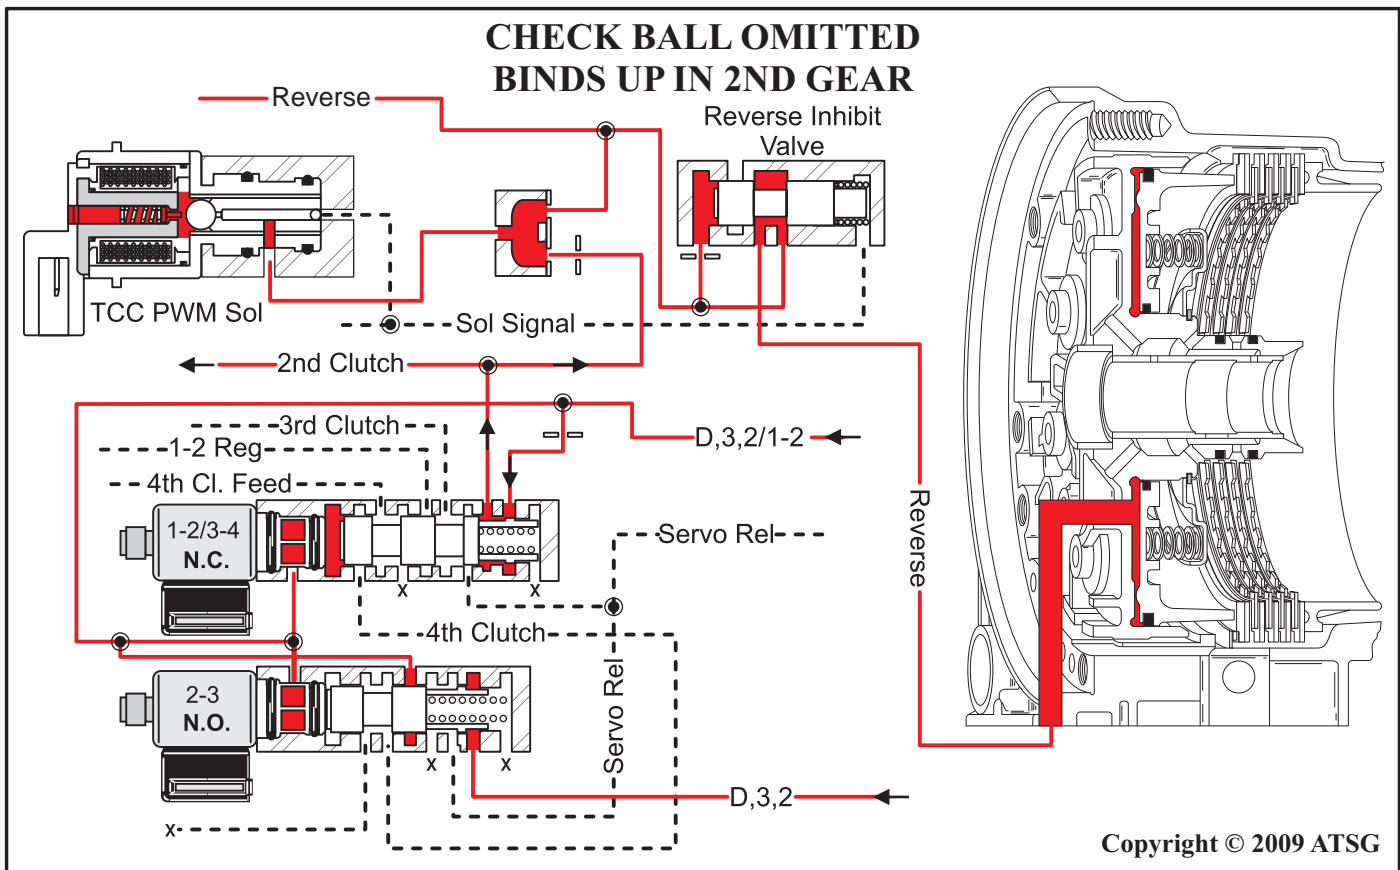
Figure 6 shows the ball missing. Oil pressure is allowed to enter the reverse clutch circuit causing the reverse clutch and 2nd clutch to apply together which causes the bind up condition on the shift.
