Technical Service Information

FORD C-6

DELAYED ENGAGEMENT FORWARD AND/OR PREMATURE FORWARD CLUTCH FAILURE

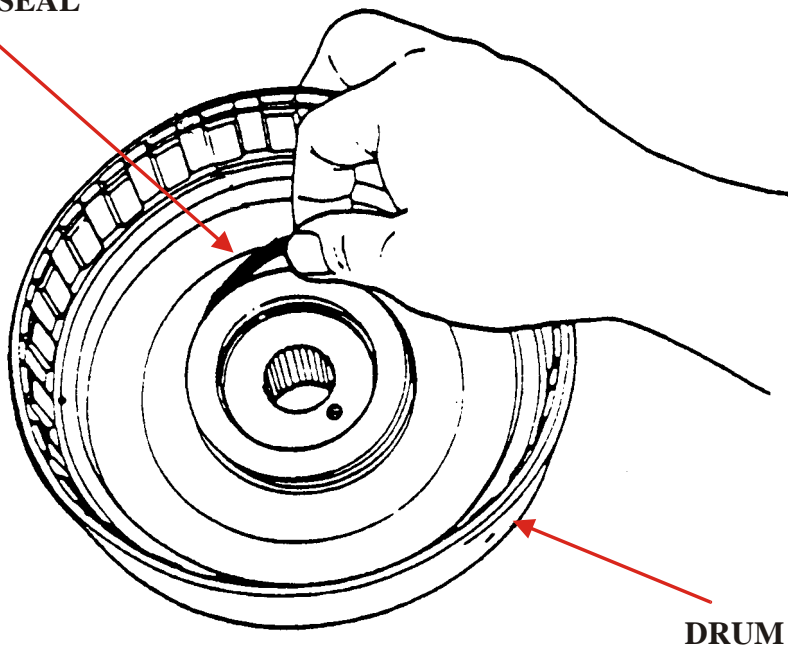
COMPLAINT: Abnormal delay when the selector lever is placed into the drive position, and reverse is normal, or premature failure of the forward clutch pack.

CAUSE: The cause may be the forward clutch piston inner "O" ring seal, that has become hard or cracked from heat. The OEM "O" ring seal for this location is made of a "Nitrile" material.

CORRECTION: Install a THM 440-T4 servo cover "O" ring seal in the forward clutch housing as it is exactly the same dimension. This "O" ring seal is made of a "Viton" material and will withstand much more heat without becoming brittle or breaking down (See Figure 1).
