G.M. POPPET VALVE CONVERTERS

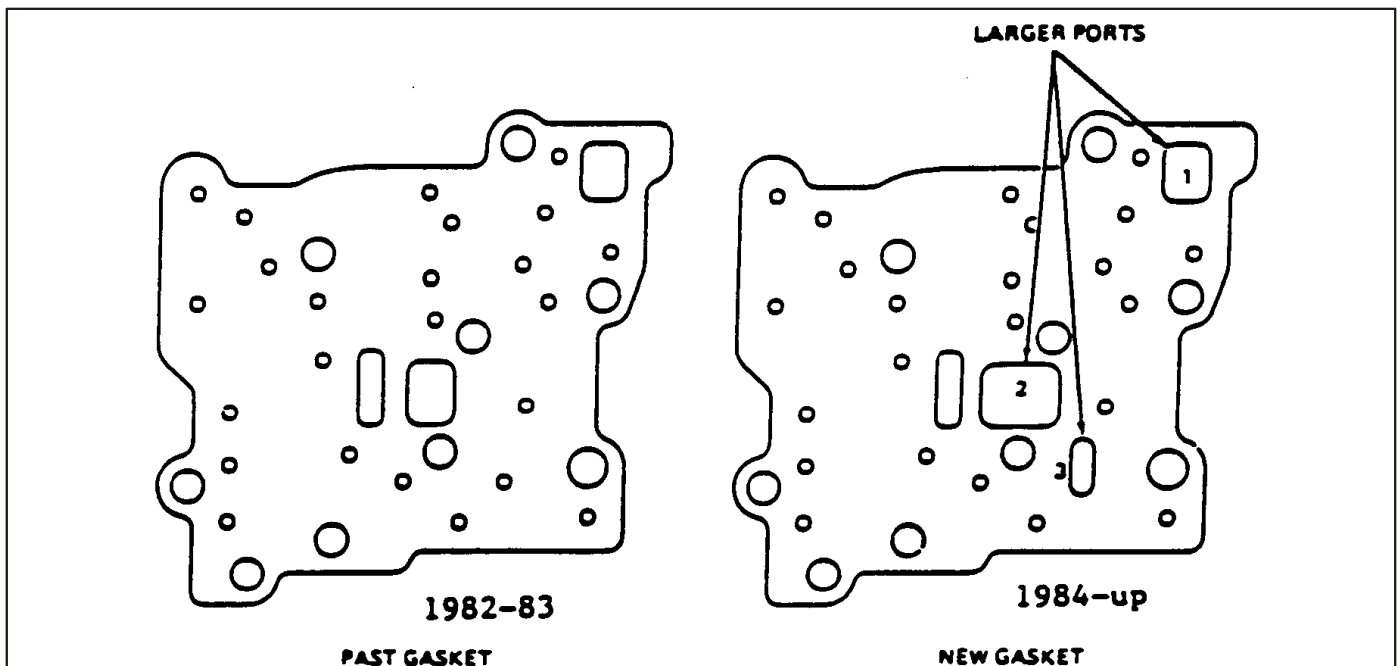
A complaint of no converter release on coast down shift or stalls engine after vehicle has been driven, can be caused by mismatch of gasket Figure 2 (1984 installed in 1982) or a mis-position cup plug in the Aux Valve body. A mismatch of a 1982 gasket in a 1984 gives a no converter clutch apply condition
