# Technical Service Information

## KM 175

### WRONG GEAR STARTS

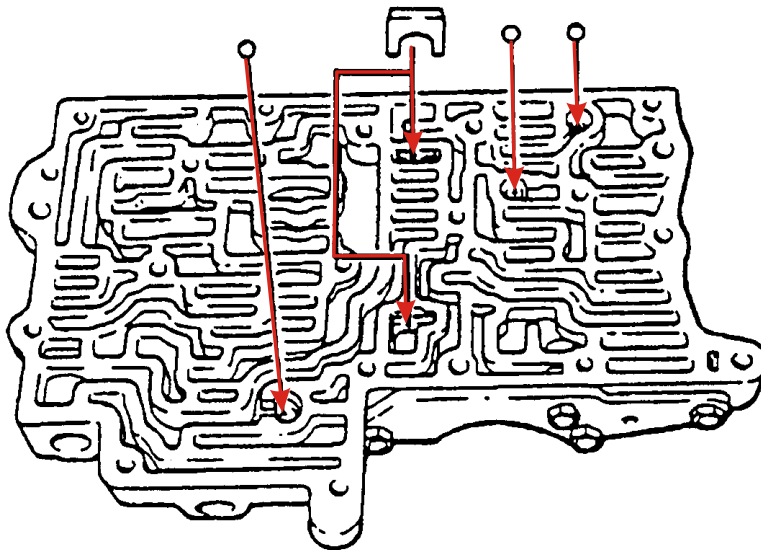
Figure 1

**CAUSE:** If the solenoids are not clogged or damaged, one or both of the stopper plates in the upper valve body may have gotten turned around or installed incorrectly when the valve body was opened for cleaning. The stopper plates can prevent the shift control valve from moving if they are installed incorrectly. See figure 1 for valve body position.

NOTE: Orifice in end plugs  
face out.
