Technical Service Information

GENERAL MOTORS SHIFT ADAPTS

COMPLAINT: A 1998 Buick Lesabre comes into the shop with a complaint of an intermittent harsh 1-2 shift. A code P1811 is stored indicating "Maximum Shift Adapt" has been reached.

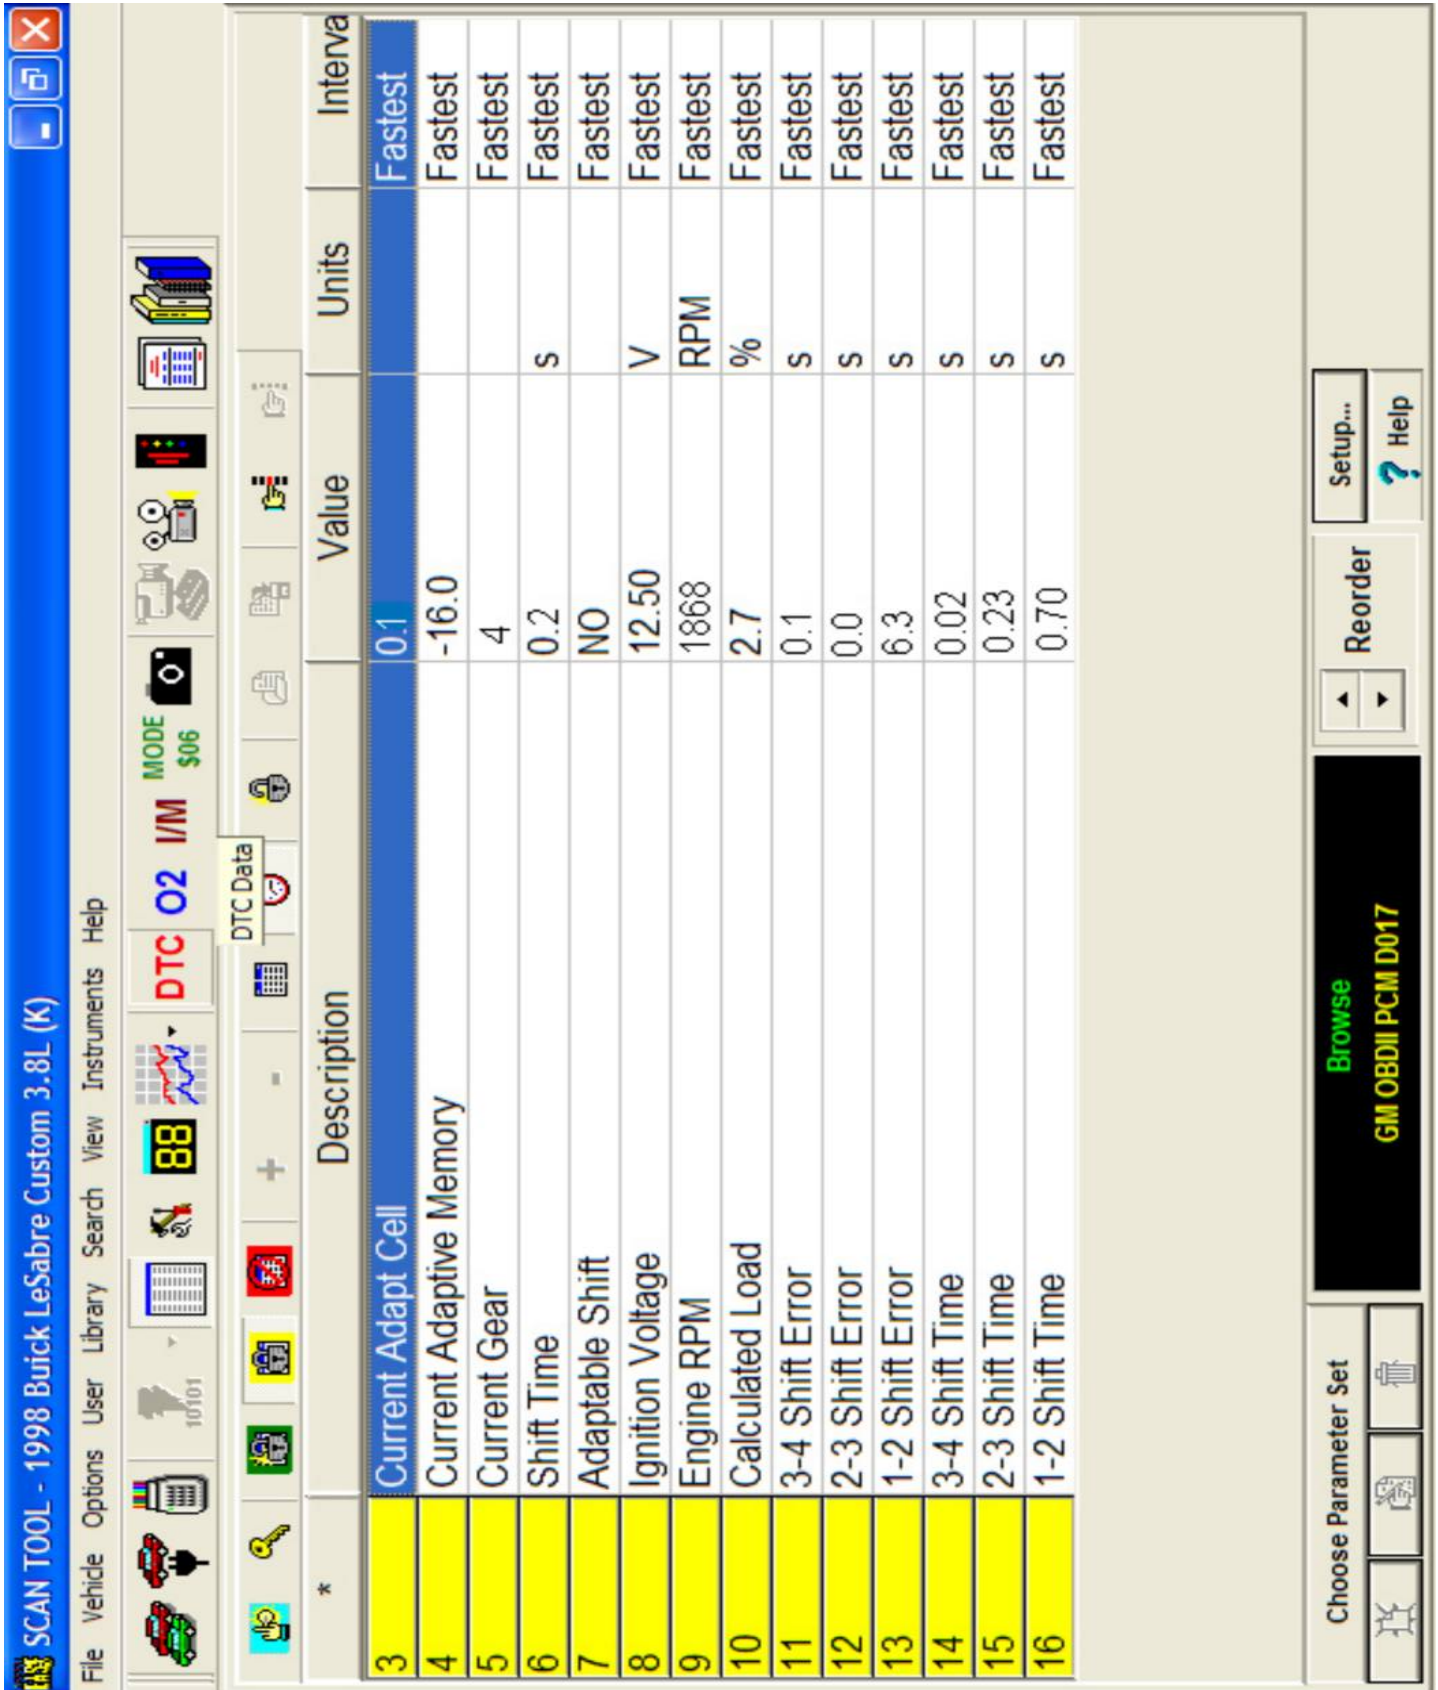
Figure 1

With the scan tool in the Transmission Data Mode, (Refer to Figure 1), the shift time for the 1-2 shift is indicating that the shift took 0.70 seconds to complete. This shift time exceeds the normal time the shift should have taken. No conventional GM automatic transmission should exceed 0.65 seconds shift time.

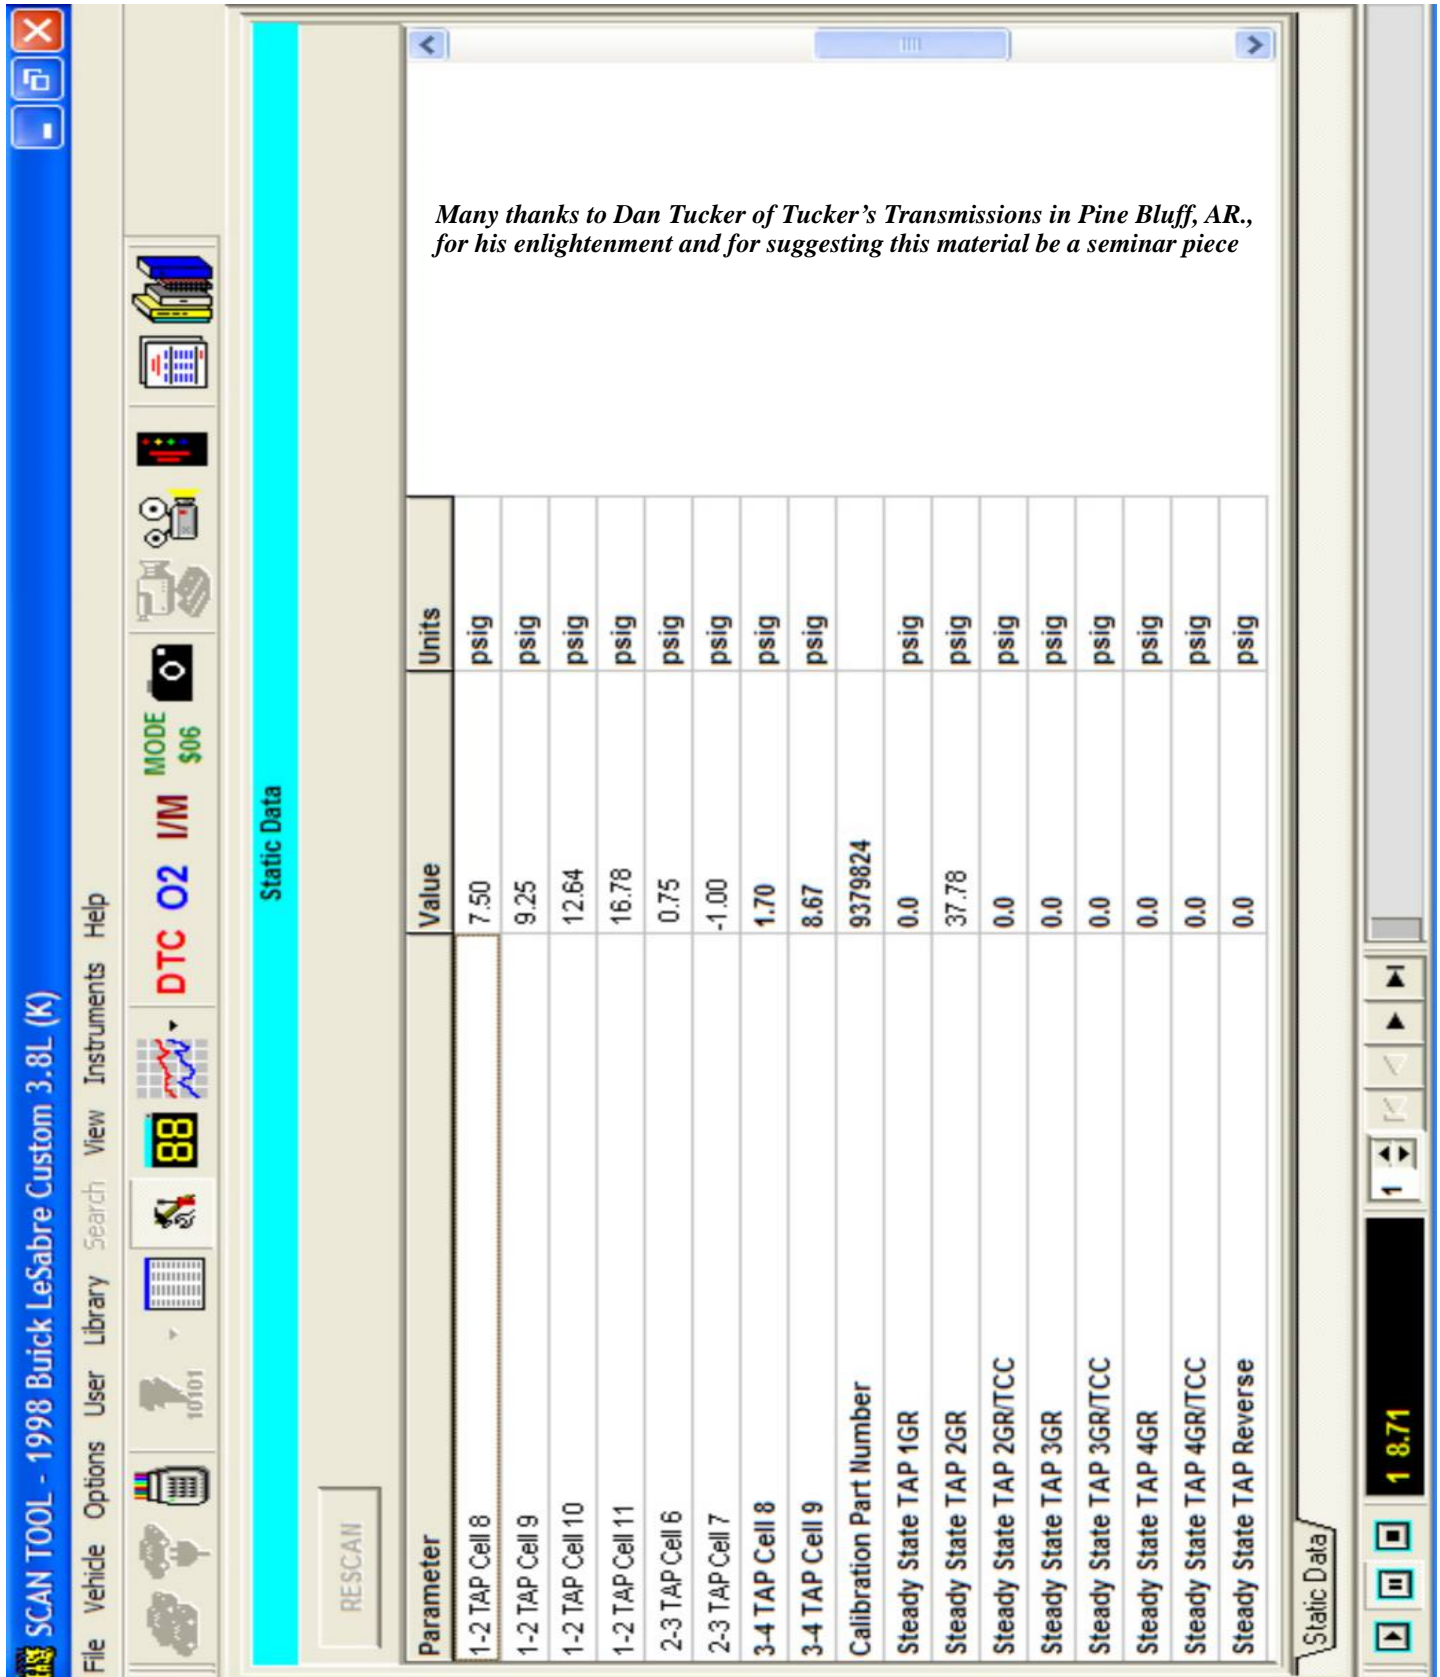
Figure 2

The P1811 indicates that the PCM has attempted to compensate for the intermittent shift timing error by raising line pressure during the 1-2 shift as seen in the shift adapt report in Figure 2. The numbers without minus signs indicate how much line rise will be added to the next 1-2 shift for that particular Tap Cell.

Should a component slip, this would be seen on the scan tools adaptive data list, (Refer to Figure 2), and would indicate a number which shows how much line pressure is going to be increased to keep that component from slipping. The worse it's slipping the higher that number will be, when there is no problem the steady state will be zero.

As can be seen in Figure 2, there is a problem with second gear, that steady state is elevated while the rest are zero. This would explain the above complaint.

CORRECTION: Using a 4T65E as an example, to correct slightly elevated Tap Cells usually requires replacement of the pressure control solenoid.

Another reason is, after repairs are completed, the PCM still believes it must slam that component on, in other words, it does not know the problem has been fixed. You must reset the shift adapts for the transmission to return to normal operating conditions.
