Technical Service Information

THM 4T60-E 2ND GEAR VIBRATION 40-55 MPH

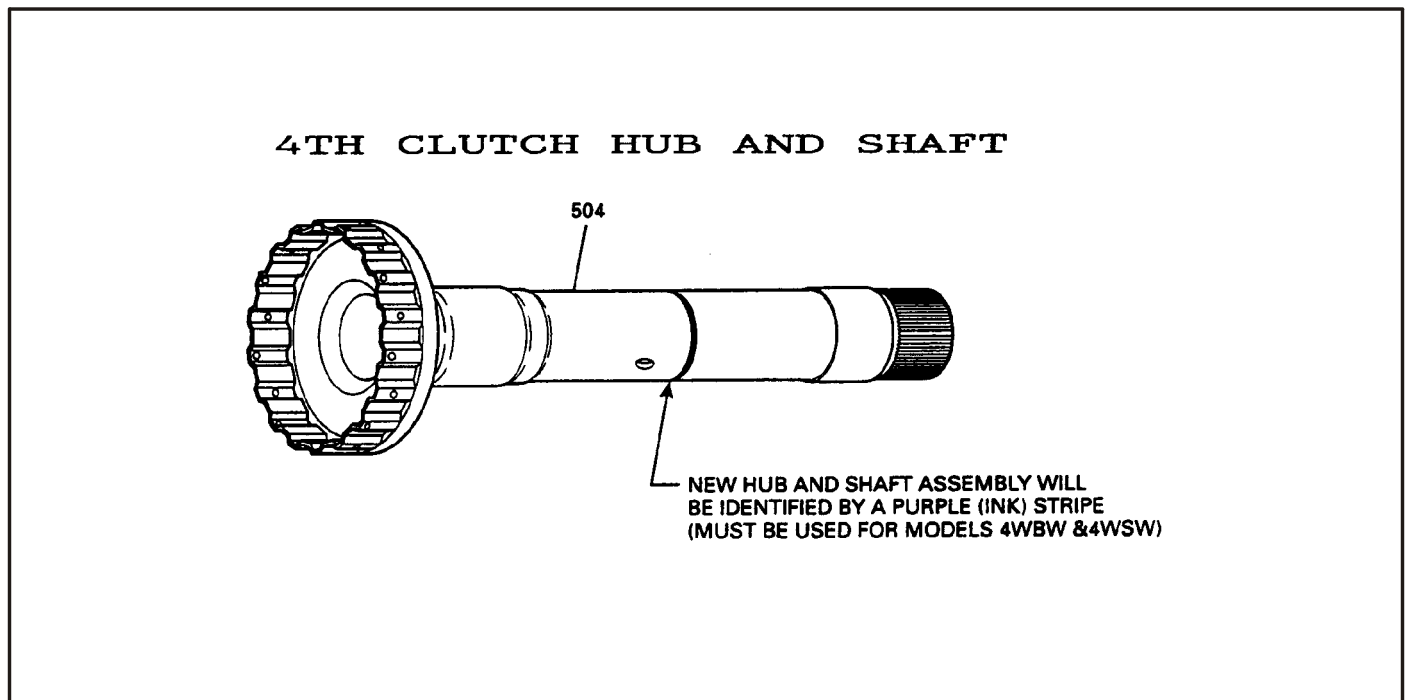
Figure 1

CAUSE: The cause may be, the 4th Clutch Hub and Shaft Assembly that houses the 4th Clutch Bearing Assembly inside the shafts bore. Sensitivity of the location of this bore in relation to the outer hub and shaft may cause the transaxle to vibrate in 2nd gear at high engine RPM.

CORRECTION: Install a newly released 4th Clutch Hub and Shaft Assembly, OEM part number 24201094, and can be identified by a purple ink stripe around its shaft as shown in Figure 1. This shaft assembly **MUST** be used for model codes 4WBW and 4WSW.
