Technical Service Information

THM 4L80-E

3RD GEAR STARTS & TIE UP IN MANUAL LOW

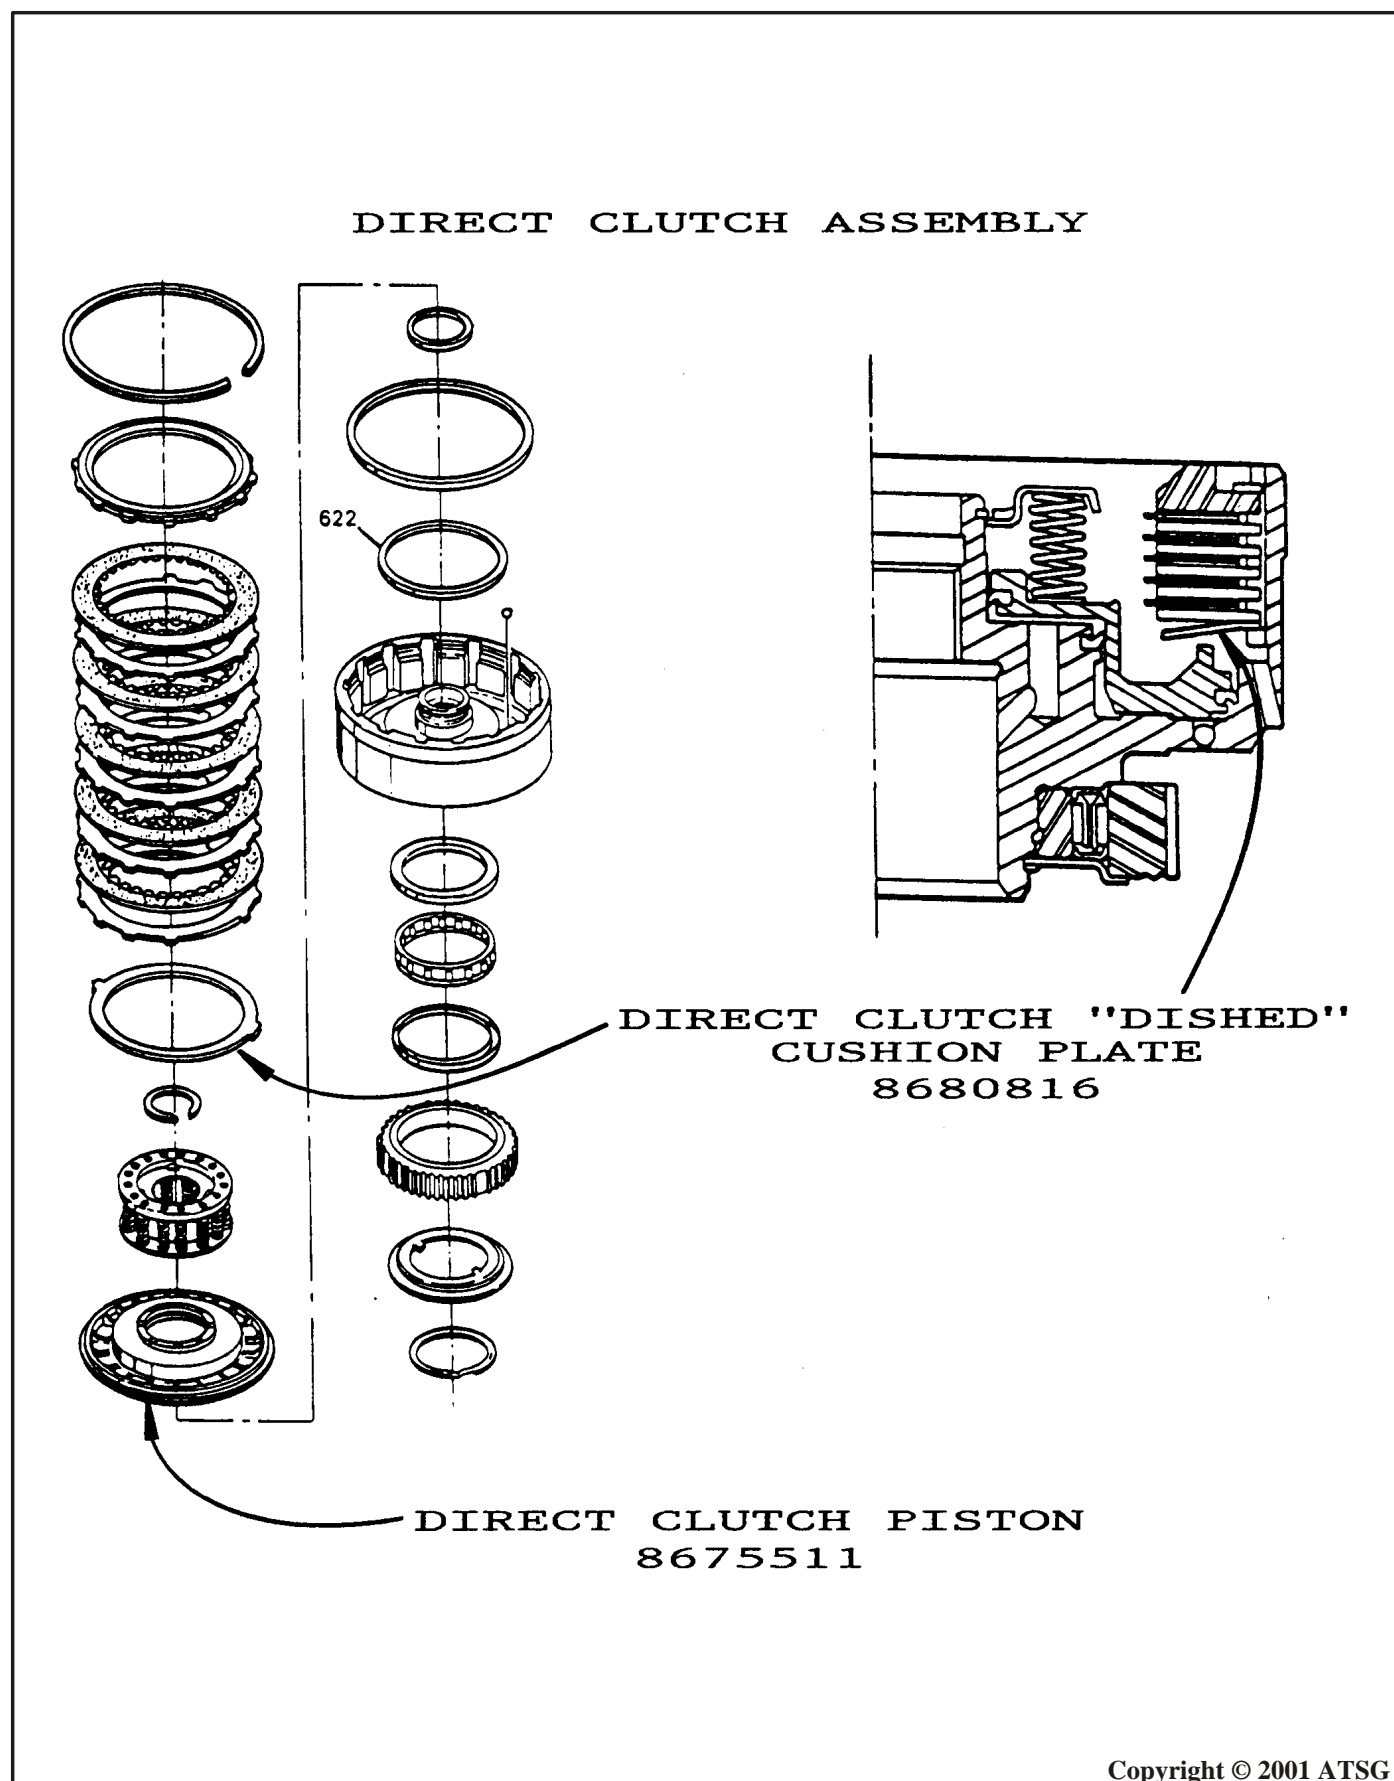
Figure 1

CAUSE: The cause may be a broken Direct Clutch "Dished" Cushion Plate in the direct clutch pack, and/or a broken Direct Clutch Piston.

NOTE: The Direct Clutch "Dished" Cushion Plate goes into the direct drum, in the direction shown in Figure 1, so that the inside diameter is closest to the Direct Clutch Piston.

CORRECTION: **STEP 1:**
If the Direct Clutch Piston is broken replace it with a new one, OEM part number 8675511 (See Figure 1).

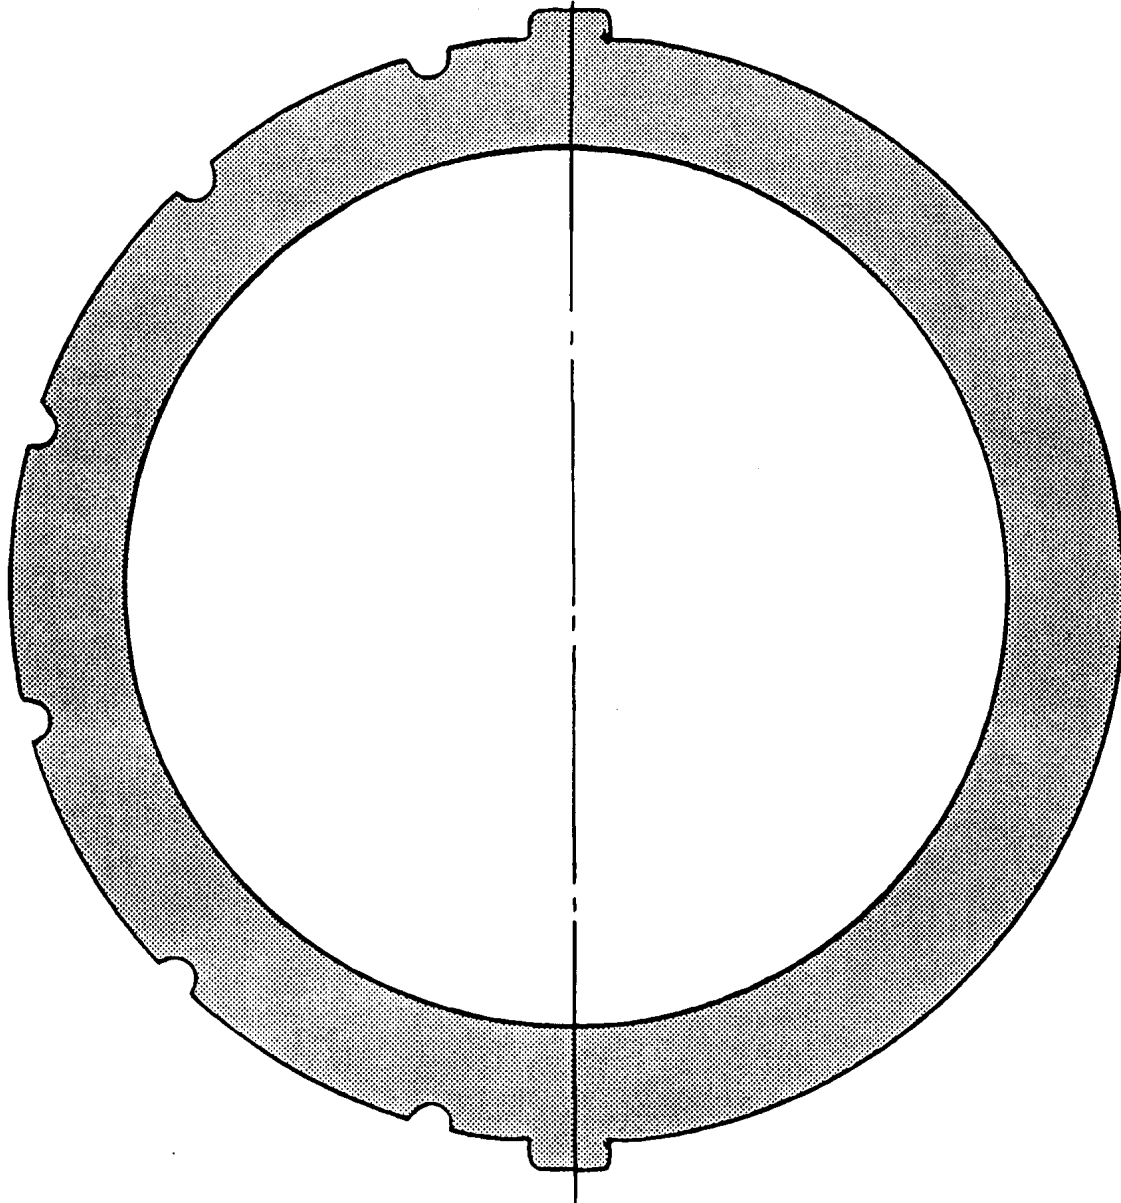
Figure 2

DIRECT CLUTCH "DISHED" CUSHION PLATE

1ST DESIGN
DO NOT USE!

2ND DESIGN
OEM PART NUMBER
8680816

STEP 2:
If the Direct Clutch "Dished" Cushion Plate is broken replace it with a redesigned version, OEM part number 8680816. The new design "Dished" Cushion Plate does not have any notches cut into the outside diameter, as shown in Figure 2.
