Technical Service Information

NISSAN RL4F02A EARLY/HARSH UPSHIFTS

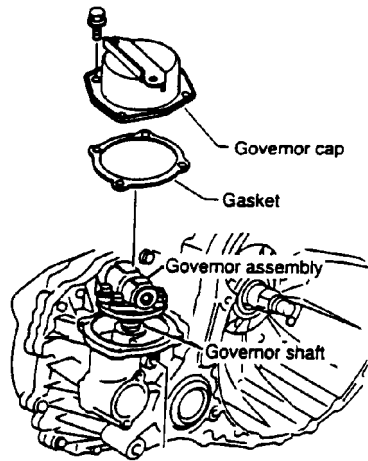
Figure 1

COMPLAINT: Some 1985-1986 Maxima vehicles with RL4F02A transaxles may exhibit early/harsh upshifts under light throttle openings and/or a clunk on a closed throttle 2-3 upshift.

CAUSE: The cause may be valve body and governor calibration.

1. Remove battery and bracket.
2. Remove air cleaner, air flow meter, air camper and solenoid valves as an assembly.
3. Remove Governor cap and gasket.
4. Install the new governor assembly (31860-24X04) on the governor shaft, and torque bolts (4) to 3.6-5.1 ft. lb. (See Figure 1).
5. Re-install governor cap and gasket.
6. Disconnect the control cable and throttle cable, remove the throttle lever (Figure 2) and remove the transaxle cover.
7. Disconnect the harness connector from the valve body, and remove ONLY the valve body bolts indicated in Figure 3.
8. Remove and replace the 6 springs that are numbered, as shown in Figure 3.
9. Re-install valve body and torque bolts to 5.1-6.5 ft. lb.
