A4LD UPDATE HANDBOOK INDEX

Updated
April, 2004

FORD A4LD

"UPDATE HANDBOOK"

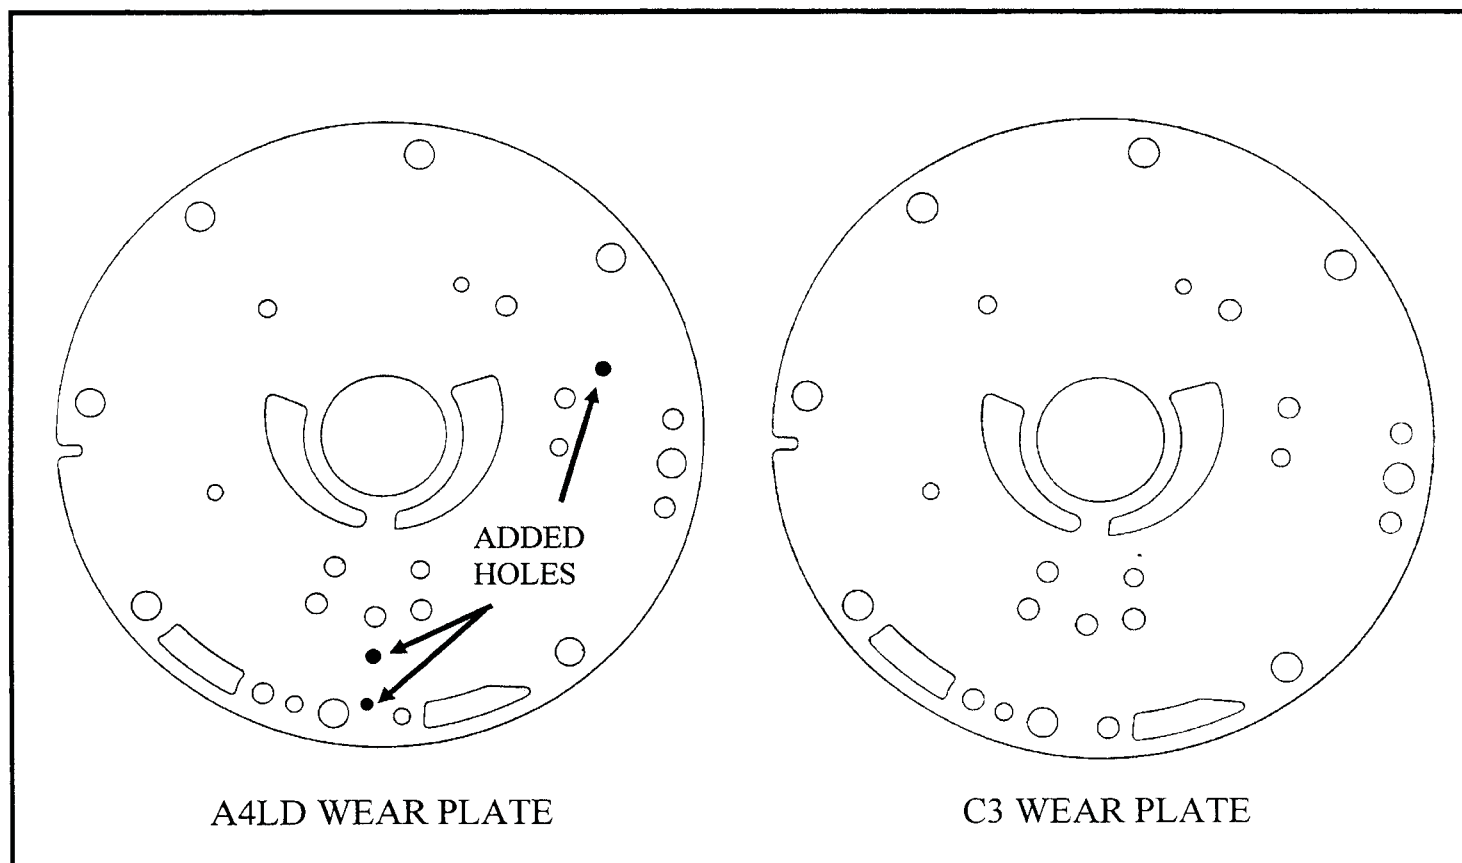
Bell housings, plates, and pumps are interchangeable as a matched set. A C-3 pump plate can be used in an A4LD pump if the 3 holes shown in Figure 9 are drilled. An A4LD pump plate must be used to locate the holes.

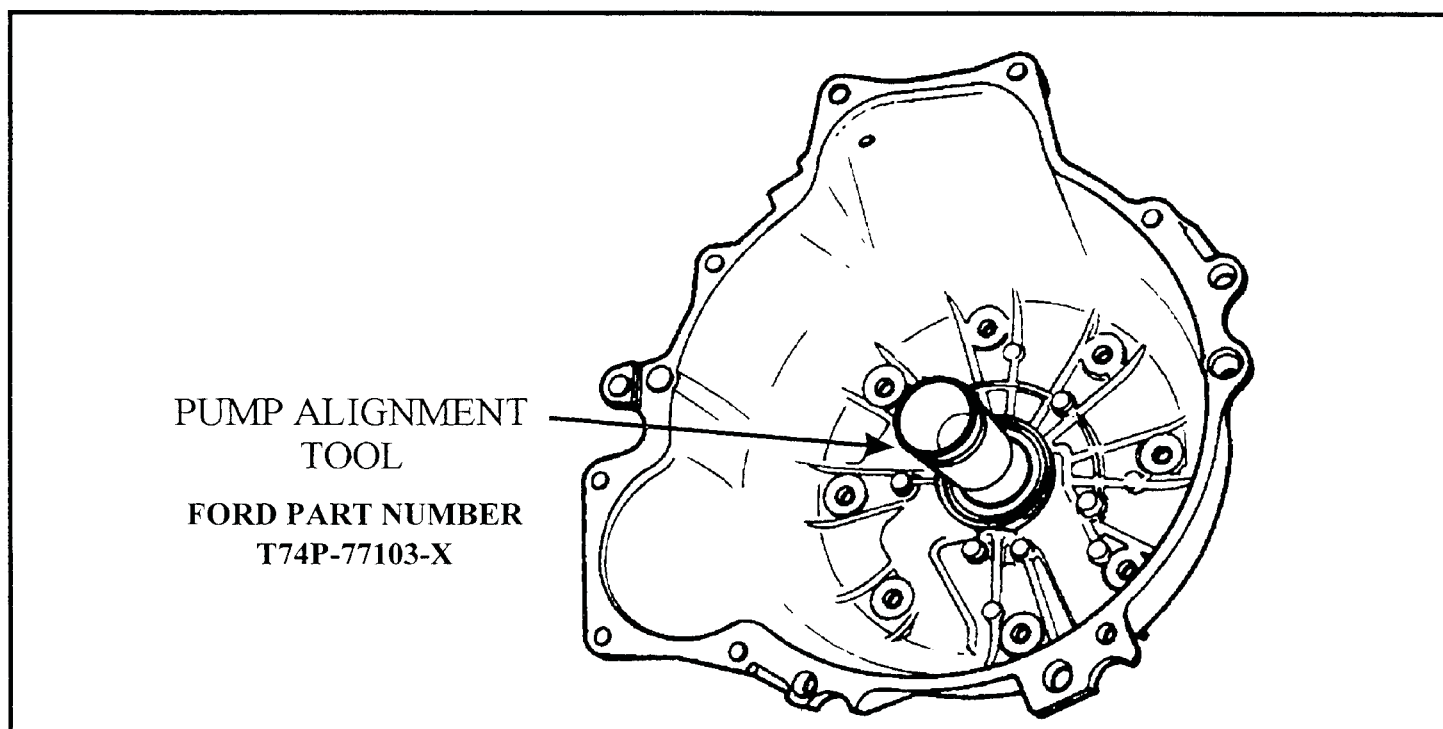
Figure 10

- (1) PUMP GEARS BREAKING
- (2) PUMP WHINE
- (3) IRREGULAR BUSHING WEAR
- (4) IRREGULAR CONVERTER HUB WEAR
- (5) FRONT SEAL LEAK OR BLOW OUT

Another concern that may be attributed to the above listed problems, is replacement of the front pump bushing in the bell housing. At the factory, Ford puts an oversized bushing in the bell housing and then bores the bushing to the proper size, and establish the centerline. When a new bushing is installed, (possibly off center) pump alignment may not be possible. Ford Motor Company recommends using a new bell housing if bushing replacement is necessary. Aftermarket exchange bell housings with line bored bushings are also available.

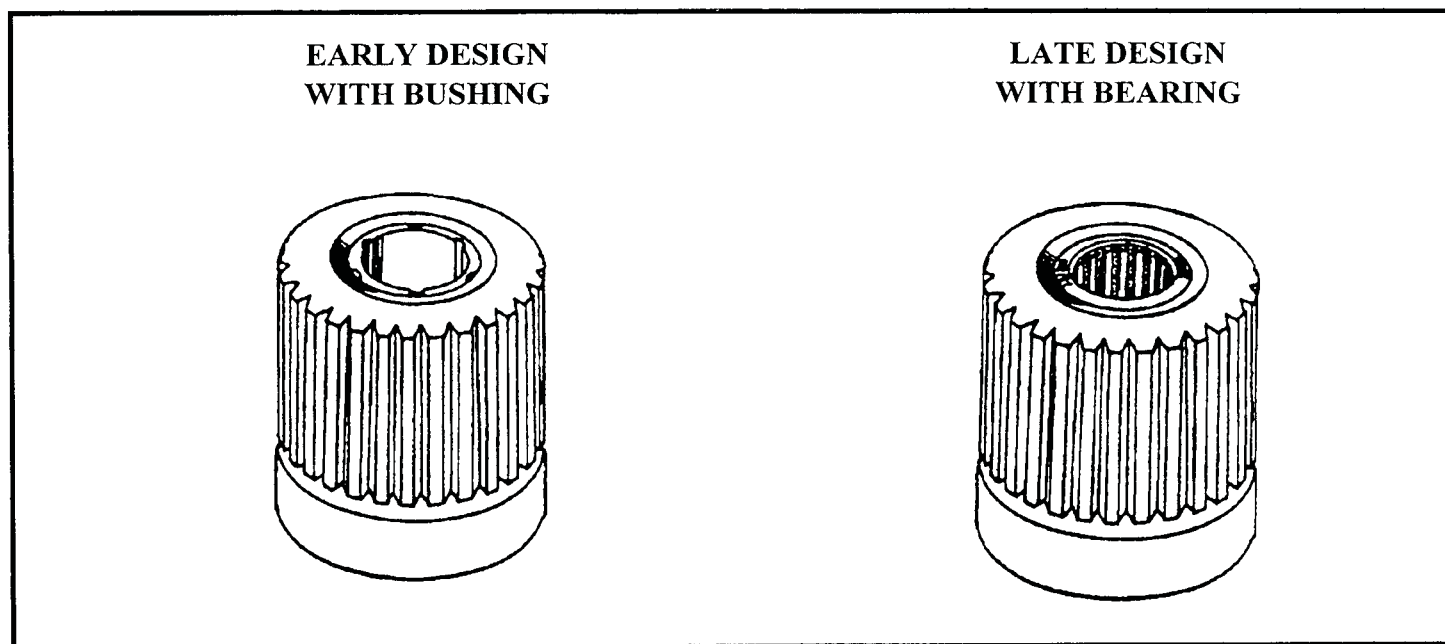
Figure 17

- 4. Bushing in the front end of the output shaft for wear and/or damage. This will support the forward clutch drum and the overdrive center shaft. Replace this bushing on All units during rebuild (See Figure 17).
NOTE: In later applications a caged needle bearing is used in this location. Inspect and replace as necessary (See Figure 17).

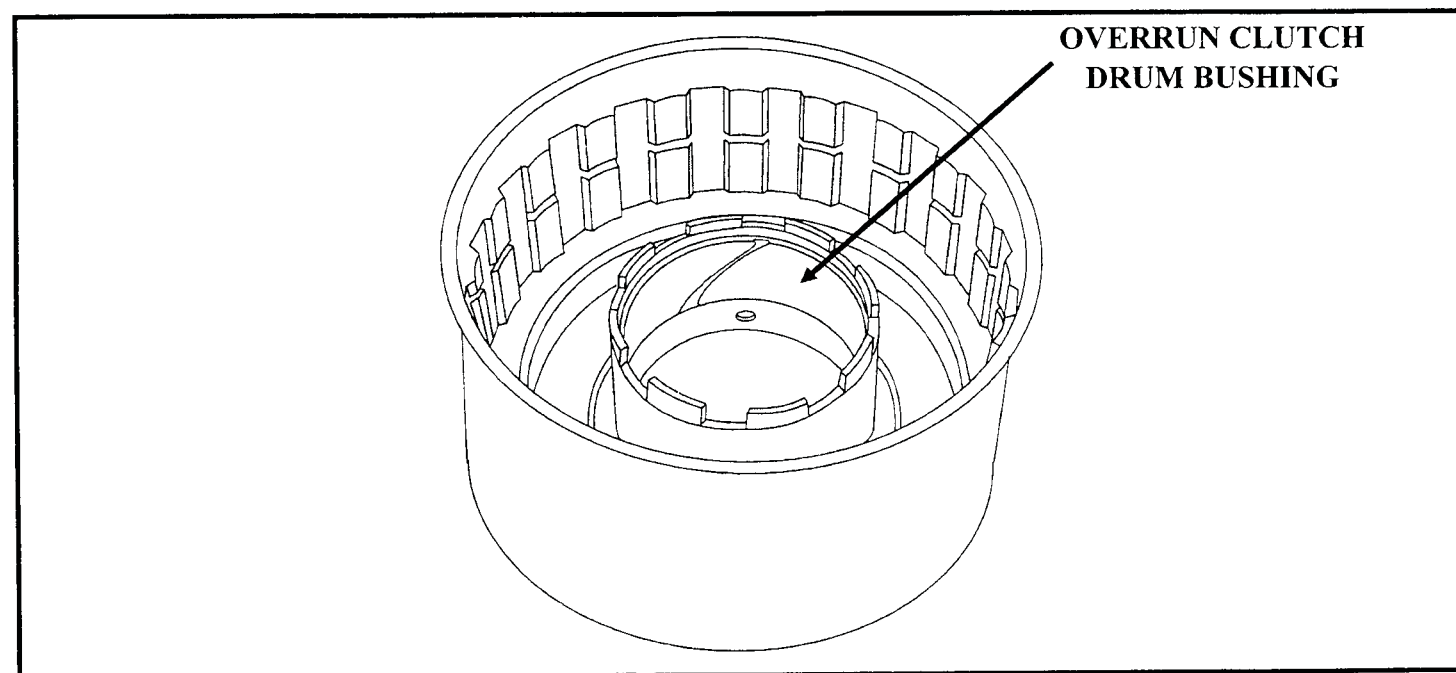
Figure 18

- 5. Overrun clutch housing bushing for wear and/or damage (See Figure 18).
 - B. Ensure that the overrun clutch spring retainer is supported evenly, using an outer pump gear, when compressing the return springs to avoid ANY distortion. This is critical, and is easily distorted with any uneven pressure.

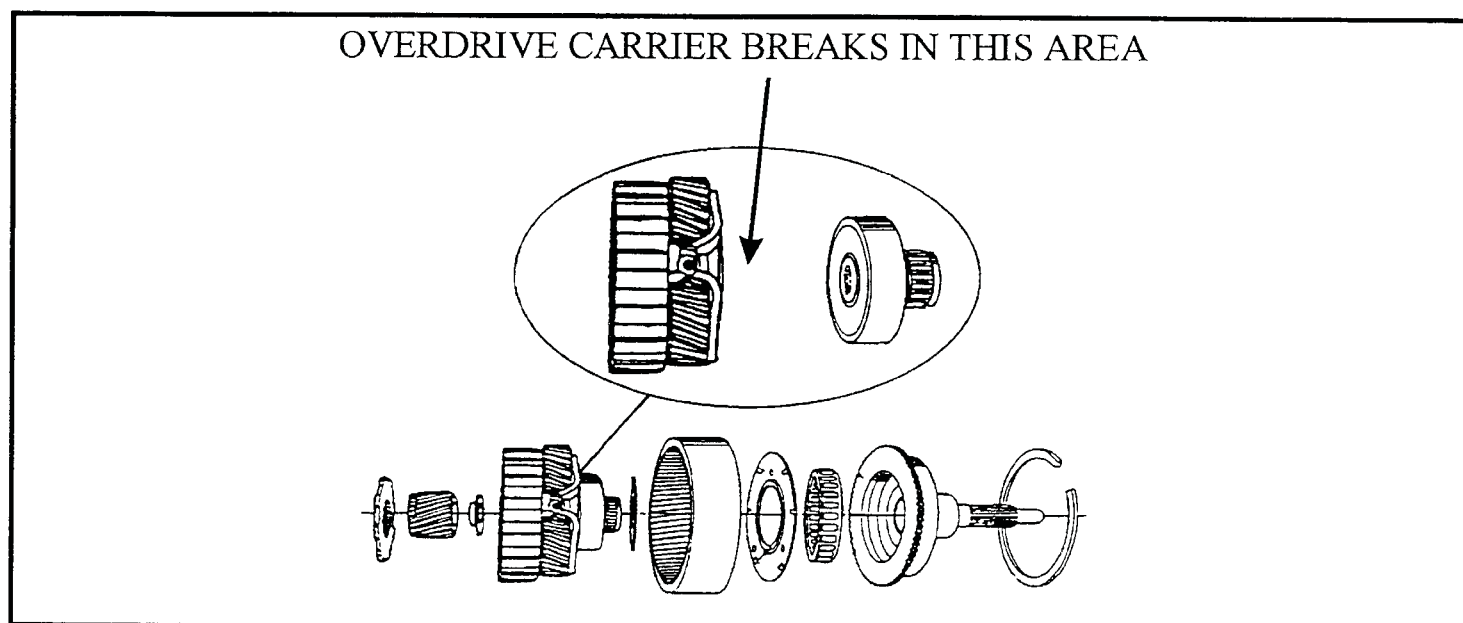
Figure 19

CAUSE: The cause may be, the overdrive sprag inner race broken loose from the carrier (See Figure 19). The problem is not always detectable because the bearing inside the carrier hides the broken area of the carrier. The sprag inner race and splined area for the input shaft "MUST NOT" turn. Use a little force if necessary to check this.

CORRECTION: Replace the overdrive carrier. Remanufactured "HEAVY DUTY" planetary carriers are available from aftermarket suppliers (See Figure 20).

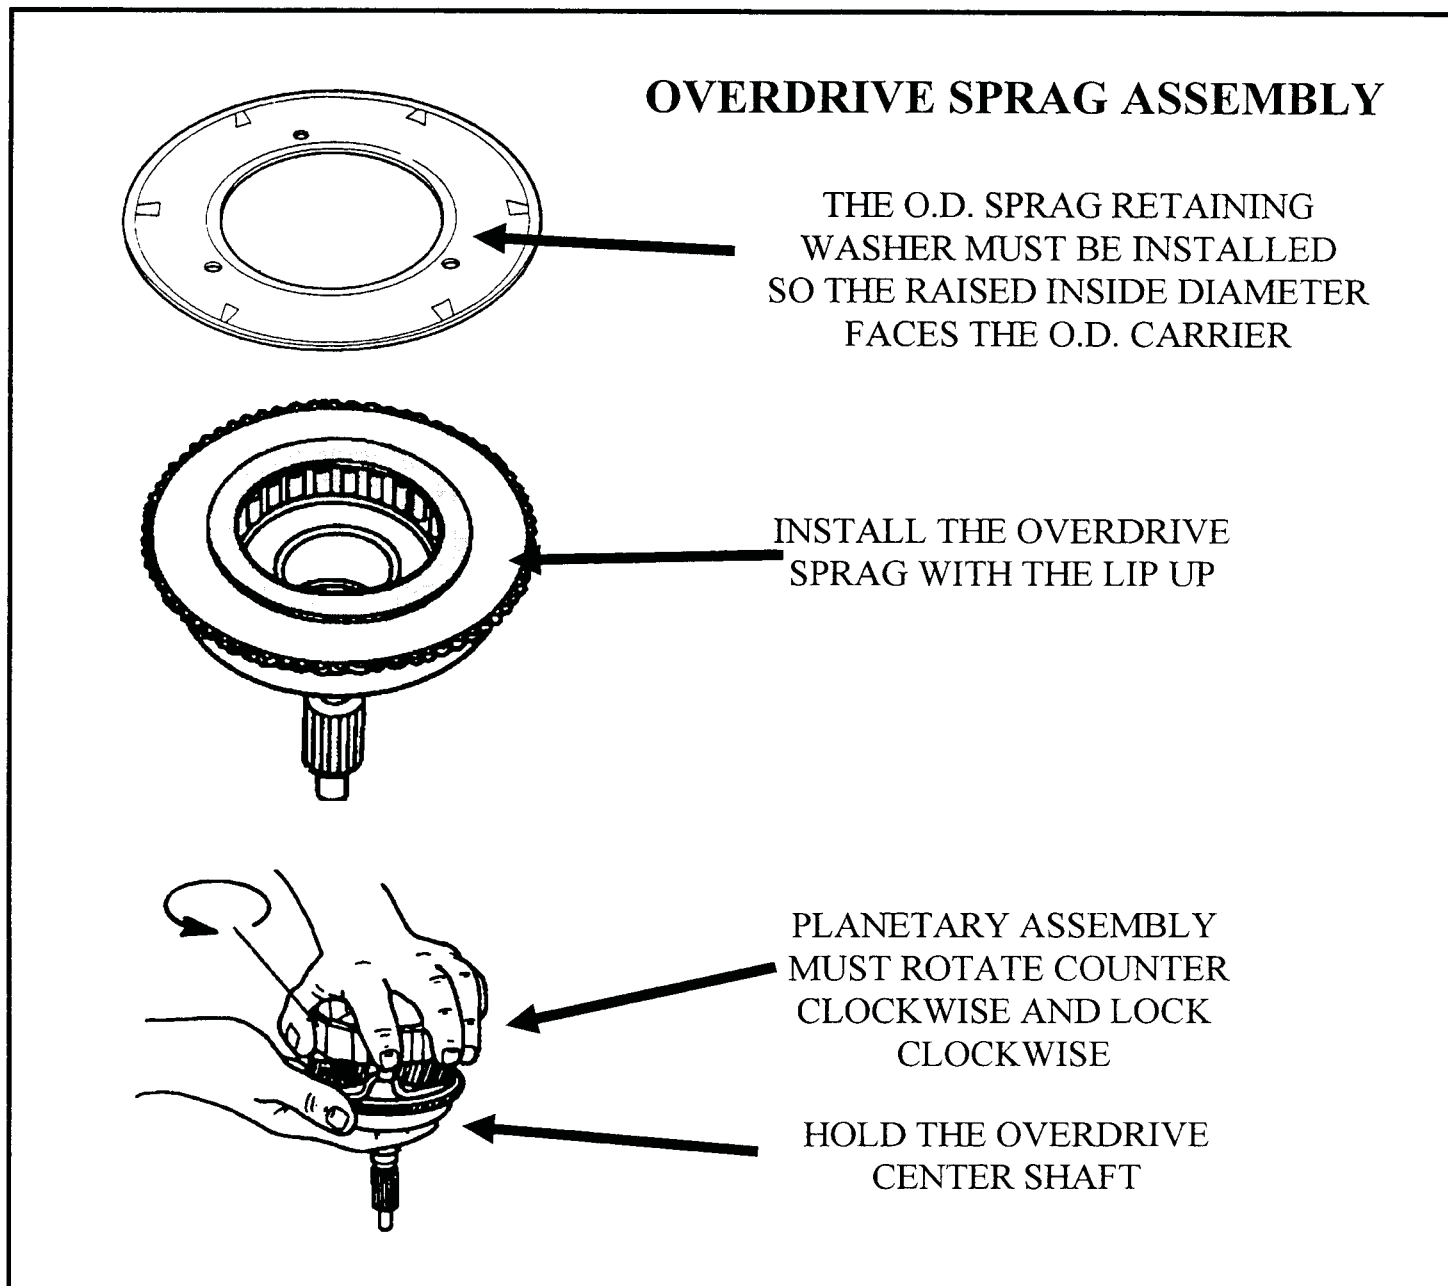
Figure 21

CAUSE: The cause may be the overdrive sprag in backwards or not holding (See Figure 21).

CORRECTION: Replace the overdrive sprag, and inspect the inner and outer sprag races for wear or damage.

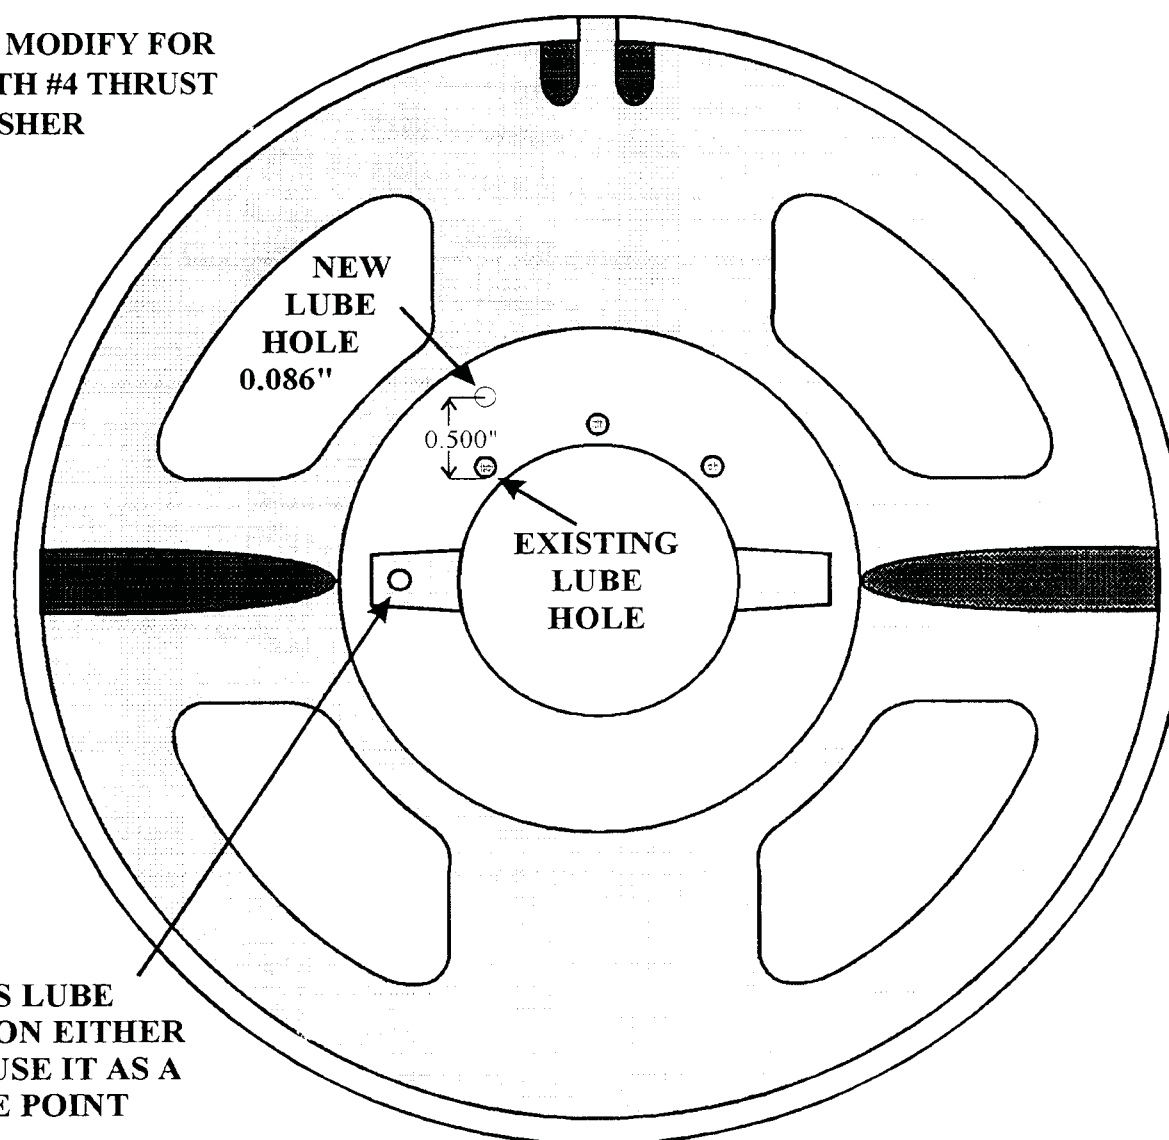
Figure 28

COMPLAINT: Failure of the selective #4 thrust washer between the center support and the direct drum.

CAUSE: The cause may be lack of lubrication to the #4 thrust washer.

CORRECTION: Drill a new lube hole in the center support. Measure 0.500" up from the bottom of the existing hole, drill a 0.086" hole all the way through the center support (See Figure 28).

**NOTE: ONLY MODIFY FOR
MODELS WITH #4 THRUST
WASHER**

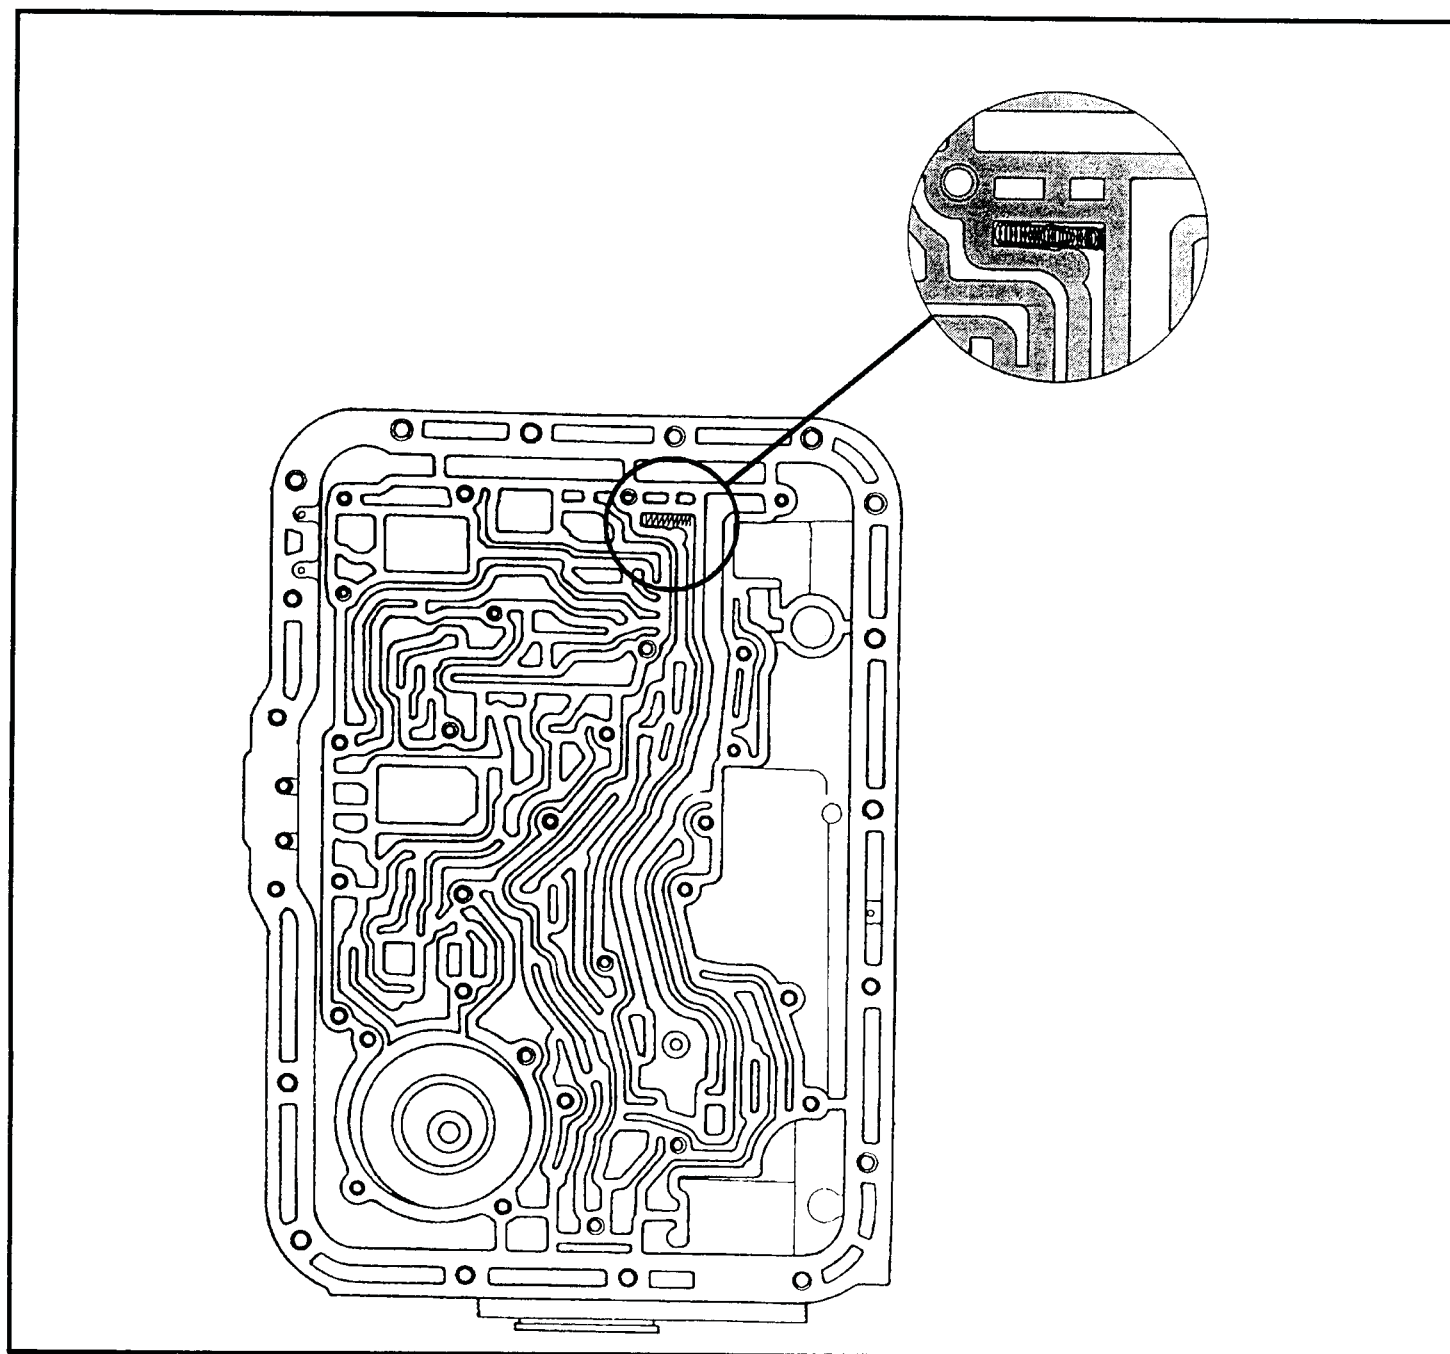
Figure 61

A spring was installed in the transmission case worm track to trap large machining chips and reduce engine stall complaints created by a stuck converter lock up valve in the valve body (See Figure 61).

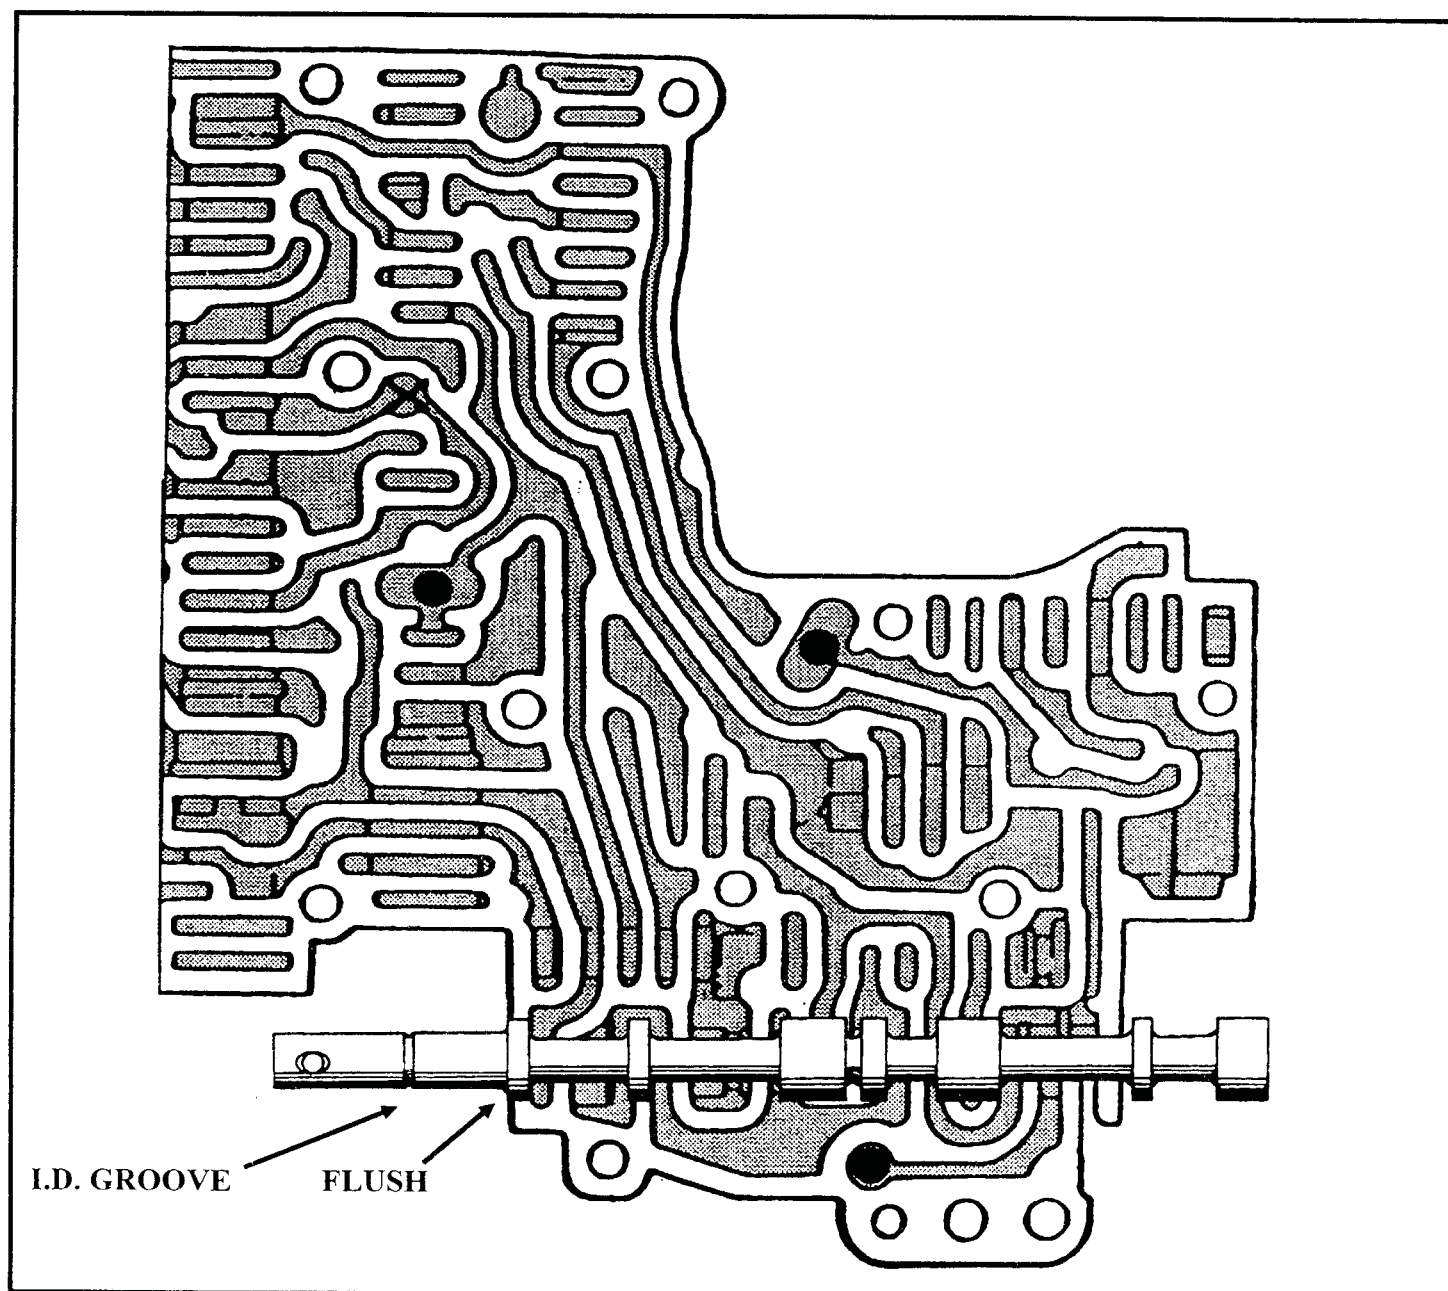
Figure 75

COMPLAINT: After overhaul, your A4LD transmission exhibits a "Tie-Up" condition, when the selector lever is placed into the park position.

CAUSE: The cause may be, an improperly adjusted manual valve. The .075" puck supplied in some gasket sets & some valve body kits WILL NOT WORK ON ALL MODELS. On SOME valve bodies, using the "Puck" to adjust the manual valve, will allow the manual valve to move past the Park position and apply the forward clutch.

- (1) Measure the link hole in the manual valve to ensure that it is .157" in diameter, and has not elongated due to wear. It is also recommended to use the latest manual valve, with the I.D. groove near the hole, OEM #E8TZ-7C389-A (See Figure 75).
- (2) With the valve body installed on the transmission, place the manual lever in the "D2" position.
- (3) With the selector in the "D2" position, the first land on the manual valve should be flush with the valve body casting, as shown in Figure 75. However .010" below flush to .020" above flush with the valve body casting is totally acceptable.
- (4) Bend the manual valve link as necessary to achieve the dimensions listed above.

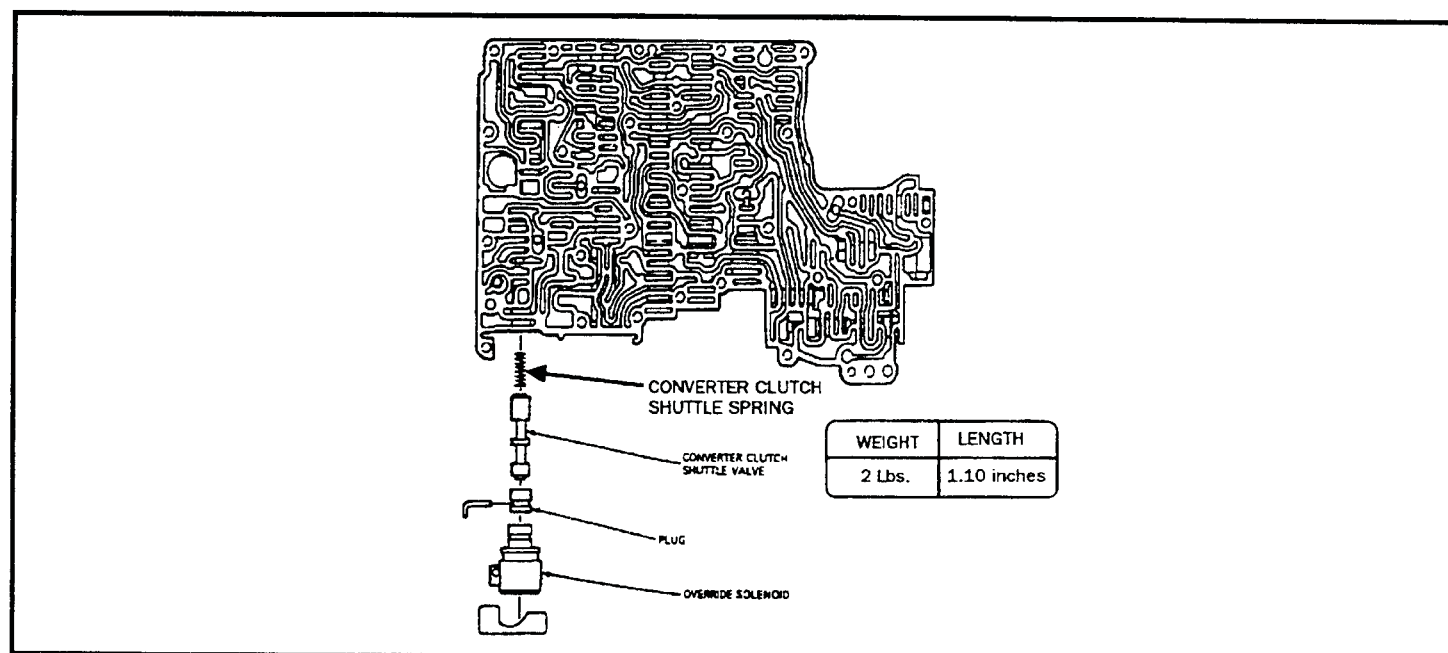
Figure 79

- CAUSE:**
- (1) The lock-up solenoid may not have been correctly bench checked during overhaul or when failure is suspected. This is due to confusion in printed material regarding air test procedures and ohms check procedures.
 - (2) The converter clutch shuttle spring is broken or collapsed
 - (3) The converter clutch TV modulator spring is not strong enough to shut off line pressure to the converter clutch shuttle valve during coastdown.

- (2) Remove the converter clutch shuttle valve and spring from the valve body. Inspect and replace as necessary, (See Figure 79). the converter clutch shuttle valve spring should be 1.10 inches in length and should weigh about 2 lbs. before coil bind.

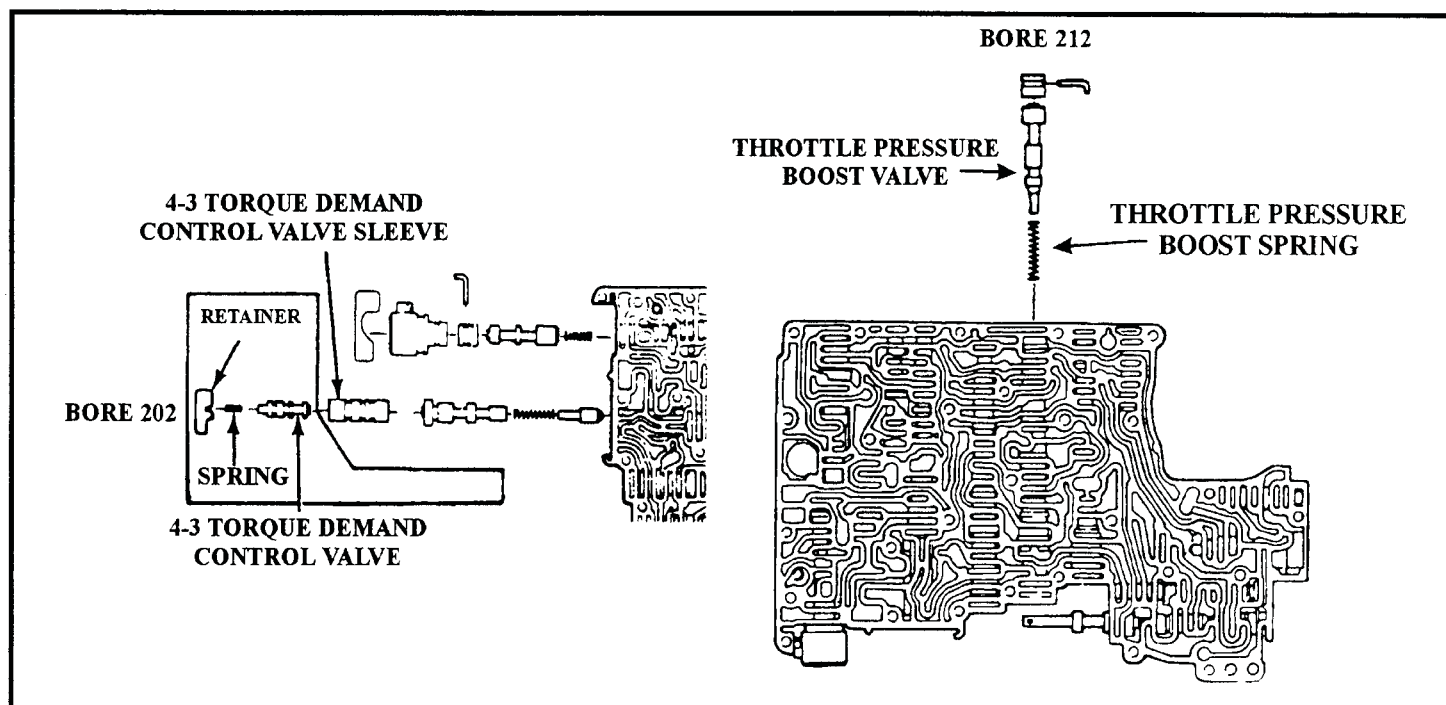
Figure 82

CAUSE: The cause may be an incorrectly calibrated throttle pressure boost spring and 4-3 torque demand control valve spring (See Figure 82).

CORRECTION: Replace both the throttle pressure boost spring and 4-3 torque demand control valve spring

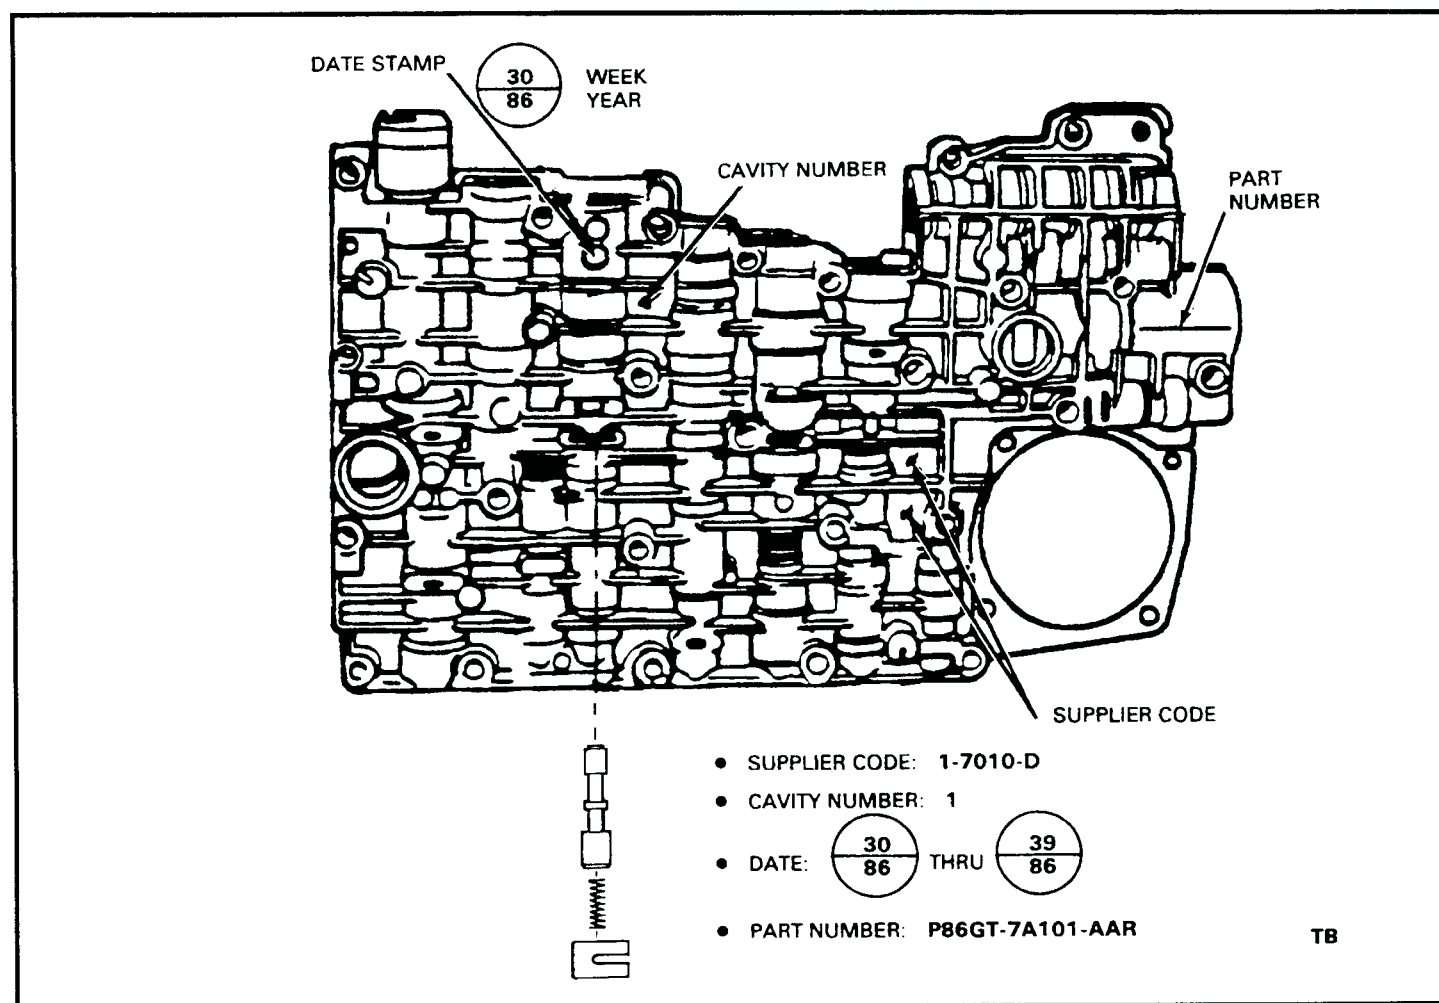
Figure 83

CAUSE: The cause may be a casting flaw with a mispositioned channel in bore # 214, which is the 3-2 kickdown timing valve bore.

CORRECTION: To compensate for the casting flaw, replace the 3-2 kickdown timing valve with an updated valve (See Figure 83).
